**Final Report - Capital Plan  
Building Condition and Energy Assessments  
Gray Memorial Arena  
10 Monique Avenue  
Dartmouth, NS**

**September 13, 2010  
Project Number 1001046.2**

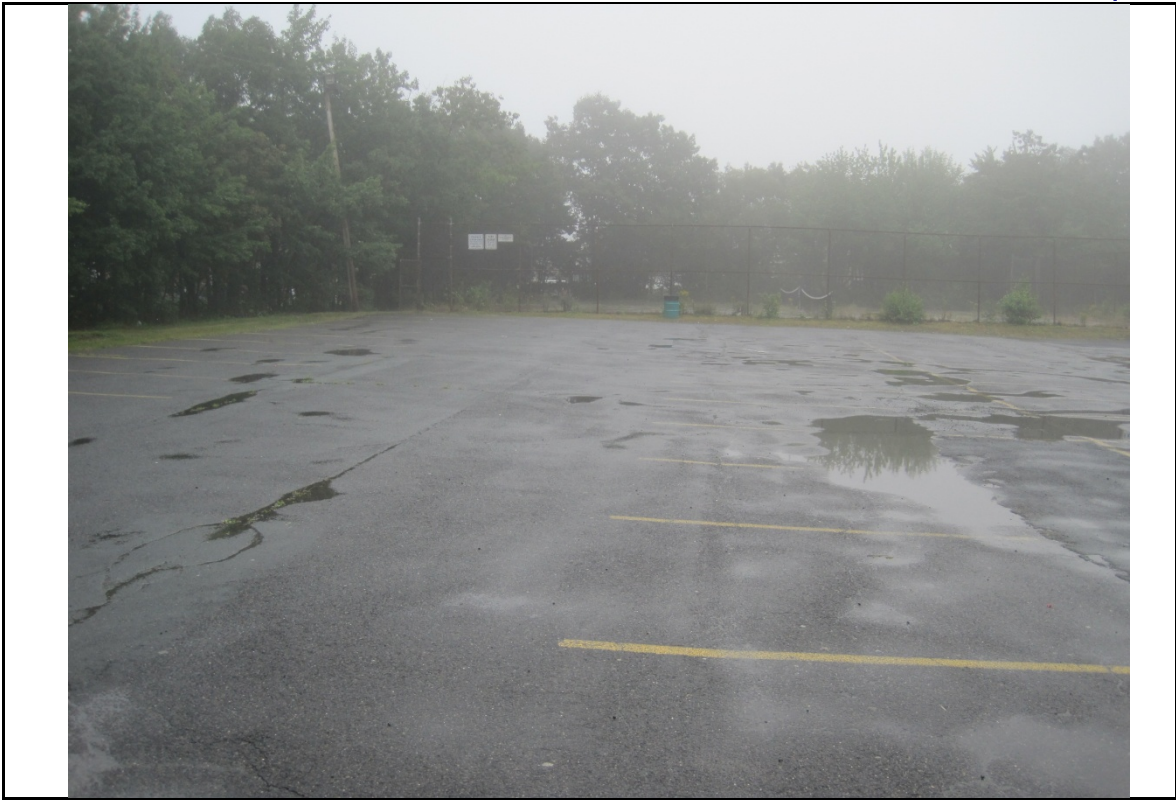
At the time of the site visit the asphalt parking areas appeared to be in fair to poor condition with numerous areas of settlement, alligator/longitudinal cracking and evidence of past localized repairs. Asphalt paving typically has an expected useful life of fifteen years depending on the frequency of use, maintenance and quality of the original installation. In addition this can be further extended with ongoing localized repairs and minor replacements completed on an as required basis. Based on the observed condition it is expected that a resurfacing will be required in the short term of the evaluation period. For the purposes of the capital plan a resurfacing/replacement allowance has been included in the short term with additional localized repairs beginning at year ten of the evaluation period with additional repairs at approximately seven year intervals thereafter.

**Photo 1:** Asphalt Parking Area

| Item | Action | Year of install | Expected Useful Life | Anticipated year of replacement | Quantity | Unit cost | Item cost |
|---|---|---|---|---|---|---|---|
| <b>Asphalt Paving - Repair</b> | Asphalt paving repair allowance | 2011 | 7 | <b>2018</b> | 1 | \$5,000 | <b>\$5,000</b> |

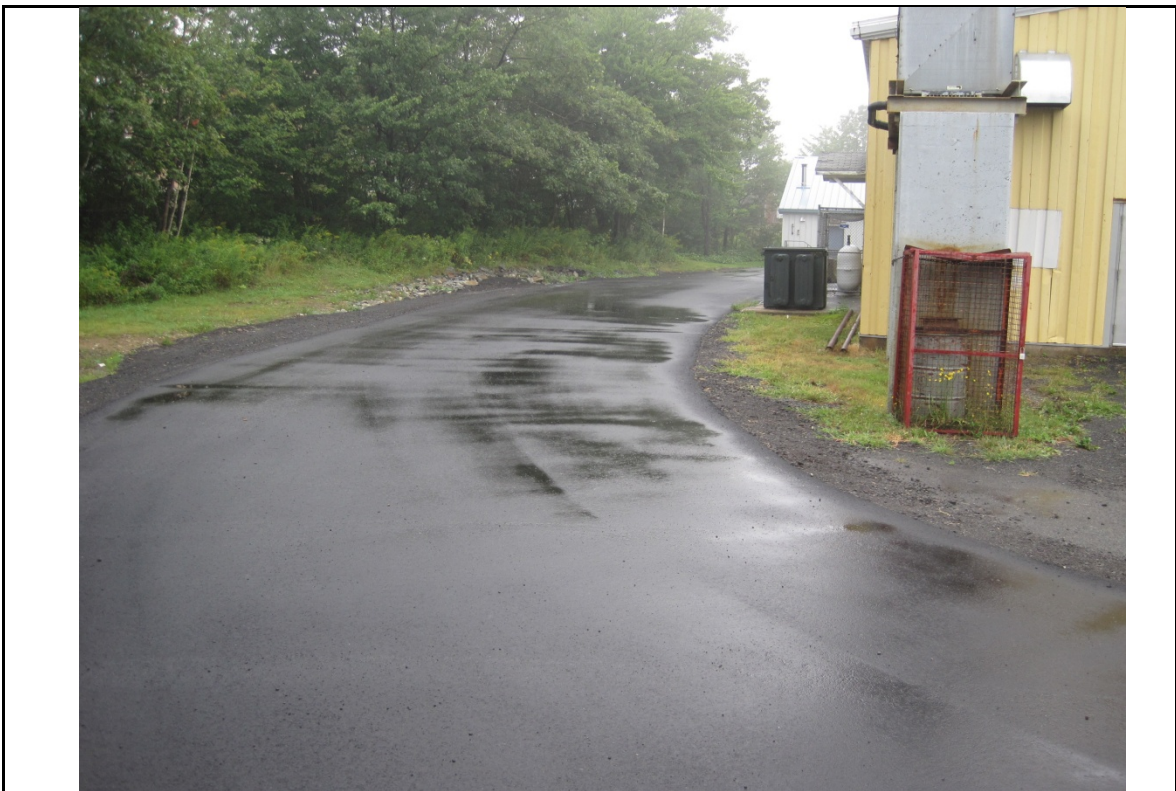
The secondary asphalt paved roadway appeared to be in good condition and it was reported that the roadway was installed in 2009 on top of an existing gravel roadway.

**Photo 2:** Asphalt Roadway at Rear of Building

Typically asphalt paved roadways have an expected useful life of fifteen to twenty years depending on the quality of the original installation and amount/frequency of use. Based on the observed condition and expected useful life, replacement is not expected to be required although localized patching and repairs can be expected during the evaluation period. It is expected that the majority of the repairs would coincide with repair of the parking areas. An allowance has been included in the capital plan for these localized repairs at seven year intervals during the evaluation period.

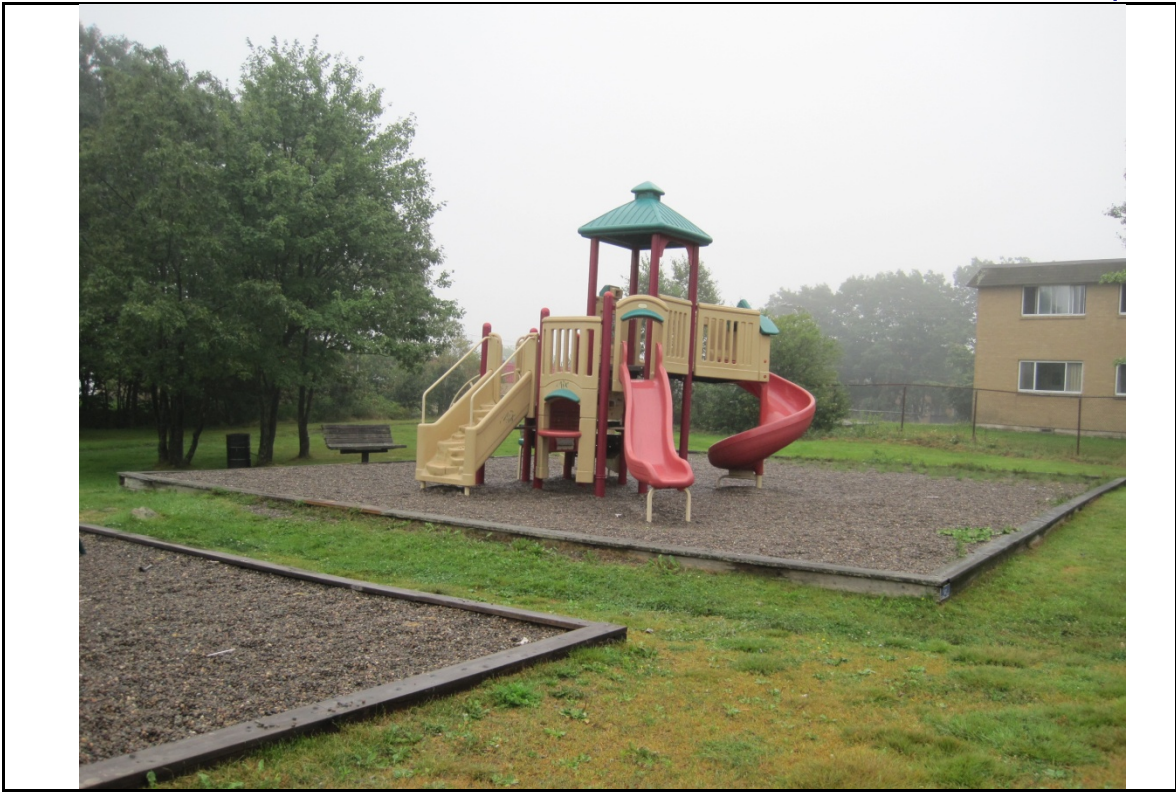
The playground area appeared to be in generally fair condition with some areas of damage and or vandalism observed. The age of the equipment was not reported but the swing set appeared to be fifteen or more years with the free standing equipment appearing to be approximately five years in age. Freestanding modular playground equipment has an expected useful life of ten to fifteen years with the swing set having a useful life of twenty or more years with occasional replacement of swing hardware. Based on the observed condition it is expected that that replacement will be required during the long term of the evaluation period. The estimated cost and timing has been included in the Probable Cost Table.

**Photo 3:** Playground Equipment

| Item | Action | Year of install | Expected Useful Life | Anticipated year of replacement | Quantity | Unit cost | Item cost |
|---|---|---|---|---|---|---|---|
| <b>Playground Equipment</b> | Replacement of playground equipment | 2005 | 15 | <b>2020</b> | 1 | \$50,000 | <b>\$50,000</b> |

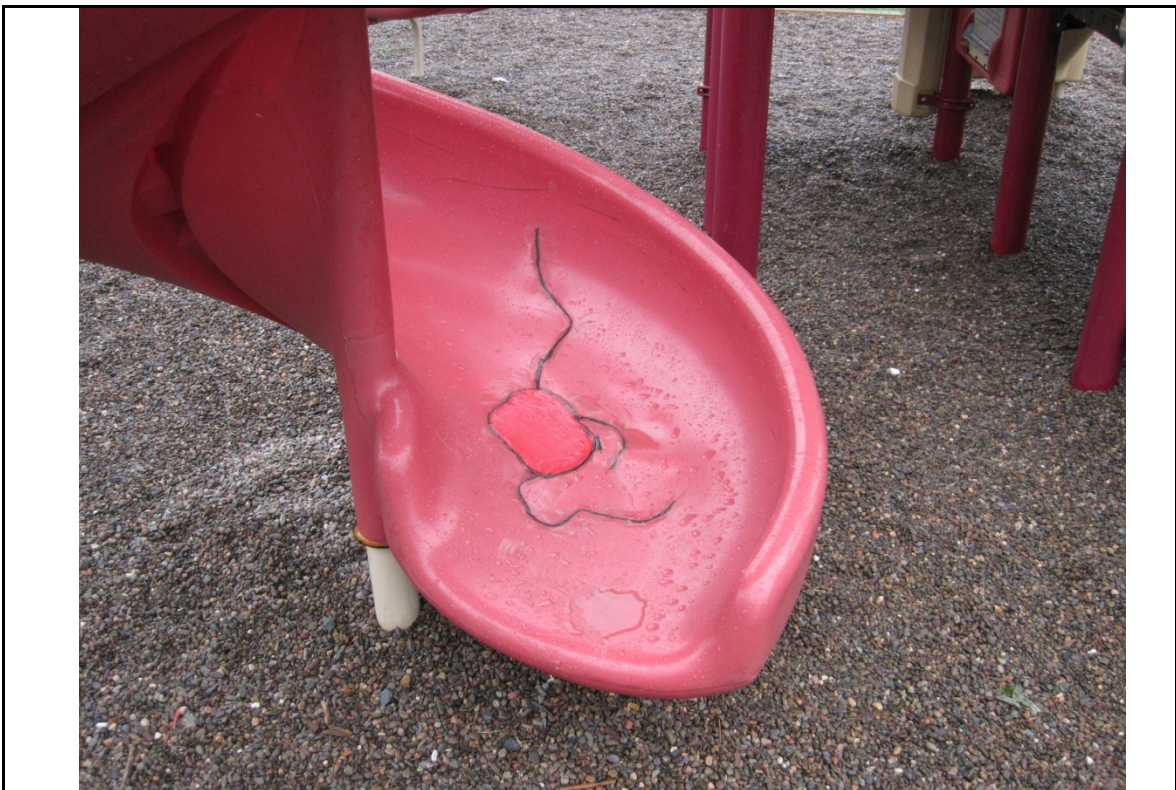
**Photo 4:** Damaged Playground Equipment

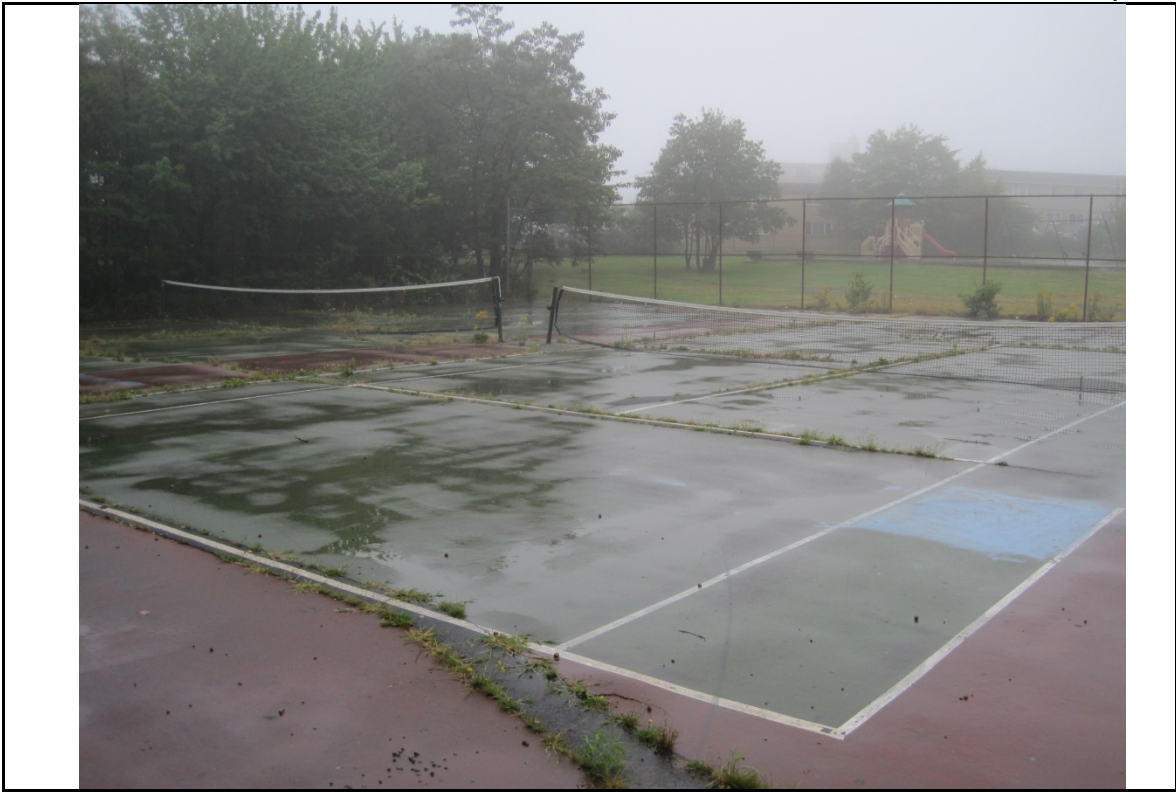
The tennis court appeared to be in poor condition with the condition of the asphalt playing surface appearing to be in unusable condition. Evidence of past asphalt repairs and extensive vegetation growth was observed during the site visit. The perimeter fencing and gates were corroded and only partially functional. Based on the observed condition it is recommended that the courts be either completely replaced or decommissioned if deemed not required. For the purposes of the capital plan an allowance for replacement has been included in the Probable Cost Table.

**Photo 5:** Tennis Court

| Item | Action | Year of install | Expected Useful Life | Anticipated year of replacement | Quantity | Unit cost | Item cost |
|---|---|---|---|---|---|---|---|
| <b>Tennis Court</b> | Replacement of Tennis Courts (2) | 1972 | 20 | <b>2011</b> | 2 | \$42,000 | <b>\$84,000</b> |

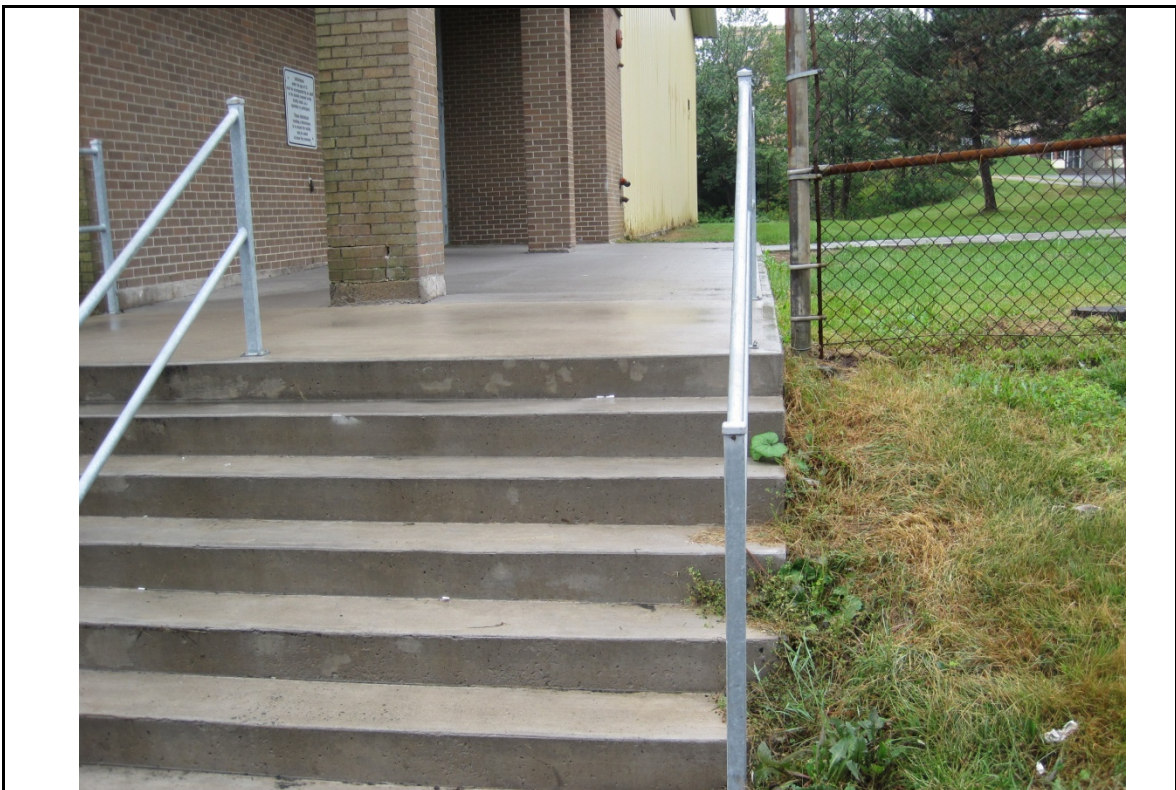
The concrete stairwell, landing, walkway and handrail accessing the main entrance appeared to be in new condition and should not require capital expenditure during the evaluation period. No costs have been included in the Probable Cost Table.

**Photo 6:** Concrete Stairwell and Walkway

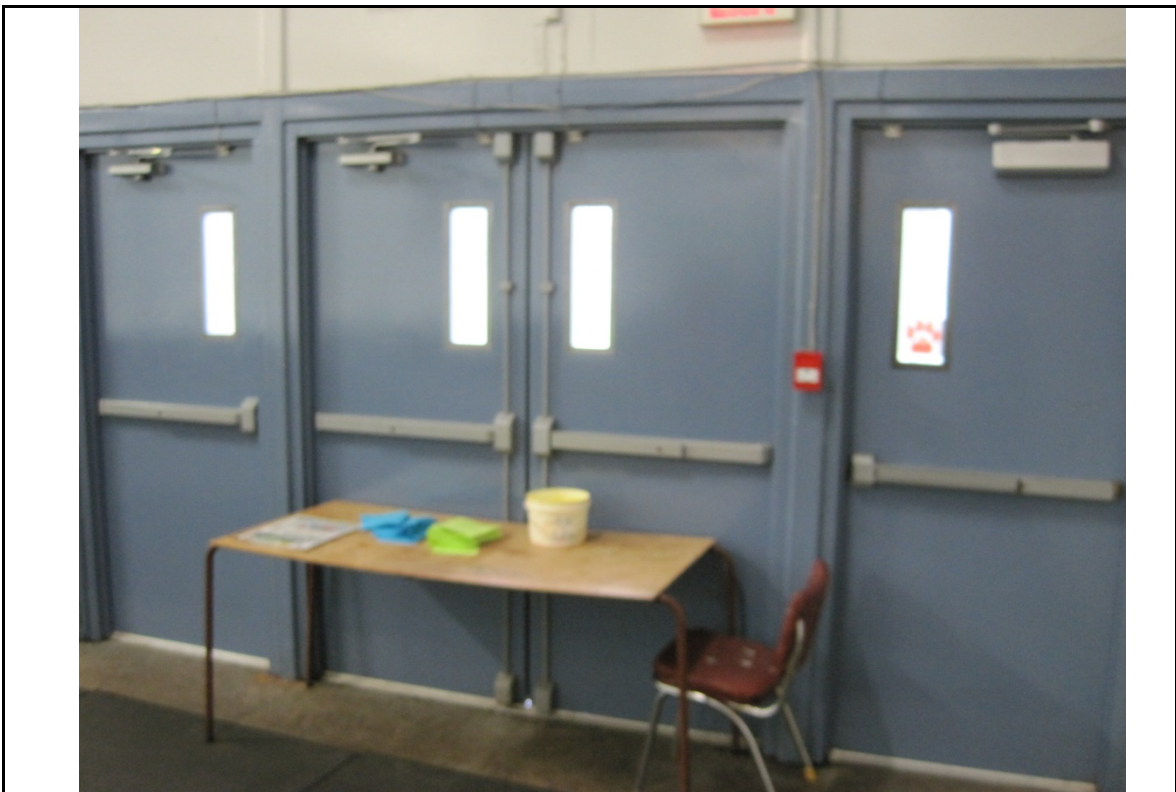
The main and secondary/exit doors appeared to be in good condition. The doors were reported to have been replaced within the past five years. Typically metal exterior doors have an expected useful life of twenty to twenty-five years. Replacement of the doors is not expected to be required until the extended portion of the evaluation period. The estimated cost and timing has been included in the Probable Cost Table.

**Photo 12:** Main Entrance Metal Doors

| Item | Action | Year of install | Expected Useful Life | Anticipated year of replacement | Quantity | Unit cost | Item cost |
|---|---|---|---|---|---|---|---|
| <b>Main and Secondary Entrance Doors</b> | Replacement at end of remaining useful life | 2005 | 25 | <b>2030</b> | 8 | \$1,350 | <b>\$10,800</b> |

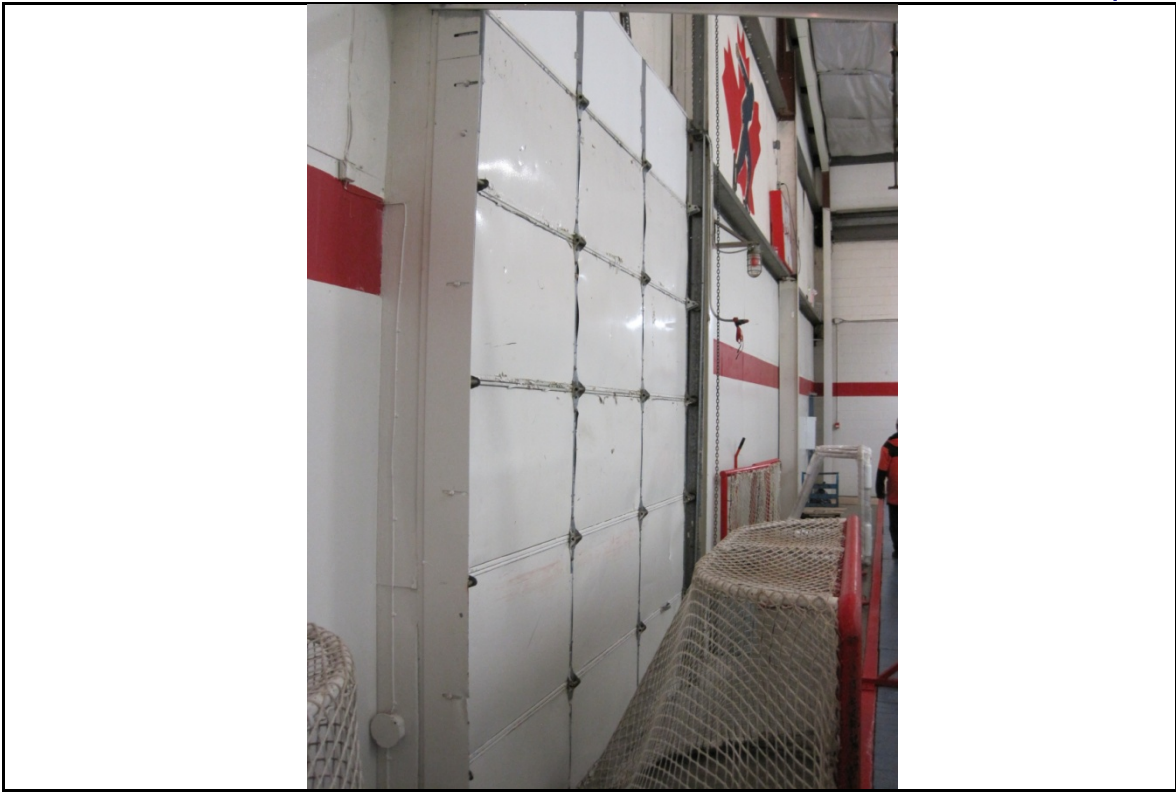
The overhead door on the east elevation appeared to be in fair condition although aged. Typically overhead doors have an expected useful life of fifteen years depending on the amount and frequency of use. Based on the observed condition and expected remaining useful life of the door replacement should be anticipated in the short term of the evaluation period. The estimated cost of the replacement has been included in the Probable Cost Table.

**Photo 13:** Overhead Door

| Item | Action | Year of install | Expected Useful Life | Anticipated year of replacement | Quantity | Unit cost | Item cost |
|---|---|---|---|---|---|---|---|
| <b>Overhead Door</b> | Replace east elevation overhead door at end of useful life | 1980 | 15 | <b>2014</b> | 1 | \$4,000 | <b>\$4,000</b> |

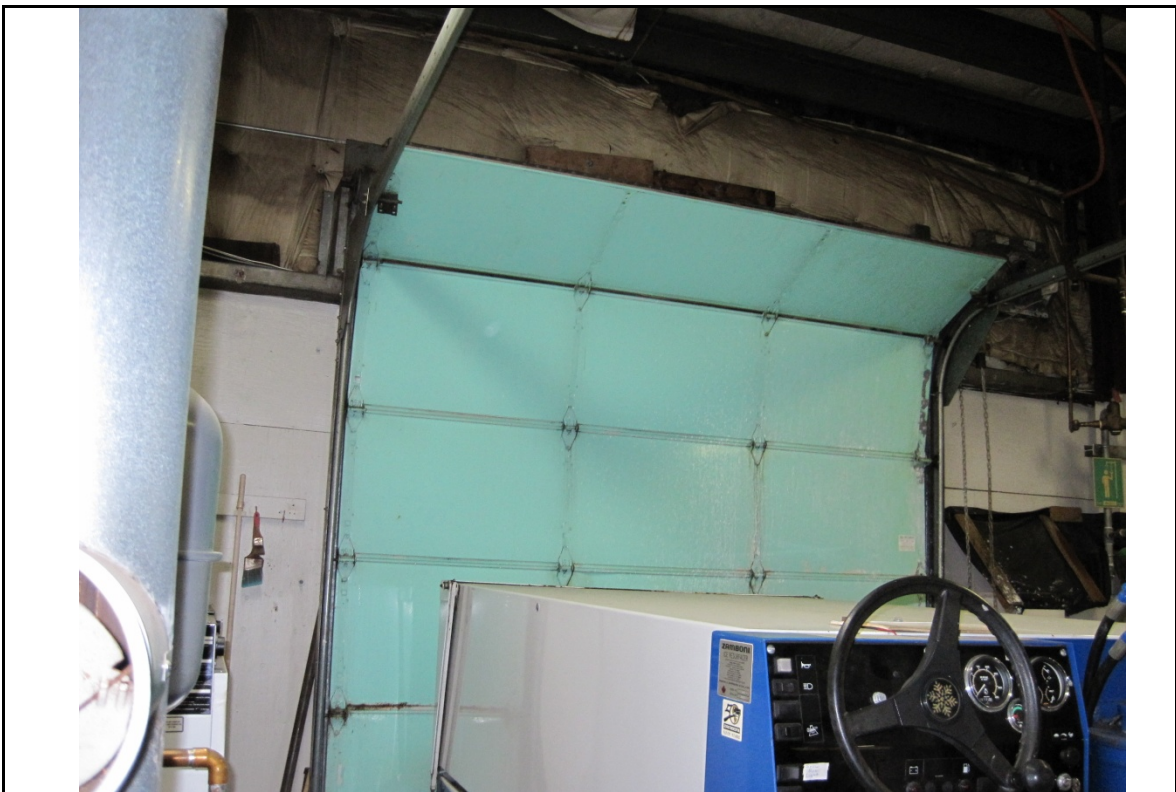
The overhead door accessing the Zamboni room appeared to be aged and in fair to poor condition. Based on the observed condition it is expected that the door will require replacement in the short term with additional cyclical replacement in the short term of the evaluation period. The estimated cost of the replacement has been included in the Probable Cost Table.

**Photo 14:** Overhead Door for Zamboni

| Item | Action | Year of install | Expected Useful Life | Anticipated year of replacement | Quantity | Unit cost | Item cost |
|---|---|---|---|---|---|---|---|
| <b>Overhead Door - Zamboni Room</b> | Replacement of overhead door to Zamboni Room | 1990 | 15 | <b>2014</b> | 1 | \$1,500 | <b>\$1,500</b> |

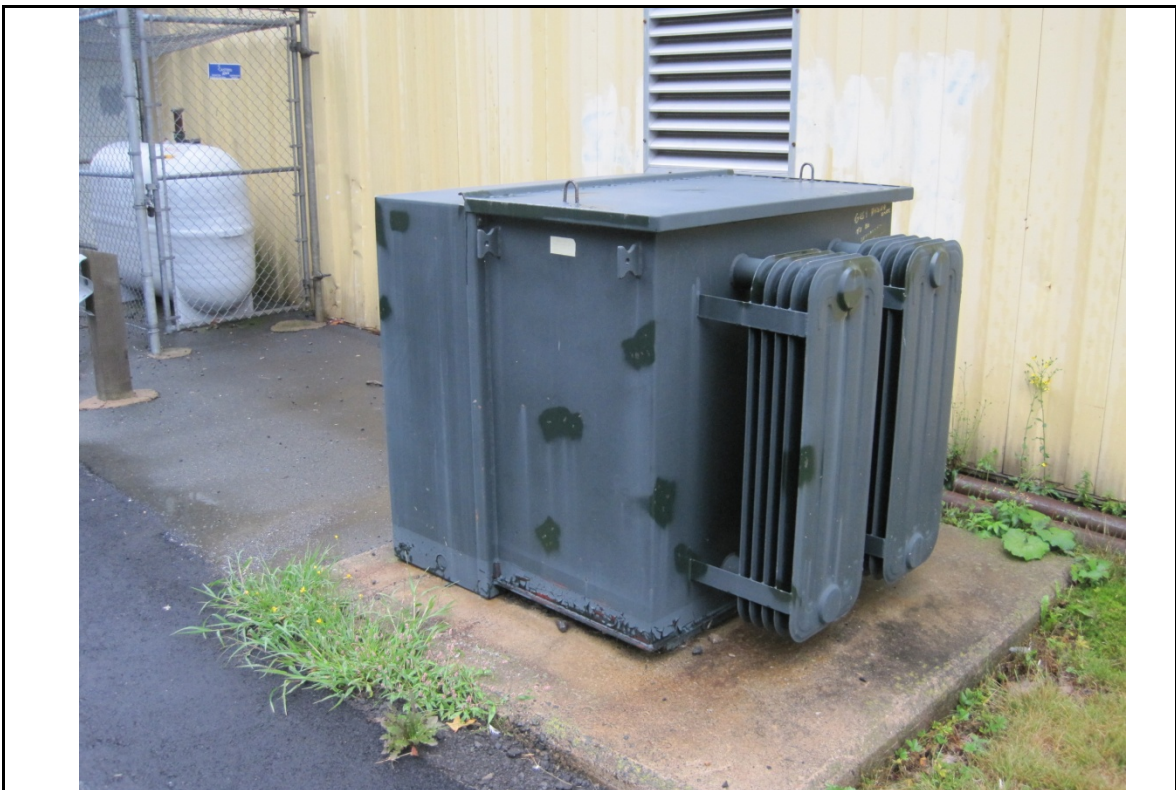
**Photo 16:** Unprotected NSPI Pad Mounted Transformer

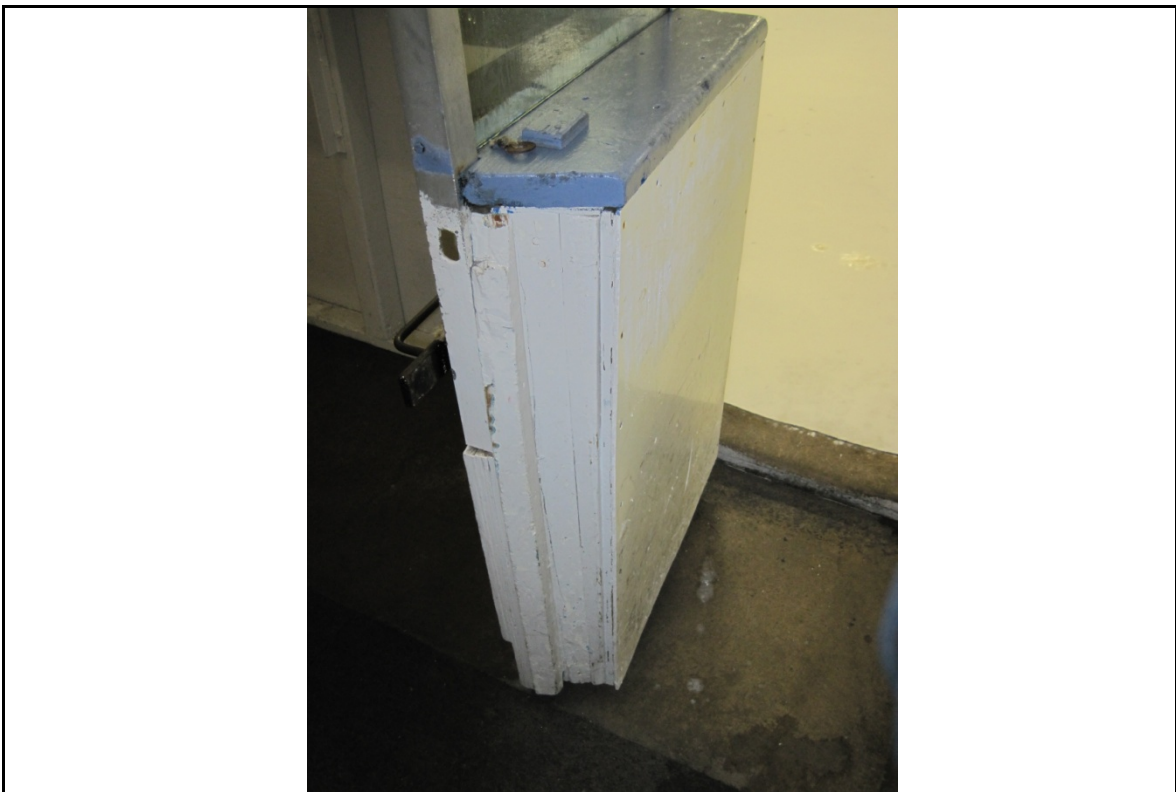
The rubber mats were in good condition and did not have signs of excessive wear or missing sections. It was reported that the majority of the mats had been recently replaced. Rubber mats will generally have an expected useful life of fifteen years however this can vary significantly with the amount of traffic. Based on the observed condition and expected useful life we anticipated that the mats will require replacement toward the end of the long term of the evaluation period. The estimated cost of the replacement has been included in the Probable Cost Table.

**Photo 19:** Rubber Mat Flooring, Dasher Boards, and Interior Finishes
