## **Final Report**

### **Capital Plan Building Condition and Energy Assessments Fire Station 53 Terence Bay 80 Sandy Cove Road Halifax, Nova Scotia**

**March, 2013**

**Project Number 1201058 4 075**

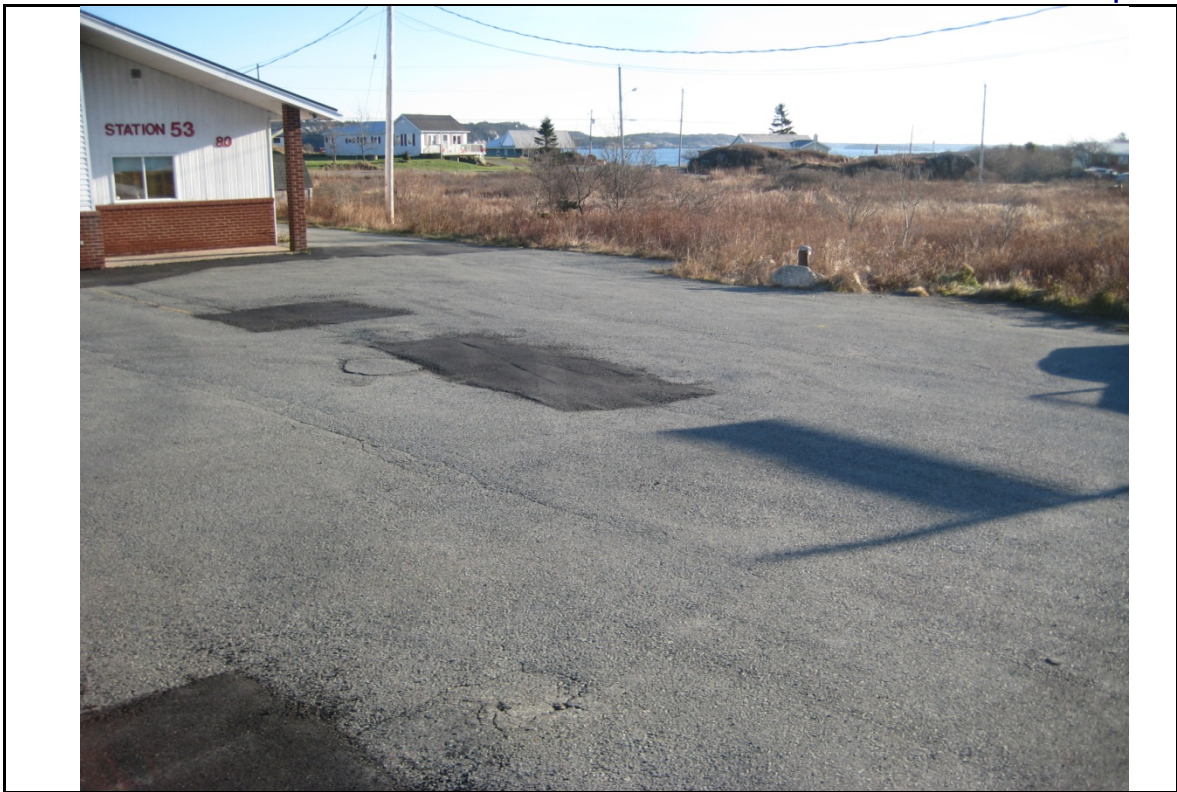
The asphalt apron and connections to the gravel parking area appeared to be in fair condition with signs of longitudinal cracking and alligatoring throughout the pavement. The age of the asphalt is unknown but it is starting to reach the end of its useful life. The expected useful life of asphalt paving is typically fifteen years but can be extended with localized repairs. Based on the observed condition and estimated remaining useful life repairs are anticipated in the short term with a replacement at the beginning of the long term of the evaluation. Repairs are also anticipated in the extended term of the evaluation period. The estimated cost and timing of the repairs and the replacement have been included in the probable cost table.

**Photo 3:** Patched Asphalt Access Area and Surrounding Landscape at Front of Building

| Item | Action | Year of Install | Expected Useful Life | Anticipated Year of First Expenditure | Quantity | Unit Cost | Cost per Occurrence |
|---|---|---|---|---|---|---|---|
| <b>Asphalt Pavement - Repair</b> | Repair 30% of surface area | 2000 | 5 | <b>2015</b> | 2,972 | \$4.50 | <b>\$13,373</b> |
| <b>Asphalt Pavement - Replacement</b> | Replace at end of useful life | 2000 | 15 | <b>2019</b> | 9,906 | \$4.50 | <b>\$44,577</b> |

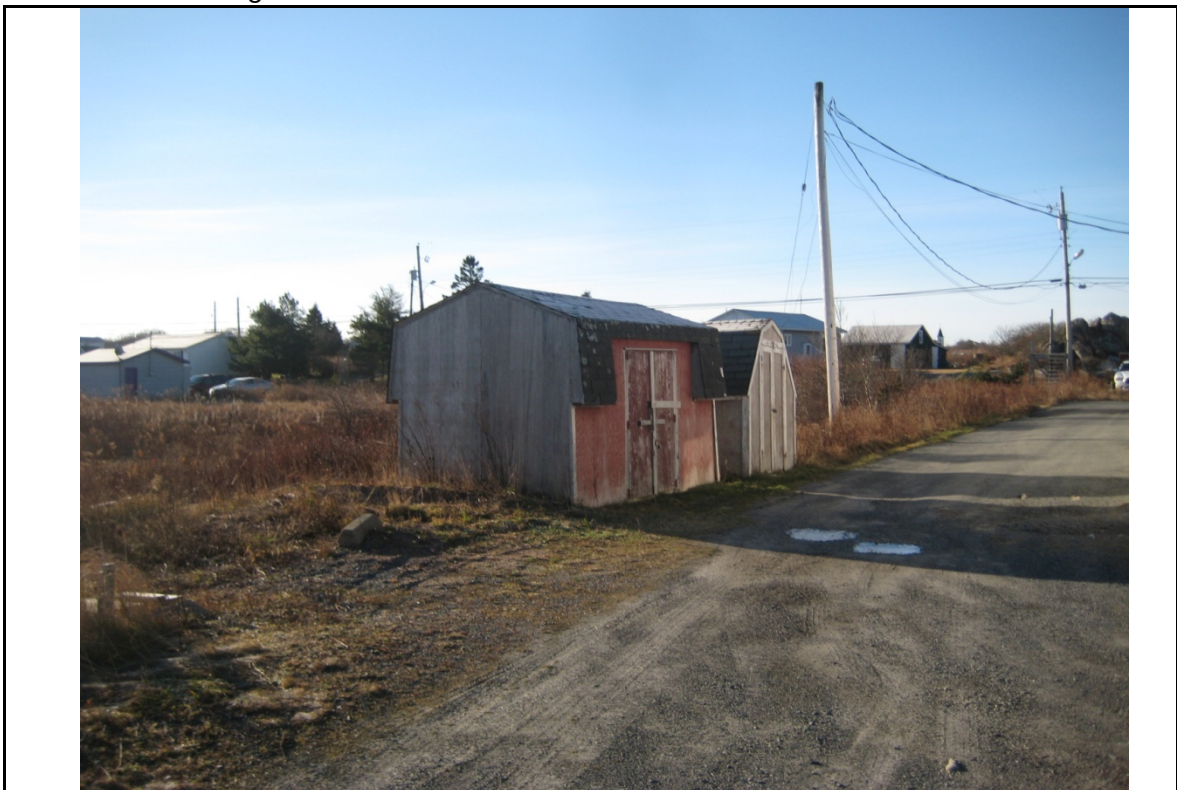
The gravel parking area appeared to be in fair condition with potholes and sections without gravel. The expected useful life of gravel parking areas is indefinite with regular grading and the addition of gravel as required. Based on the observed condition and estimated remaining useful life, adding gravel and grading is recommended throughout the evaluation period. Typically this is completed as part of maintenance budget and no cost has been included in the probable cost table.

**Photo 4:** Asphalt to Gravel Transition to Rear Building Gravel Parking and Storage Sheds

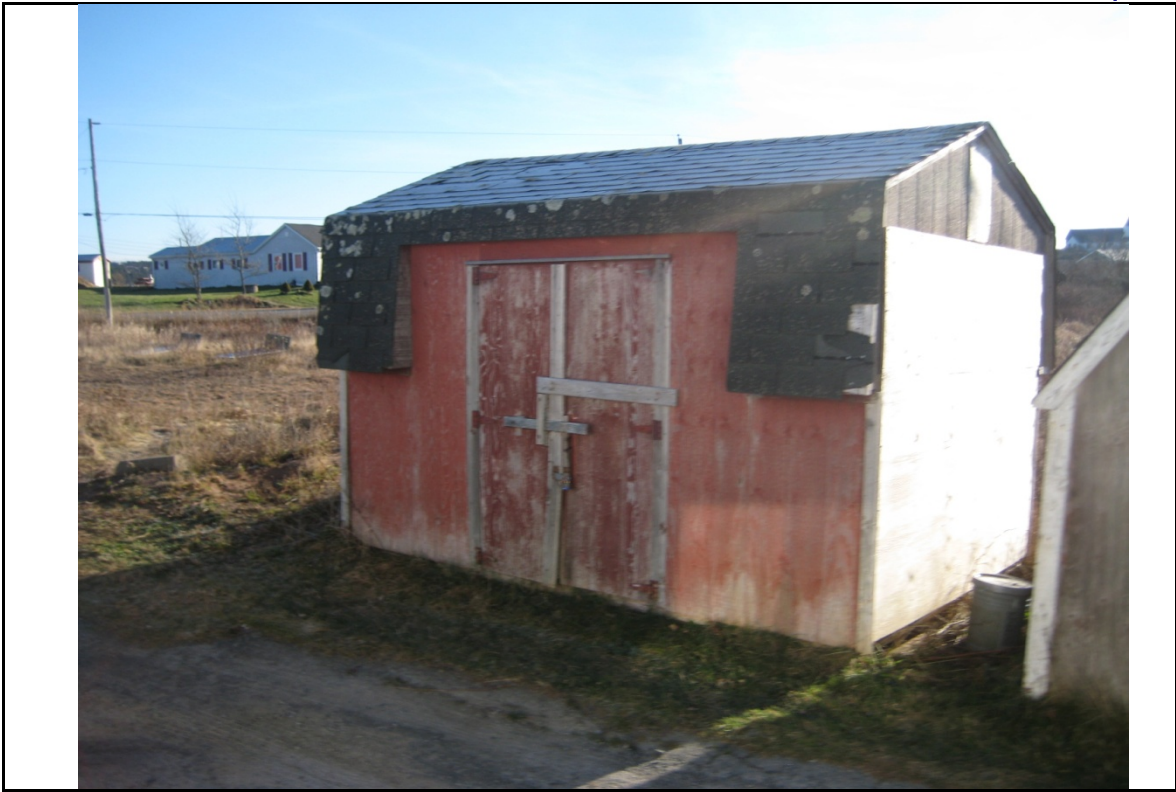
The sheds appeared to be in fair condition with signs of damage and wear to the exterior sheathing. It is assumed that the sheds are reaching the end of their expected useful life. The expected useful life for this type of barn is typically twenty to twenty-five years. Based on the observed condition and estimated remaining useful life a replacement is anticipated during the short term of the evaluation period. The estimated cost and timing of the replacement have been included in the probable cost table.

**Photo 5:** Storage Sheds located South-East of Building

| Item | Action | Year of Install | Expected Useful Life | Anticipated Year of First Expenditure | Quantity | Unit Cost | Cost per Occurrence |
|---|---|---|---|---|---|---|---|
| <b>Sheds</b> | Replace at end of useful life | 1990 | 20 | <b>2014</b> | 3 | \$2,500 | <b>\$7,500</b> |

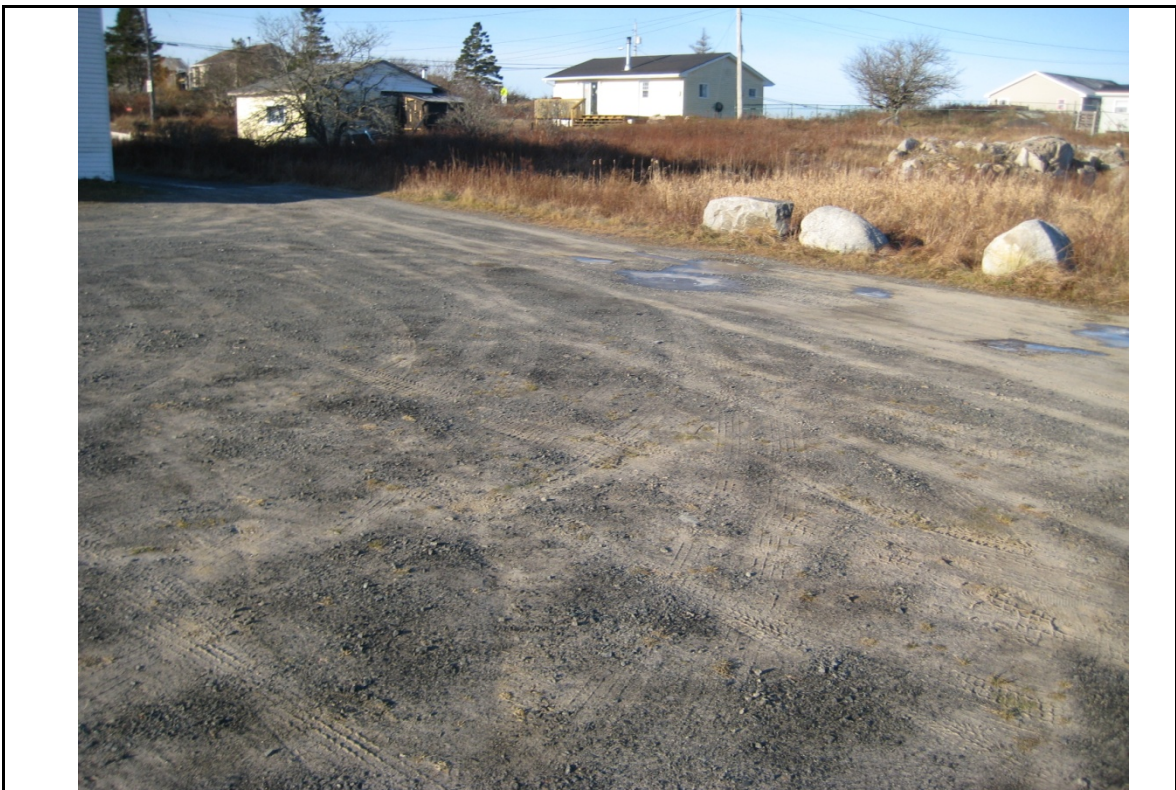
**Photo 6:** Gravel Parking at Rear of Building

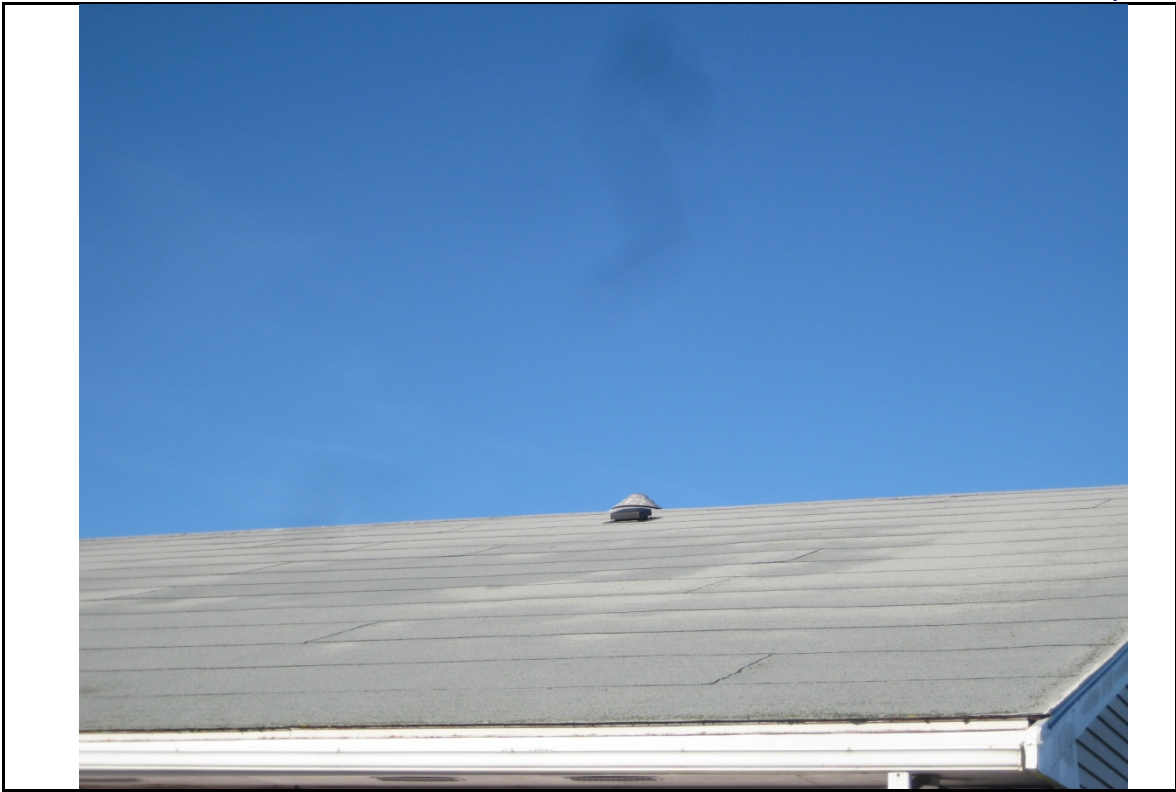
The modified bitumen roof covering appeared and was reported to be in fair condition with no reported areas of active or recent water ingress; however, it is estimated to be at least fifteen years old. The expected useful life of a modified bitumen roof covering is typically twenty years with repairs after fifteen years. Based on the observed condition and age of the building, a replacement is anticipated in the short term with repairs to the new roof in the extended term of the evaluation period. The estimated costs and timing of the replacement and repair have been included in the probable cost table.

**Photo 7:** Sloped Rolled Bitumen Roof

| Item | Action | Year of Install | Expected Useful Life | Anticipated Year of First Expenditure | Quantity | Unit Cost | Cost per Occurrence |
|---|---|---|---|---|---|---|---|
| <b>Modified Bitumen - Replacement</b> | Replacement at end of useful life | 1998 | 20 | <b>2018</b> | 6,284 | \$12.00 | <b>\$75,408</b> |
| <b>Modified Bitumen - Repairs</b> | Repair 25% of roof covering | 1998 | 15 | <b>2033</b> | 1,571 | \$12.00 | <b>\$18,852</b> |

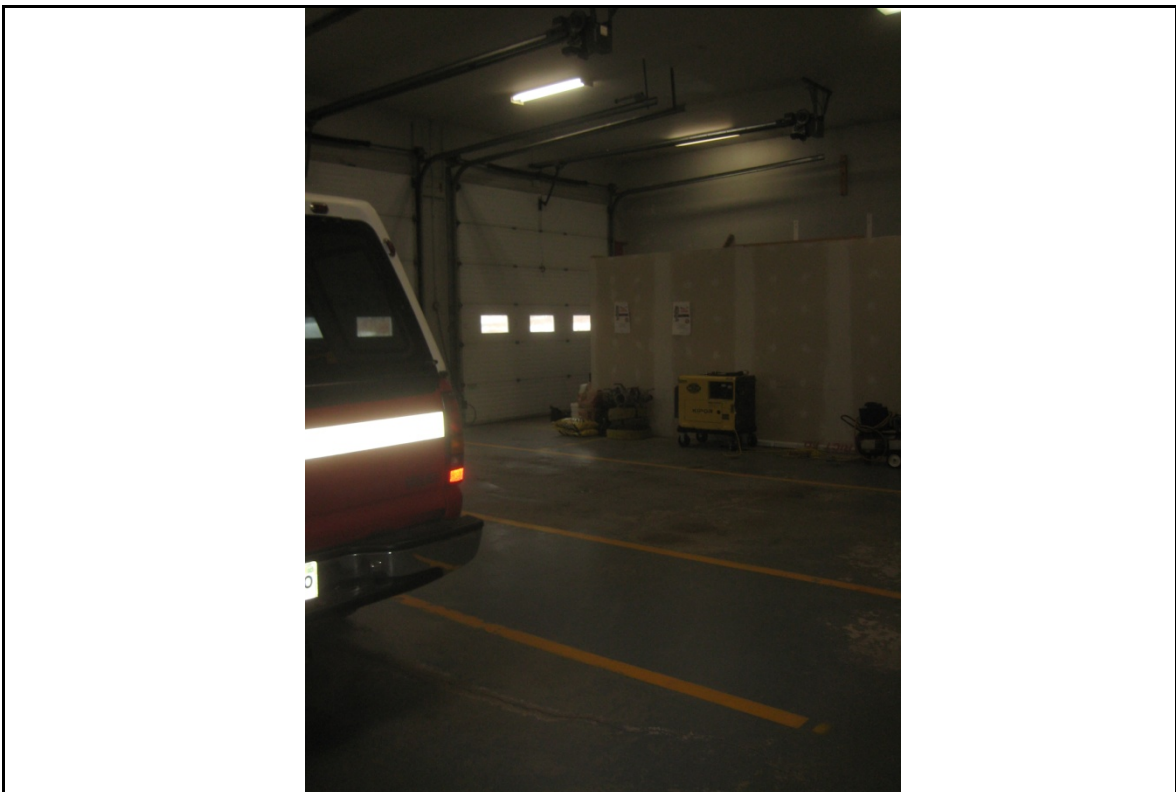
**Photo 8:** Apparatus Bay Finishes

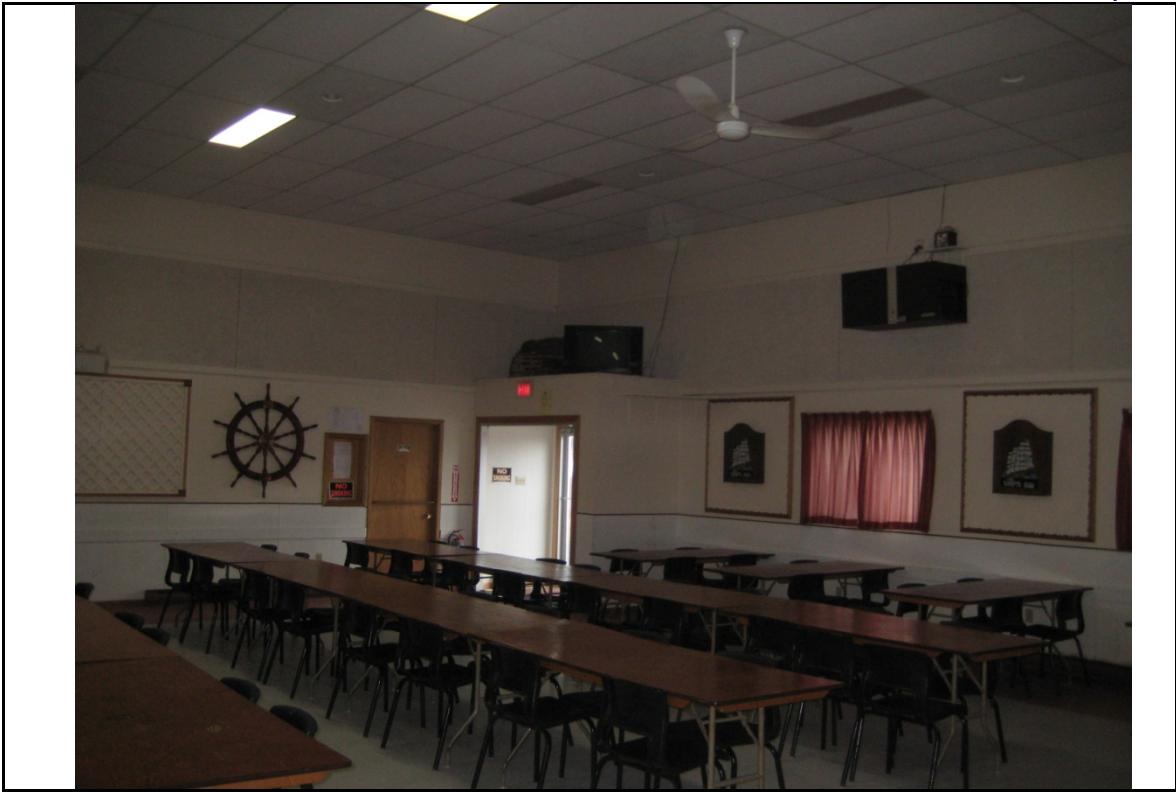
The suspended ceiling tiles in the community hall appeared to be in fair to good condition and it is estimated to be no more than ten years old. The expected useful life for these tiles is typically twenty years. Based on the observed condition and estimated remaining useful life a replacement is anticipated during the long term of the evaluation period. The estimate cost and timing of the replacement have been included in the probable cost table.

The VCT flooring in the hall area of the community hall appeared to be in fair to good condition with no signs of damage; however, it is estimated that the tiles are more than ten years old. The expected useful life of VCT is typically twenty-five years. Based on the observed condition and estimated remaining useful life a replacement is anticipated in the extended term of the evaluation period. The estimated cost and timing of the replacement have been included in the probable cost table.

**Photo 9:** Community Centre Meeting Room Finishes

| Item | Action | Year of Install | Expected Useful Life | Anticipated Year of First Expenditure | Quantity | Unit Cost | Cost per Occurrence |
|---|---|---|---|---|---|---|---|
| <b>Community Hall - Suspended Ceiling</b> | Replace at end of useful life | 2003 | 20 | <b>2023</b> | 854 | \$5.15 | <b>\$4,399</b> |

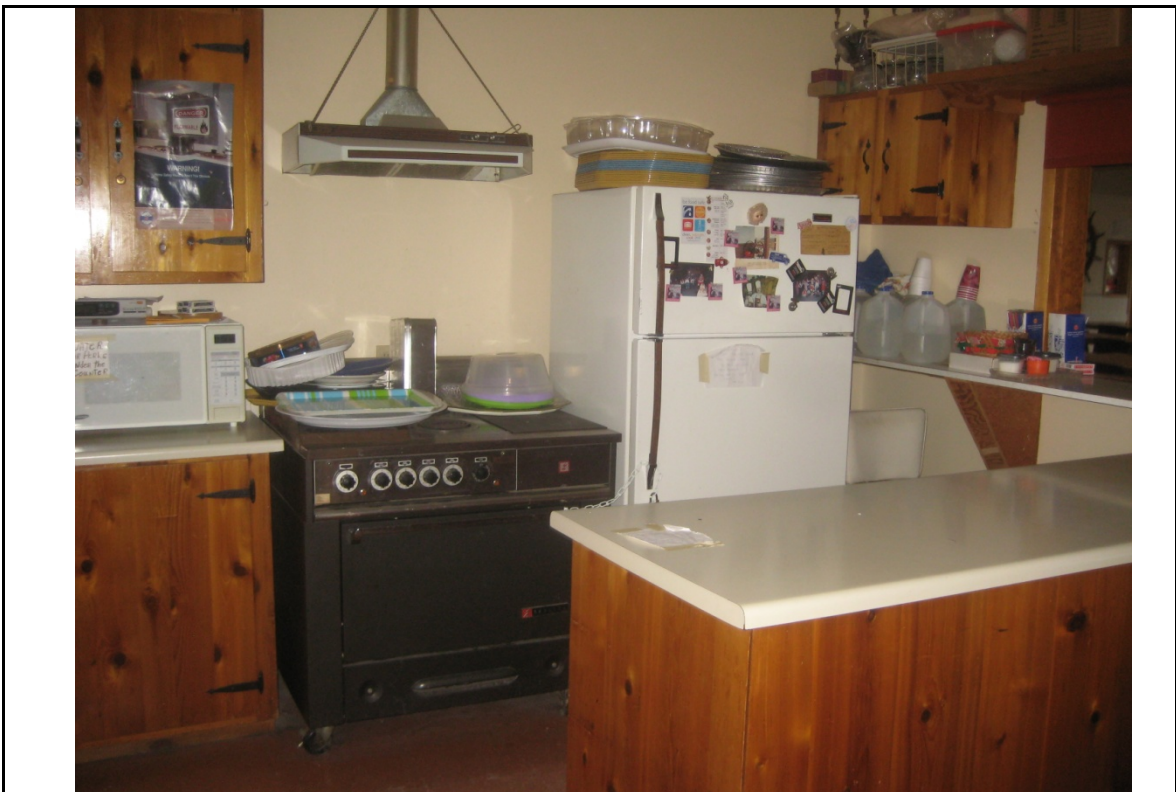
The kitchen equipment appeared to be in fair to good condition with no reported issues; however, most of the equipment is more than ten years old, except the bar fridges which are reaching the end of their useful life. The expected useful life for this equipment is typically twenty to twenty-five years. Based on the observed condition and estimated remaining useful life, a replacement of the bar fridges is anticipated during the short term of the evaluation period and the rest of the equipment in the extended term. The estimated costs and timing for these replacements have been included in the probable cost table.

The cabinetry and countertops appeared to be in fair to good condition with no evidence of damage to the cabinetry or the countertops; however, it is estimated that the cabinetry is original to the building and the countertops appear to be more than twenty years old. Typically the expected useful life of wood cabinetry and laminated countertops is twenty to twenty-five years, which the cabinetry has surpassed. Based on the observed condition and estimated remaining useful life a replacement of cabinetry and countertops is not anticipated until the beginning of the long term of the evaluation period. The estimated cost and timing of the replacement have been included the probable cost table.

**Photo 10:** Typical Kitchen Finishes

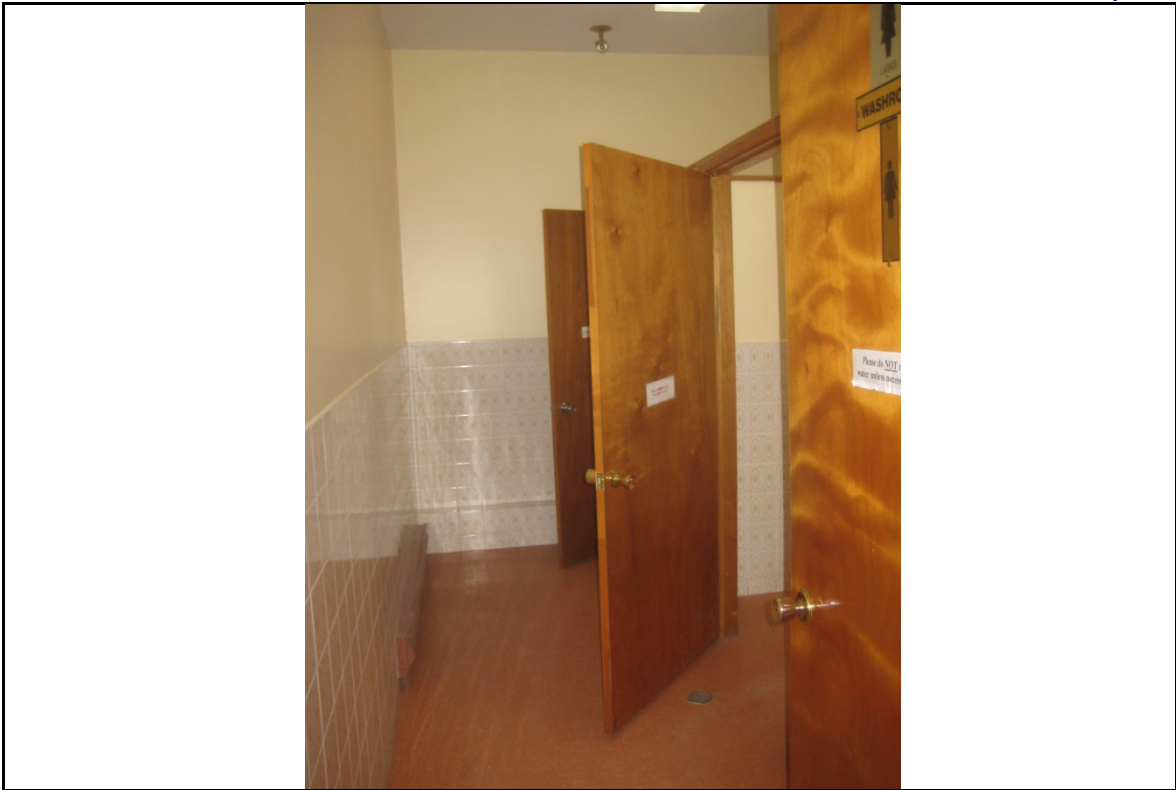
The ceramic wall tile in the washrooms appeared to be in fair to good condition with no signs of damage to the grout or to the tiles. The age of the tiles is unknown but it is estimated to have been installed more than twenty years old. The expected useful life of these tiles is typically sixty years. Based on the observed condition and estimated remaining useful life a replacement is not anticipated during the evaluation period. No cost has been included in the probable cost table.

**Photo 11:** Typical Washroom Finishes

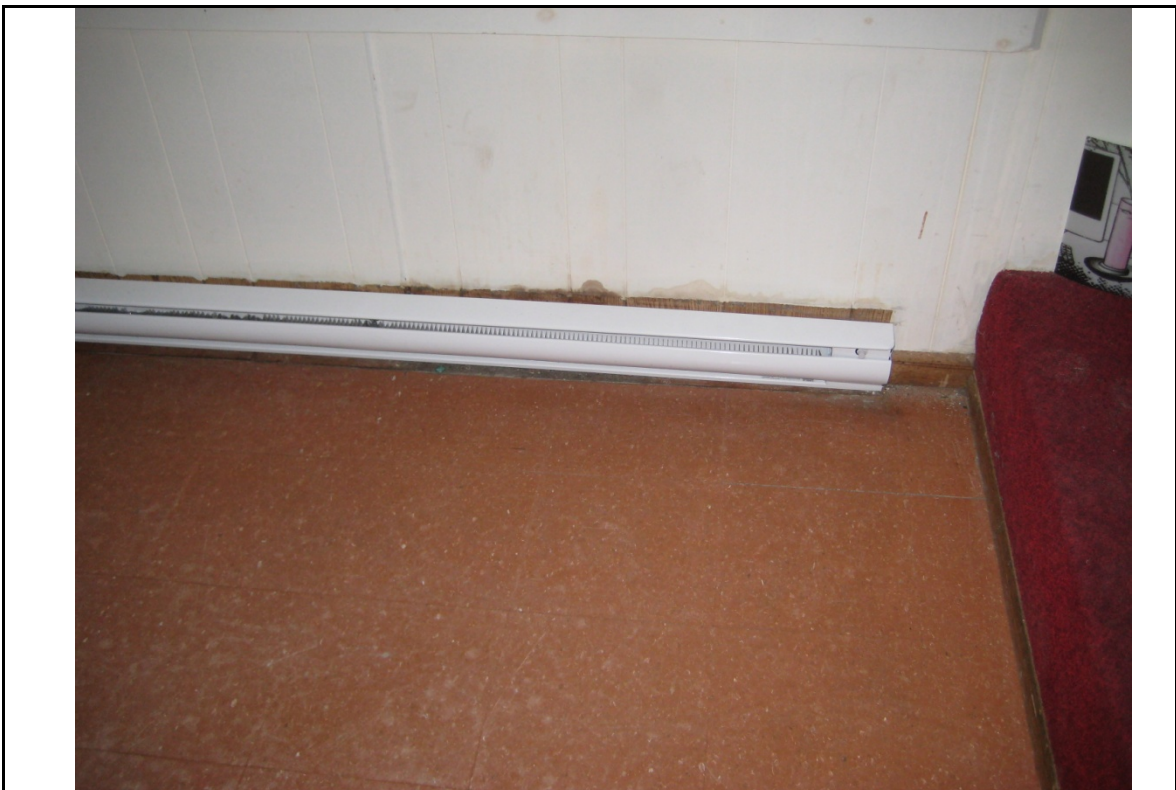
**Photo 12:** Sample of Electric Baseboard Heater

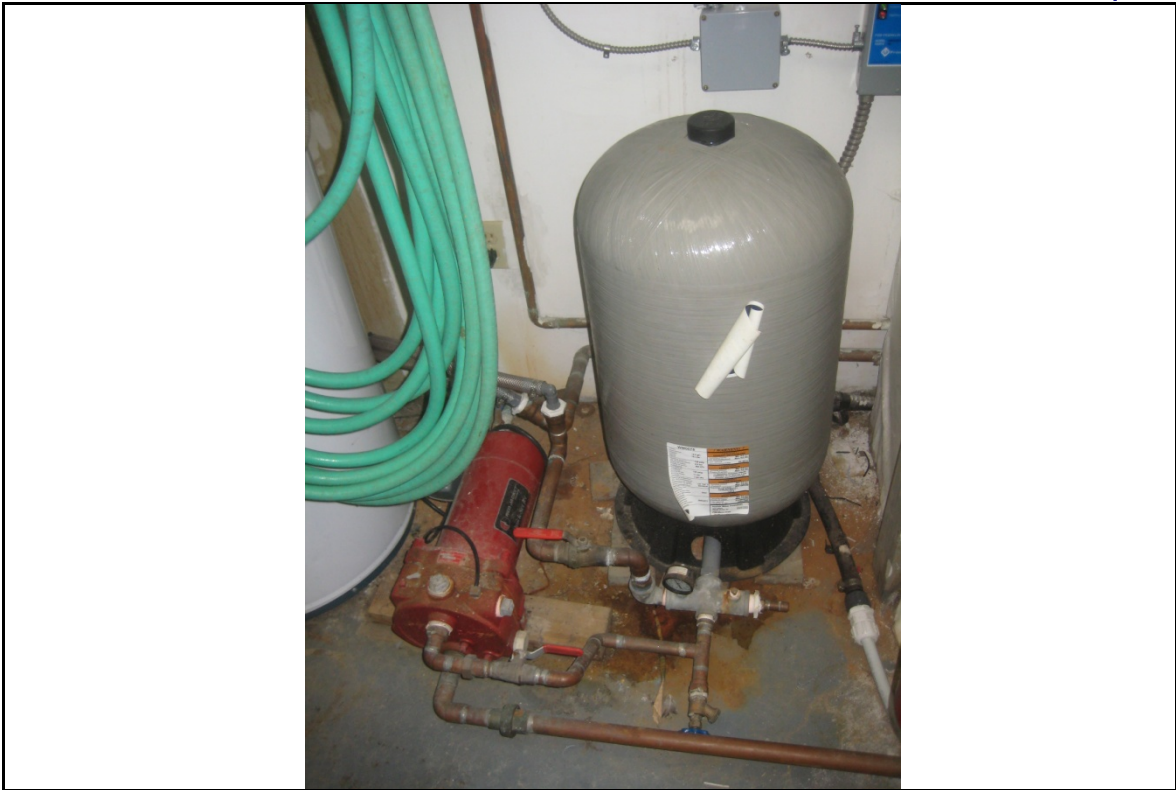
**Photo 13:** Domestic Water Service Equipment (Pressure Tank)

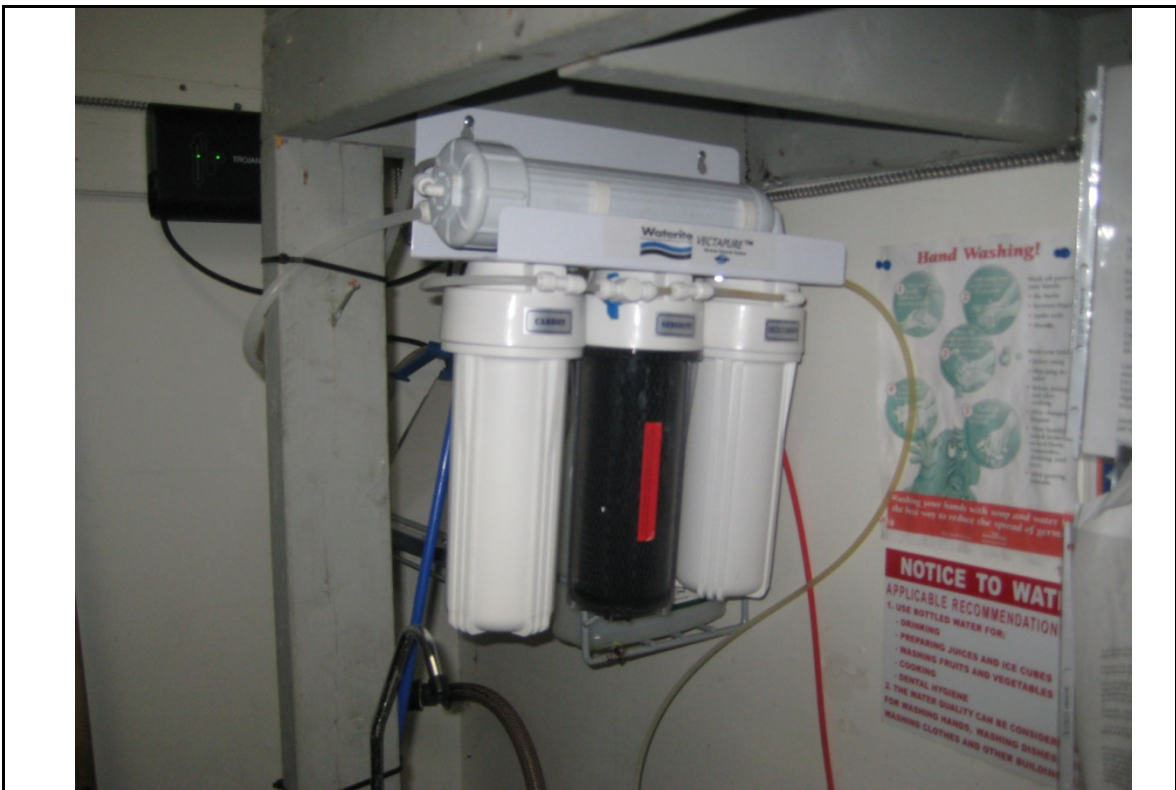
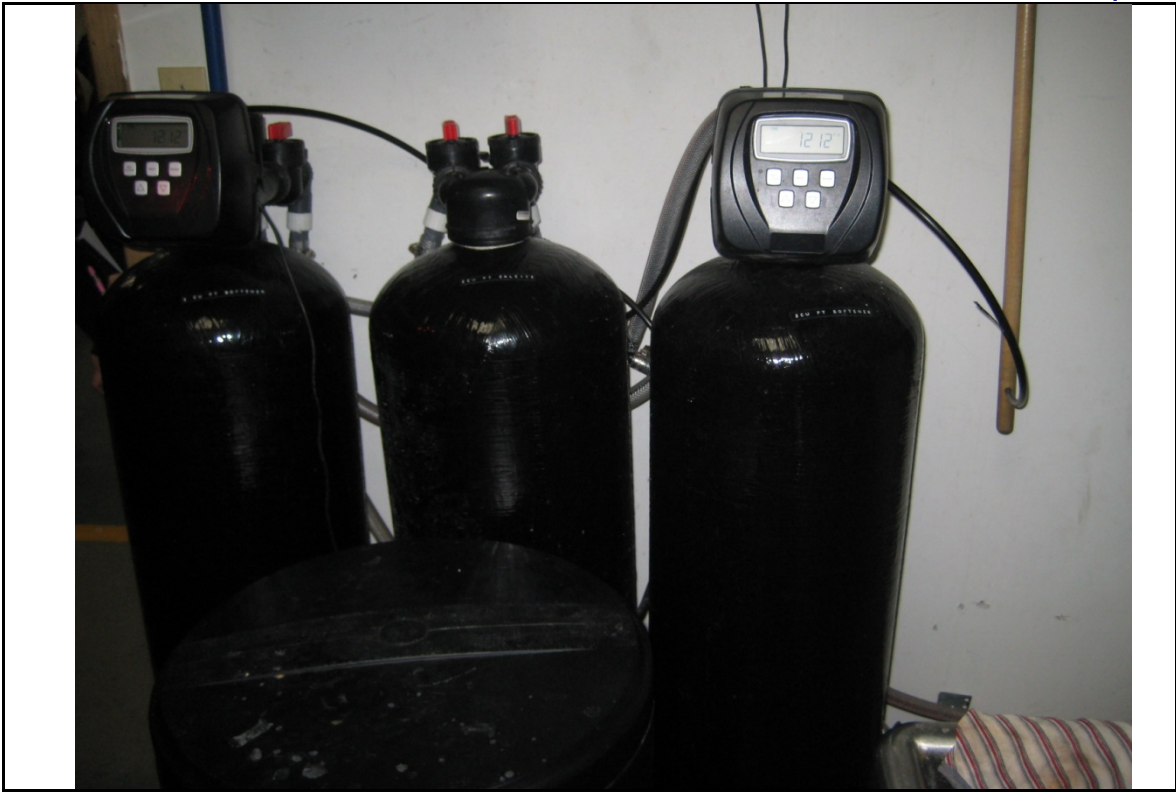
**Photo 14:** Sampling of Domestic Water Treatment Equipment

**Photo 15:** Sampling of Domestic Water Treatment Equipment

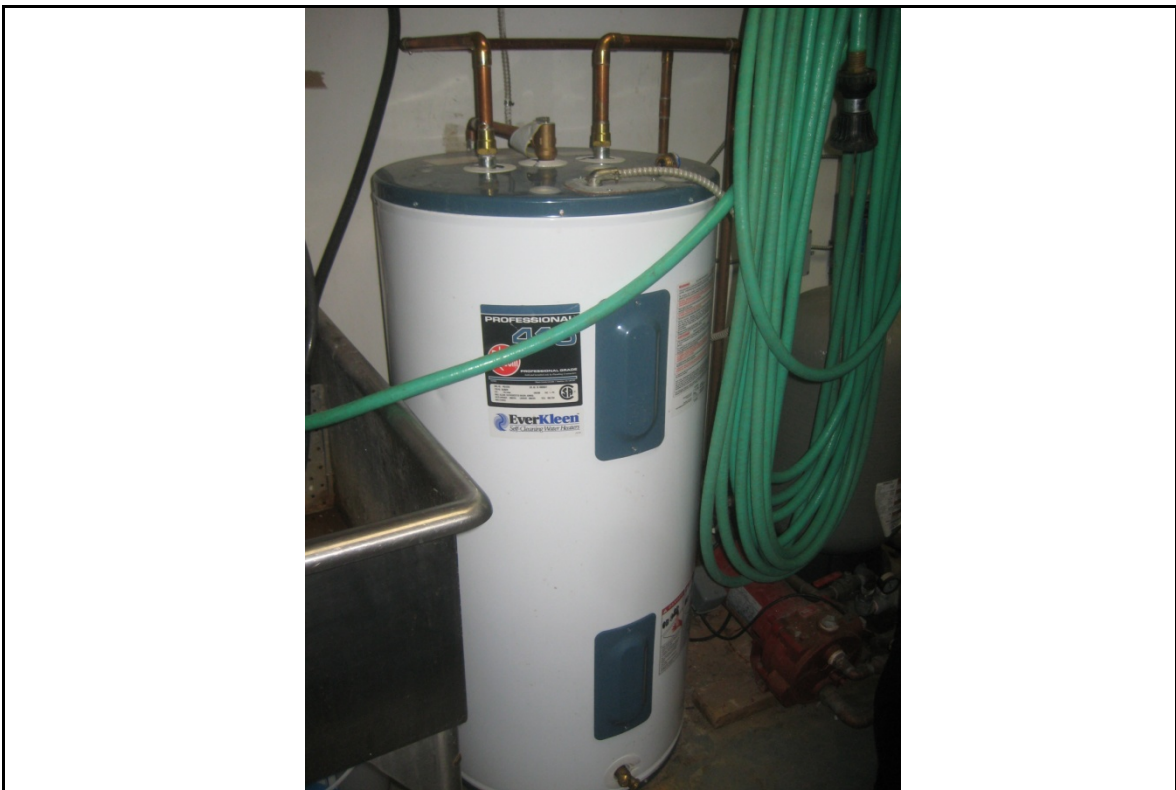
**Photo 16:** Domestic Water Heater

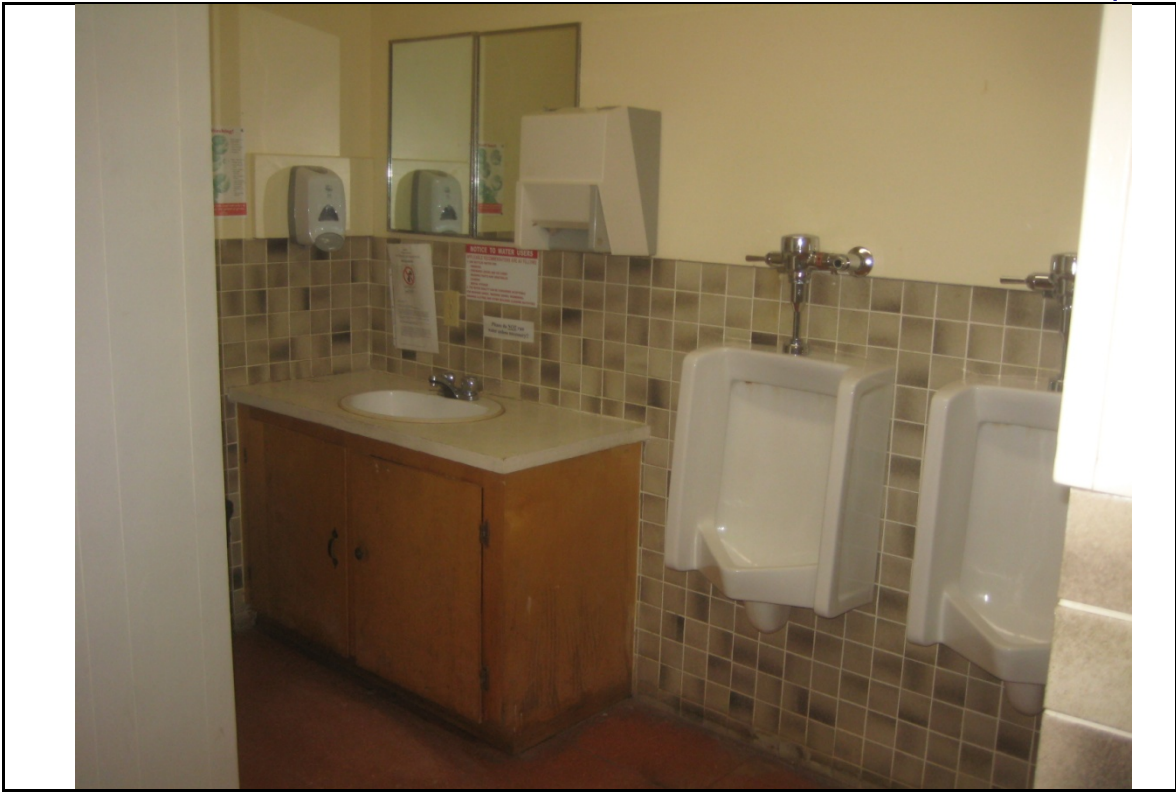
**Photo 17:** Sampling of Domestic Plumbing Fixtures

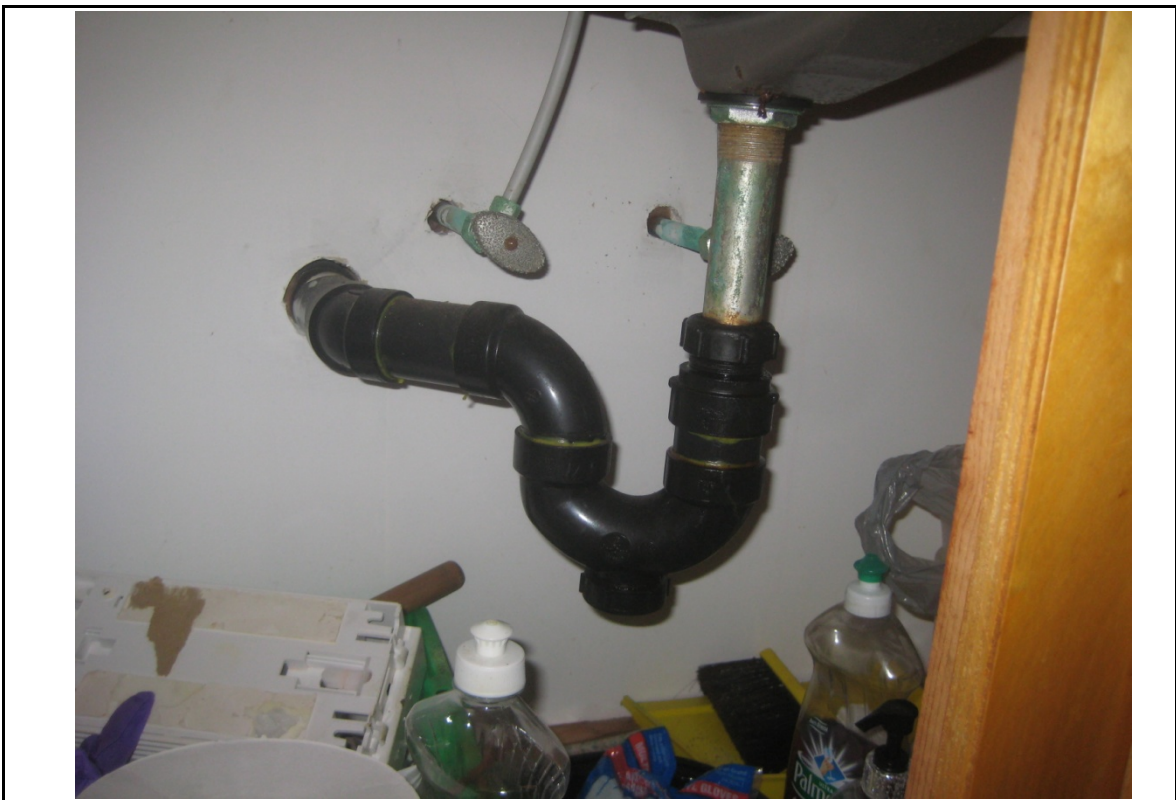
**Photo 18:** Sampling of Domestic Water and Sanitary Drainage Piping

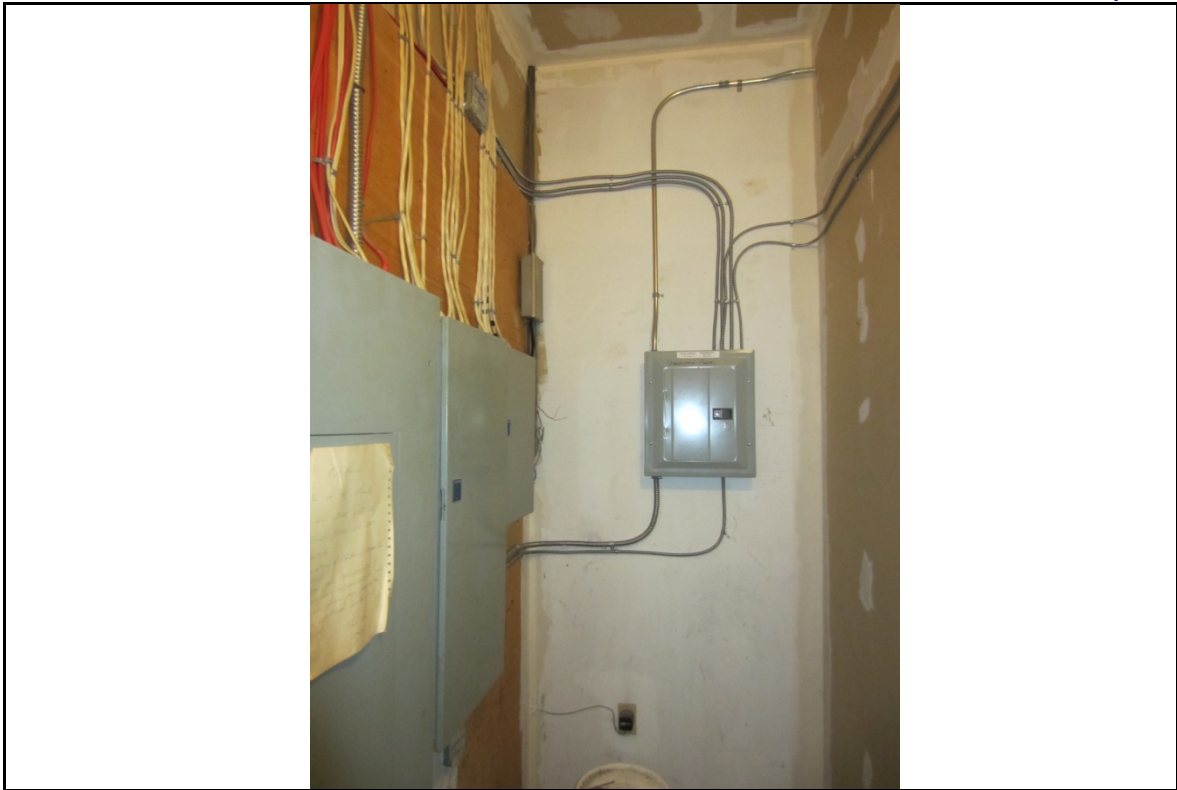
**Photo 19:** Electrical Transfer Switch for Plug In Portable Generator

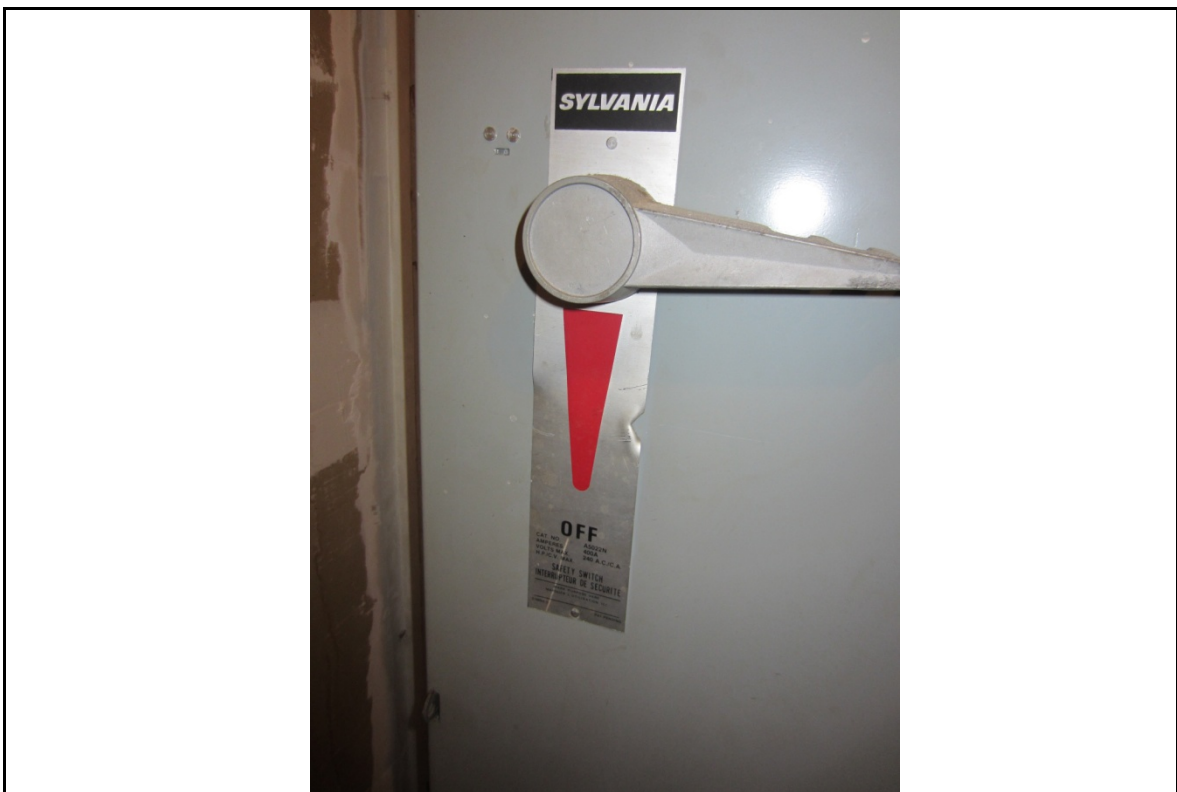
**Photo 20:** Sylvania Main Disconnect Rated for 200A 120/240V

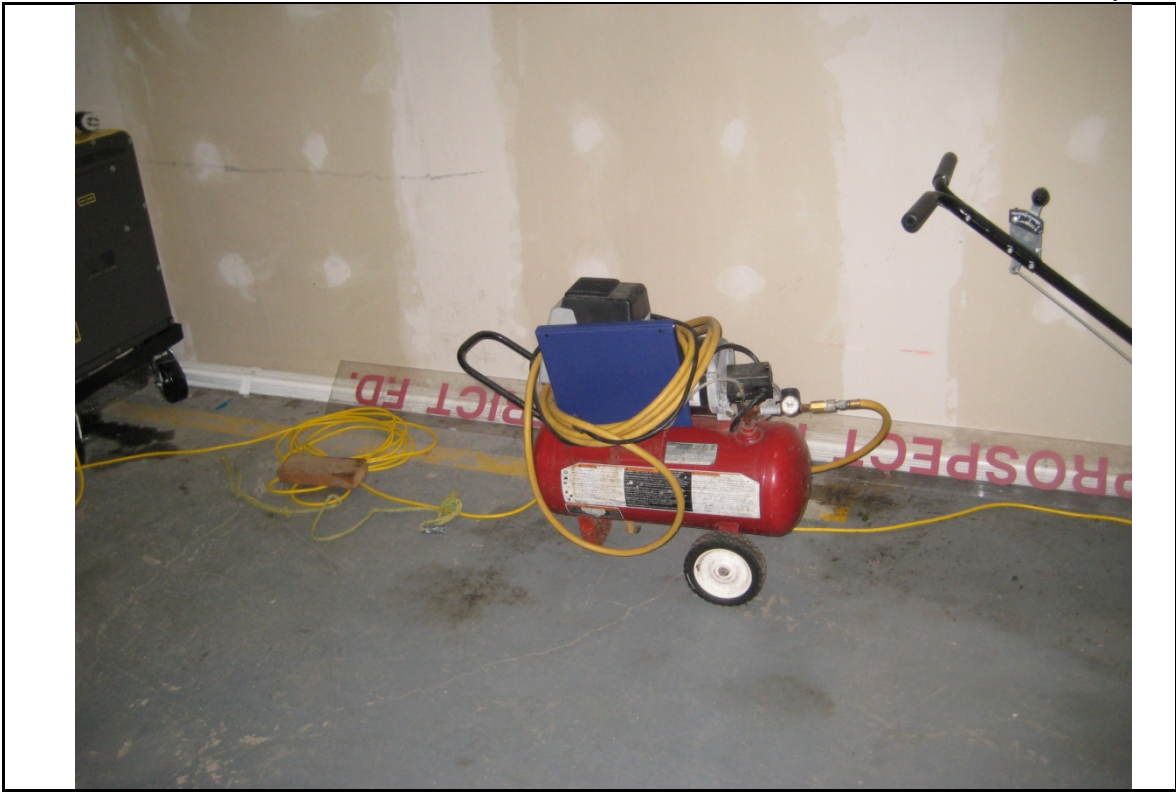
**Photo 21:** Portable Air Compressor

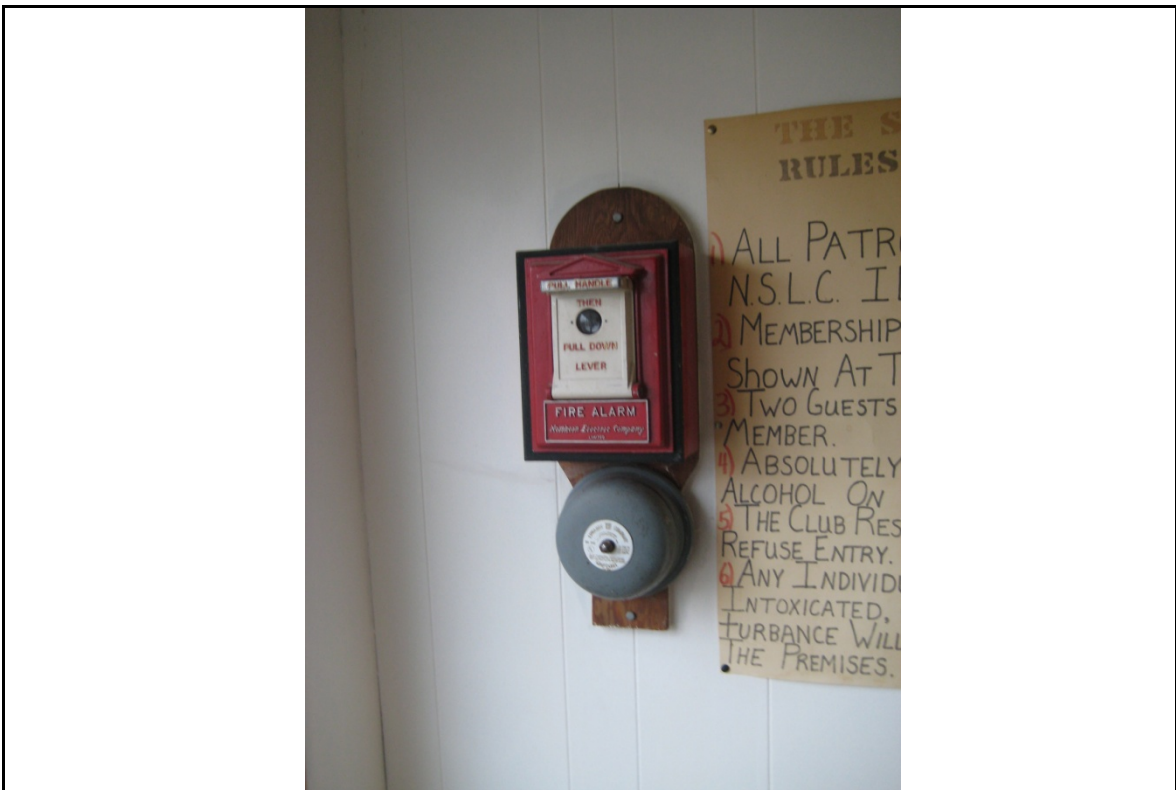
**Photo 22:** Fire Alarm Bell

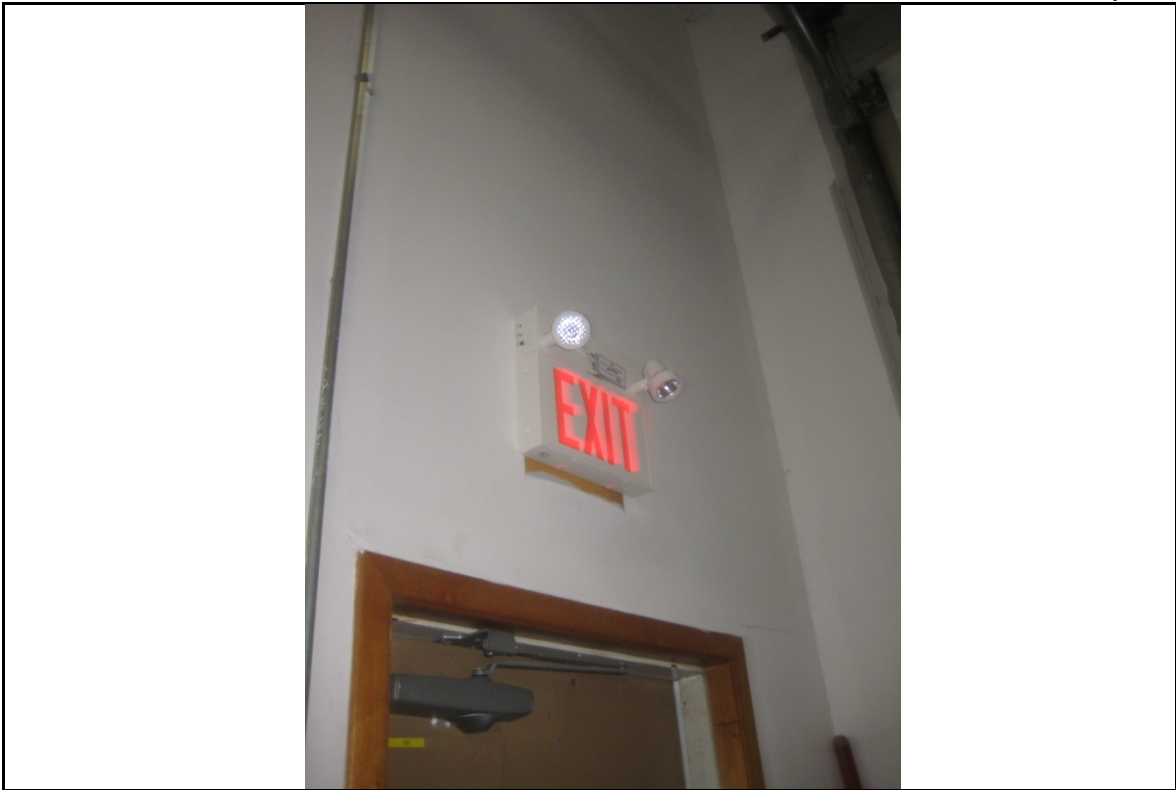
**Photo 23:** Exit Lighting With Emergency Battery Pack Backup Lighting

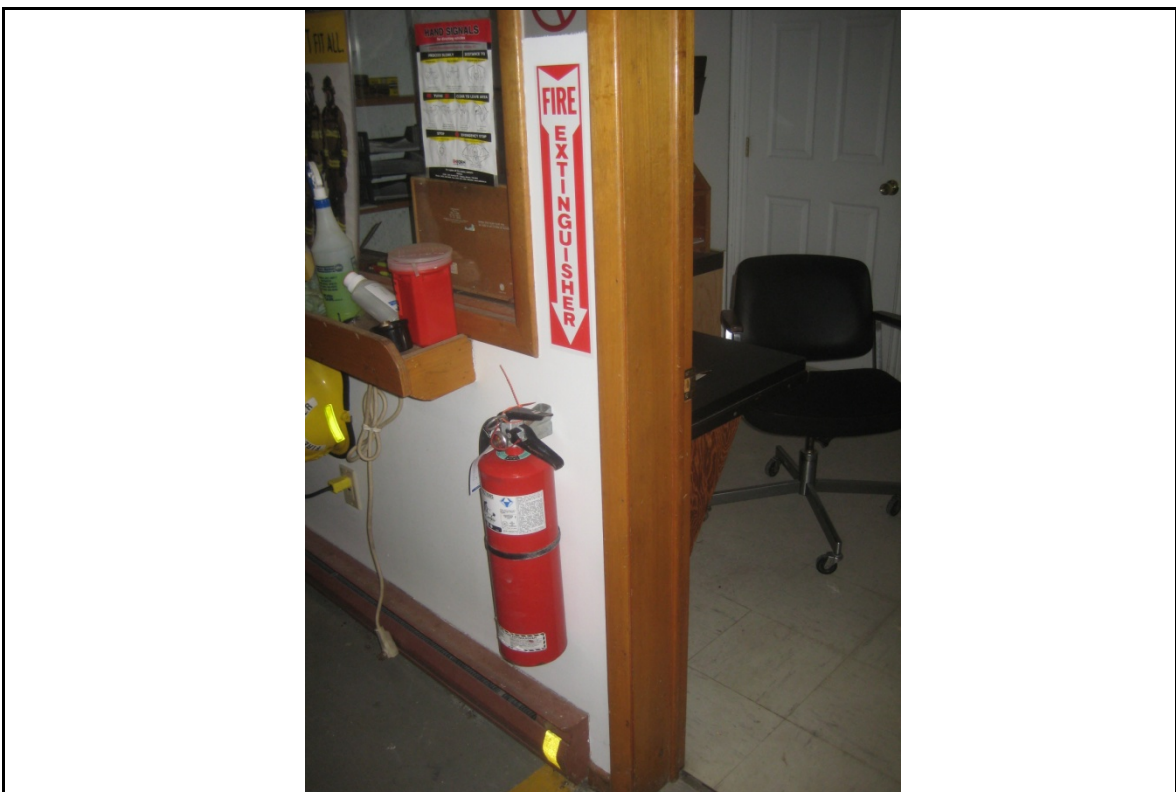
**Photo 24:** Fire Extinguisher
