STAIRS HOUSE

CONSERVATION MANAGEMENT PLAN

DRAFT

20.04.30

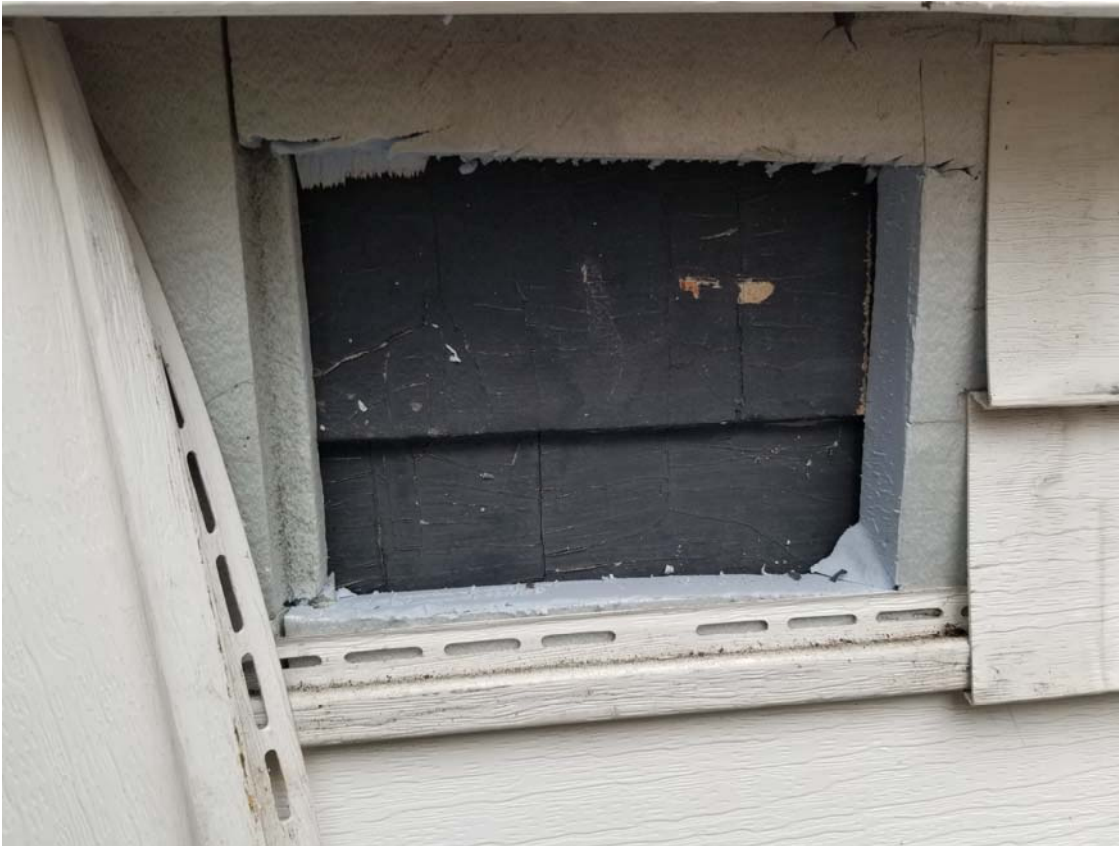
At the time of this plan, the buildings on the Stairs House property all remain as fully occupied rental units and as such access to the unit interiors has been limited. The exterior of the buildings have been reviewed on multiple occasions principally for this plan during the first weeks of March 2020. Assumptions based on observations will be presented later in this plan when discussing individual building systems. On March 11th an opening was made in the vinyl siding on the eastern ear wall of the Stairs house, exposing 1 ½" of extruded polystyrene insulation lying between the vinyl cladding and wood shingles below. Exposed shingles were in good condition with minimal paint layers, though thick enough for thin cracking to form. Note Charcoal colour.

Based on inspection of sills around the building, this insulation layer exists around the building.
