Portland St and Eisener Blvd

MicroTraffic Video Diagnostic Findings and Recommendations

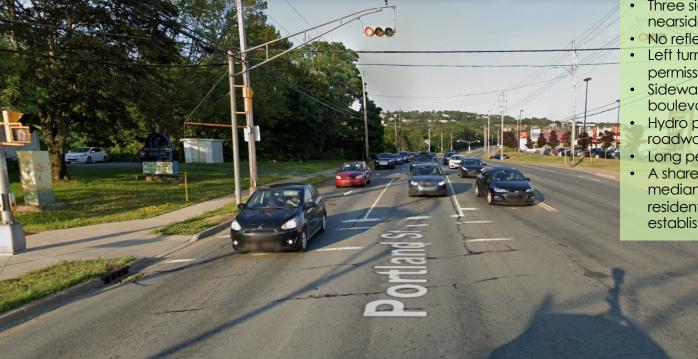
Portland St. Looking East

- Two through lanes in each direction and a westbound left turn auxiliary lane
- Westbound lane designation is painted on the roadway, no advanced signage is provided
- Eastbound far-side and Westbound nearside transit stop/ pull outs
- 50 km/h posted speed limit
- Three signal heads EB and WB (one nearside)
- No reflective back plates on signals
- Left turn signalization: WBL protected/ permissive (EBL is not permitted)
- Sidewalks on both sides of the road with boulevard separation
- Hydro poles located <0.5m away from the roadway
- Long pedestrian crossing at south crosswalk
- A shared opposing permissive left turn median lane allows vehicles to access residential driveways and commercial establishments along Portland

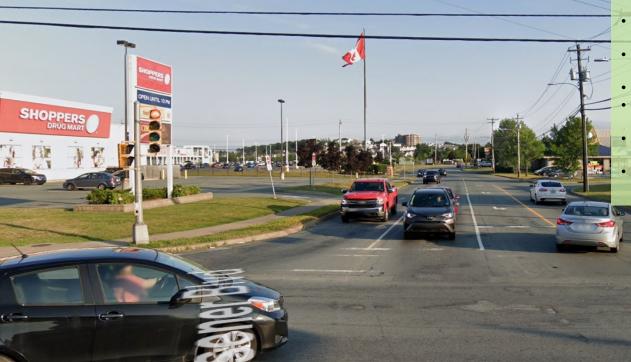
Eisener Blvd. Looking South

- Northbound: through movements are not permitted (one way southbound). Two left turn lanes and one right turn lane
- Southbound: One left turn lane and one shared through and right turn lane
- 50 km/h posted speed limit
- Turn radii of approximately 9 m (estimated from Google Earth) for SBR and NBR allow for moderately elevated right turn speeds.
- Sidewalk with boulevard separation is on the east side of the roadway only
- 3 signal heads in the NB and SB directions with
 no reflective backplates
- Left turn signalization is protected
- Pedestrian crossing not permitted on west
 approach
- Commercial accesses are close to the intersection (south approach)
- Long pedestrian crossing distance in the Northbound/Southbound directions

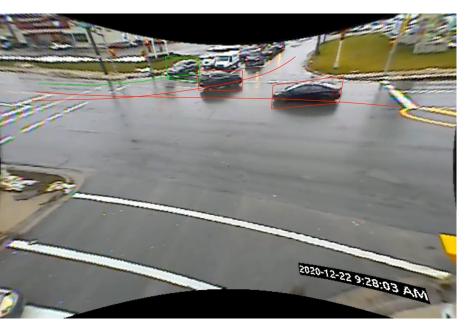
West-left vs East-through data shows a high frequency of detected conflicts over a 50-hour period. Several conflicts occurred with through vehicle speeds exceeding the 50 km/h posted speed limit (up to 75 km/h).

At impact speeds of 50 km/h, opposing drivers have a 40% chance of a severe injury (MAIS 3+), which increases to >90% at 75 km/h.

West-Left vs East-Through: PET= 1.6s, vehicle speed 56 km/h

Key Issue	Recommendation
 Left Turn Across Path: A high volume of vehicles use Portland (>13,000 veh/day in each direction) Frequent high-risk conflicts were detected for WBL vs EBT. These events show the high speed of oncoming EB drivers and the potential difficulty in finding appropriate gaps in traffic to complete permissive WBL turns. This high level of driver workload and focus on gap acceptance may result in drivers neglecting to check for VRUs using the south crossing prior to initiating their left turn. Frequent uncontrolled commercial accesses along Portland present the same exposure to LTAP collisions. Several low-risk NBL vs SBT conflicts were observed at the end of the protected NB left turn phase. In most cases these were due to queues of WB vehicles preventing left-turning vehicles from clearing the intersection. It is unknown what the cause of congestion is and how far the WB congestion extends along Portland. 	 Convert WBL to protected only or extend protected portion of protected permissive phase. Consider corridor level strategies for access management that limit uncontrolled cross median movements Check and potentially extend all red clearance interval for NBL and SBT; ensure technical guidance is followed at a minimum.

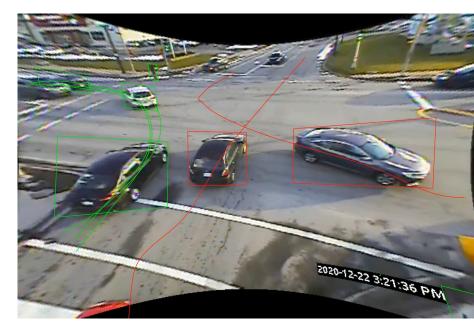
North-Left vs South-Through: PET= 2.8s, vehicle speed 20 km/h

Multiple NBL vs SBT conflict clips show a queue of WB vehicles that prevent the NBL vehicles from clearing the intersection during the protected left turn phase.

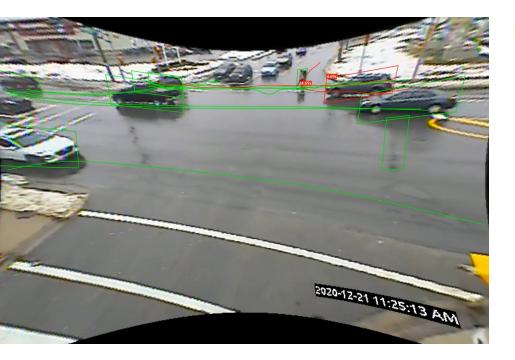
Pedestrian East-Right Hook conflict data show conflicts occurring with through vehicle speeds of nearly 20km/h.

At impact speeds of 20 km/h, pedestrians have a ~10% chance of a severe injury (MAIS 3+).

Due to high right turn radius, vehicles can complete turns at higher speeds, exposing crossing vulnerable road users to increased risk when crossing

Pedestrian East-Right Hook: T2 = 2.0s, vehicle speed: 18 km/h

Key Issue	Recommendation
 Pedestrian safety: The fatal collision involved a northbound-right vehicle and a pedestrian. 5 east-right hook conflicts were detected during the 50-hour analysis period. Pedestrians are exposed to longer crossing distances due to skewed crossings. The right turn influence vehicle turning speed and risk level to pedestrian in a collision. General improvements to pedestrian safety and visibility would be valuable at this location given its collision history and the desire lines from residential homes north of the intersection to access commercial establishments south of the intersection. 	 Curb radius reductions No right turn on red (to go with radius reduction especially if this pushes turn into 2nd receiving lane) Zebra markings Tactile surfaces on directional curb cuts 90 degree crossing alignments Leading pedestrian intervals
 Speeds: 93 high-risk conflicts (impact vehicle speed >50 km/h) were detected during the 50-hour analysis period. The open cross section and arterial environment along Portland may contribute to high-speed trends. 	 Speed moderation techniques should be considered along this corridor (corridor- level speed management strategy), especially given the surrounding land use (residential driveway accesses, etc.).
