Draft Report

Halifax Forum Redevelopment 2901 Windsor Street Halifax, Nova Scotia

February 2018

Project Number 1701079

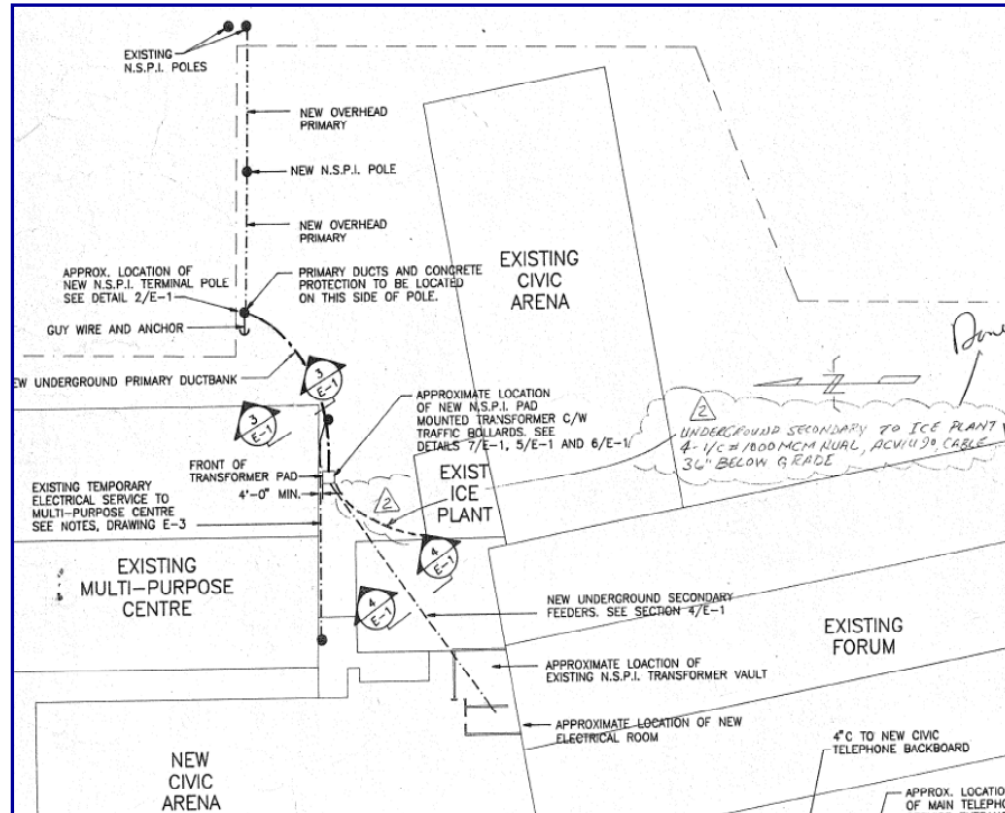
The above is an excerpt from the as built electrical drawing from construction of the Civic Centre. December 2017

However, the presence of multiple feeds at locations anticipated to be renovated will disrupt the existing power distribution to the main electrical room. This may be minimized at the time of detailed design however until that time, the renovation solution has allowed for relocation of the NSPI transformer, grounding system and both the primary and secondary feeds below ground. In addition as the main switch dates from 1996, an allowance for replacement has been added to the cost estimate.

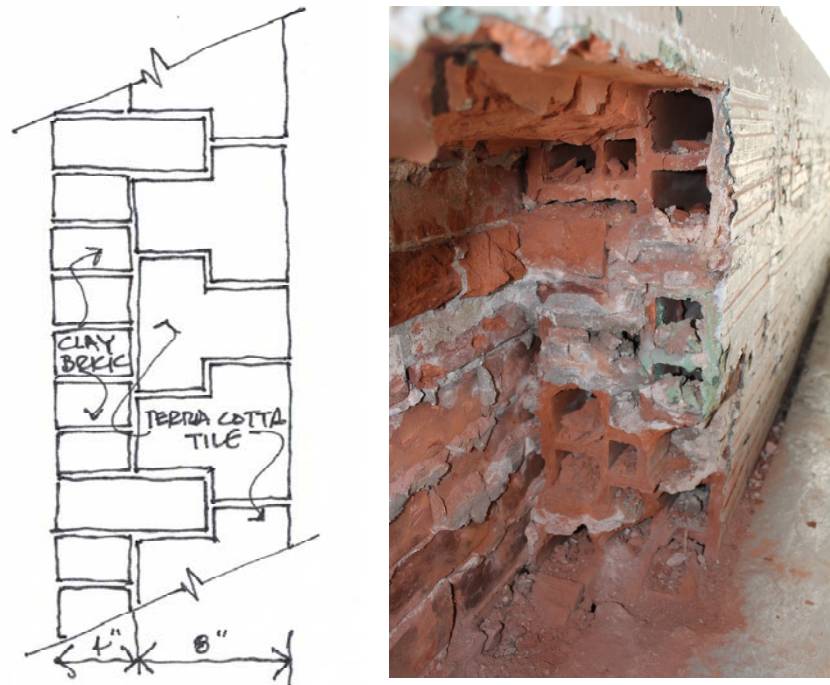
The exterior wall system of the forum consists primarily of 2 wythes of masonry – one 4" deep exterior clay brick and one layer of 8" deep terra cotta tiles (which are locally known as "speed tiles") with a total depth of approximately 12 inches. The terra cotta tiles are T shaped to allow a brick header courses every 7 courses, which ties the brick and terra cotta tiles together. This is a non-load bearing, unreinforced, face sealed system, without any insulation, and was constructed as part of the original 1927 construction. The below sketch and image taken during destructive testing of the wall system illustrate the wall construction. This construction is consistent from above the foundation wall to the roof.

Drawing of wall construction left and image of open wall above the upper concourse right

Recent additional destructive testing has revealed that there is no physical connection, such as reinforcing steel or steel brackets connecting the exterior wall construction to the main structure. The concrete columns (discussed in the structure section in more detail) appear to be sound below the level of the upper stands, but the 8"x8" steel columns between the upper stands and underside of the roof are badly deteriorated due to moisture penetration. Several columns have rusted through.

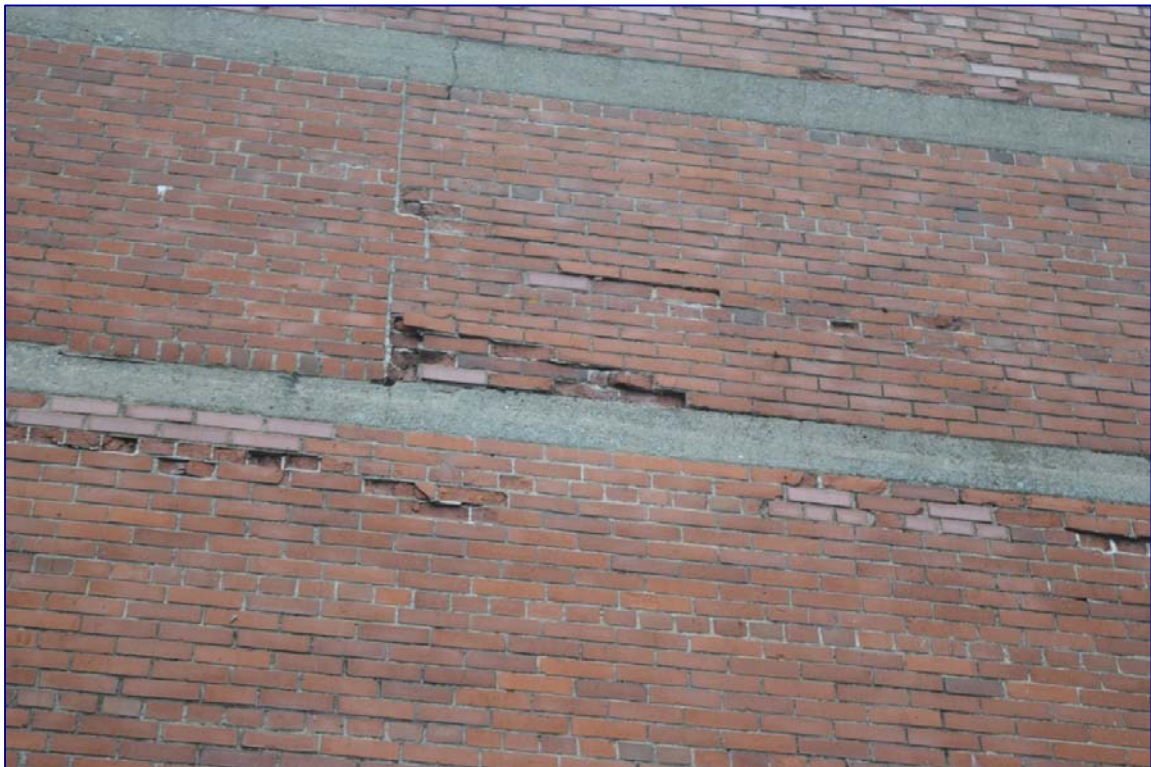
Image from the south elevation of the Forum taken October 2017

as Campbell Comeau Engineering. As can be seen from the pattern of deterioration in the attached photo, hard materials have been inserted into the softer outer wall. The new harder mortar and bricks resist the expansion and contraction of the wall. This is having the effect of acceleration deterioration, spalling and allowing more moisture and water penetration into the wall assembly, which in turn is causing accelerated deterioration of the wall assembly including the imbedded structural Steel.

It was reported to the August 27, 2003 Heritage Advisory Committee Meeting that “about 50% of the bricks are repointed”. There have been envelope repairs completed since the 2003 registration with Heritage including selective repointing and brick replacement. This has result in less than 50% of the bricks being original to the building.

This photo also illustrates the continuous poured concrete bands that surround the building below the upper glass block windows. Because no expansion joints were poured into these bands, they have been subject to cracking and exacerbated the differential thermal expansion and contraction between the exterior wall assembly and interior structural components.

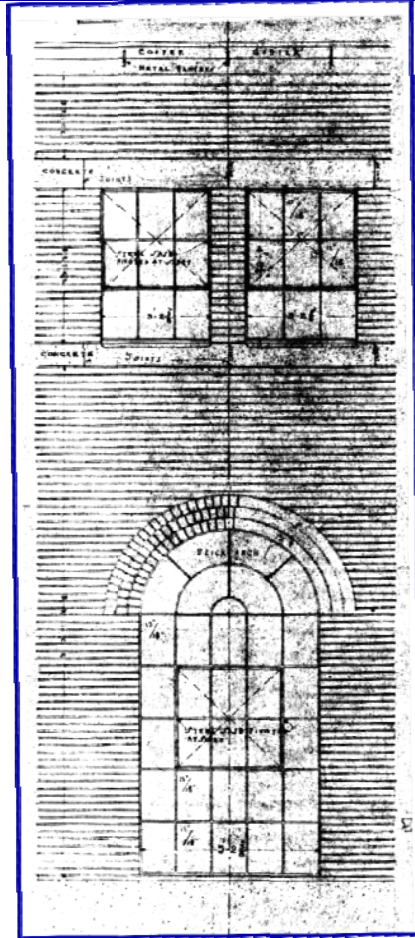
Excerpt from original building drawings

As can be seen from the adjacent excerpt from the original Architects Working Drawings, the upper level clearstory windows were originally glass lights in metal frame matching the design of the arched windows below. These windows appear to have been replaced with glass block, probably due to deterioration of the metal frames. Based on the direction of the municipality an allowance for replica windows has been included in the cost estimate instead of the glass block.

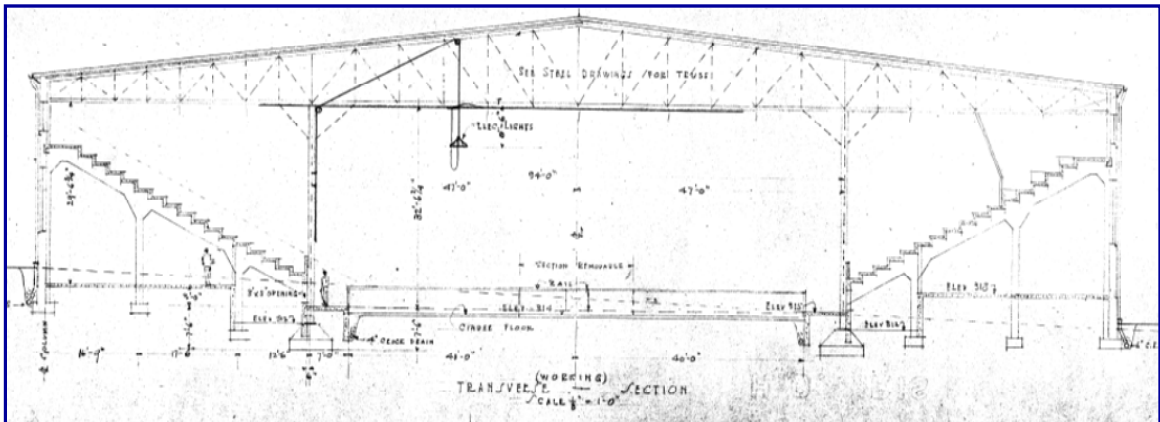
A limited structural assessment was completed by Campbell Comeau Engineering and the findings summarized by CMEL for inclusion into the report. The Forum structure is approximately 89 years old. The steel roof framing displayed signs of minor surface corrosion with bubbled and flaking paint throughout. The thickness of the wood decking was not observed during the site review, but it is noted on the original drawings as 1 ¼" thick. The wood battens are 3" wide by 2" deep at approximately 22" c/c. A structural analysis of the wood decking and wood battens indicate they have sufficient capacity to support the current NBCC 2010 requirements for snow loading.

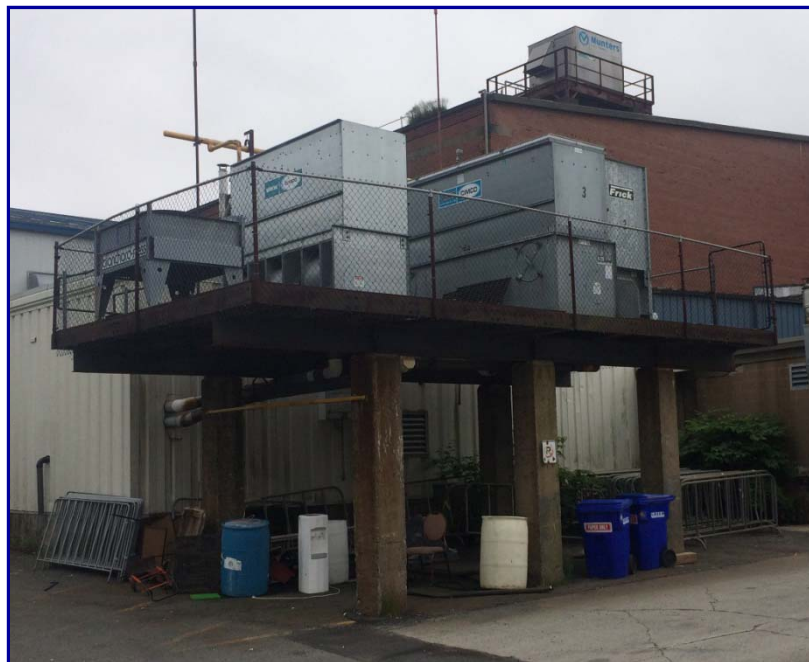
The chillers are from 1999 and 2004 respectively and are served by two Tamper pumps and one Armstrong pump acting as a backup. The chillers are in fair shape for their age as a result of ongoing maintenance. The two Tamper pumps are in poor shape as they are from 1995 and are in full time operation. However the Armstrong pump, which is also from 1995, is in good condition due to the minimized use as a backup. Three evaporative condensers serve the plant. The three condensers were installed separately in 1988, 2000 and 2007. They are all in fair to poor condition due to the combination of their age and exposure to the harsh maritime climate. Along with the three condensers there are four Cimco compressors. These compressors are reciprocating compressors that have

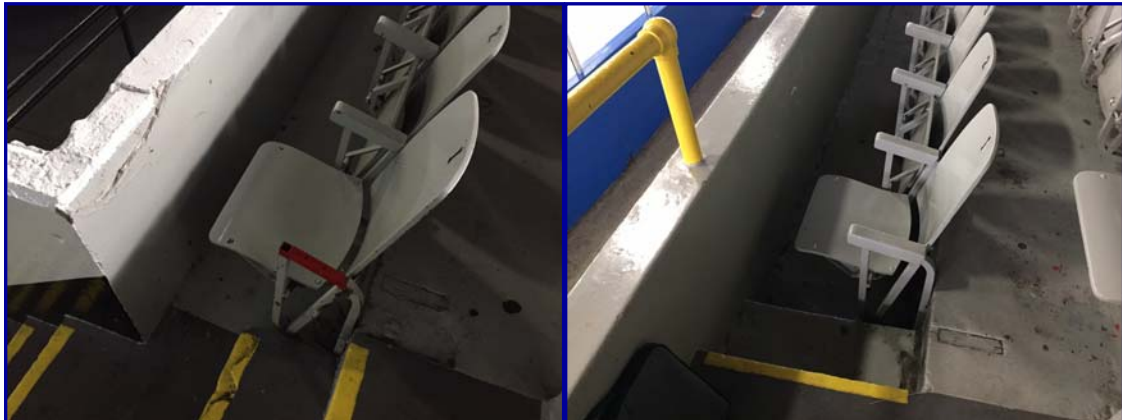
The rise to run of the original stepped bench seating was (and is) 1"-3" rise to 2'-6" run. With the original bench type seating, the required minimum distance between seat rows would meet current clear width dimension of 400mm (approx. 16"). However, when fixed seating with backs and folding seats were added, the required width was reduced to 14" (with the seat folded up). The yellow seats however, provide 17" clear when folded.

There are many areas close to the ice surface where the clear width is so small that it is not even possible to sit in the seats without lifting ones knees or sliding them sideways.

Current codes require that travel distance from any seat cannot require passing more than 7 seats to reach an aisle. This means that the maximum number of seats between aisles is 15. Currently in the Forum the standard number of seats between aisles is 22. There are also large sections where the number of seats between aisles is 30.

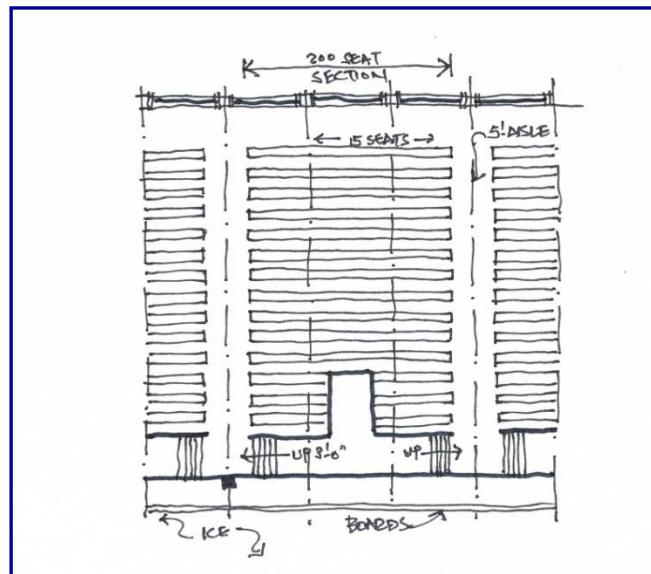
Halifax Regional Fire Department has provided a limited occupancy requirement established in January 2017 of 4600 including all staff and patrons. The sketch below illustrates a typical 200 seat section taking into account the allowable density of seating. This approach will result in approximately 3,730 code compliant seats – a reduction of 880 seats, or 19% of the existing seating. However, as outlined above, many of the existing seats are uncomfortably close to guard rails and many are not code compliant.
