Lacewood Dr and Parkland Dr

MicroTraffic Video Diagnostic Findings and Recommendations

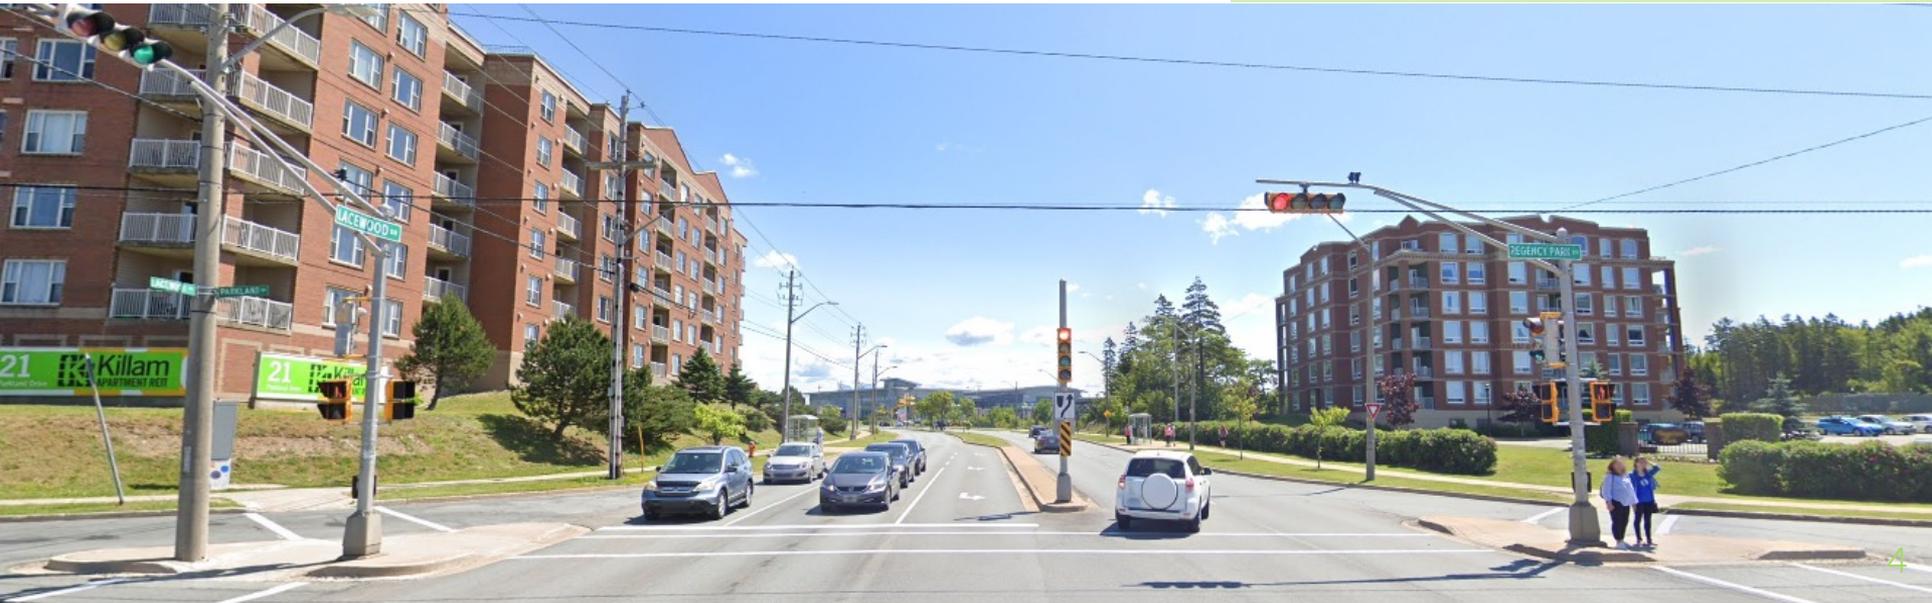
Lacewood Dr. Looking East

- Two through lanes and a left turn auxiliary lane
- Right turn channelization islands
- 60 km/h posted speed limit
- Three signal heads EB and WB (one nearside each)
- Left turn signalization: protected/ permissive
- No reflective back plates on signals
- Sidewalks on both sides of the intersection with boulevard separation
- Nearside transit stop WB and farside transit stop EB

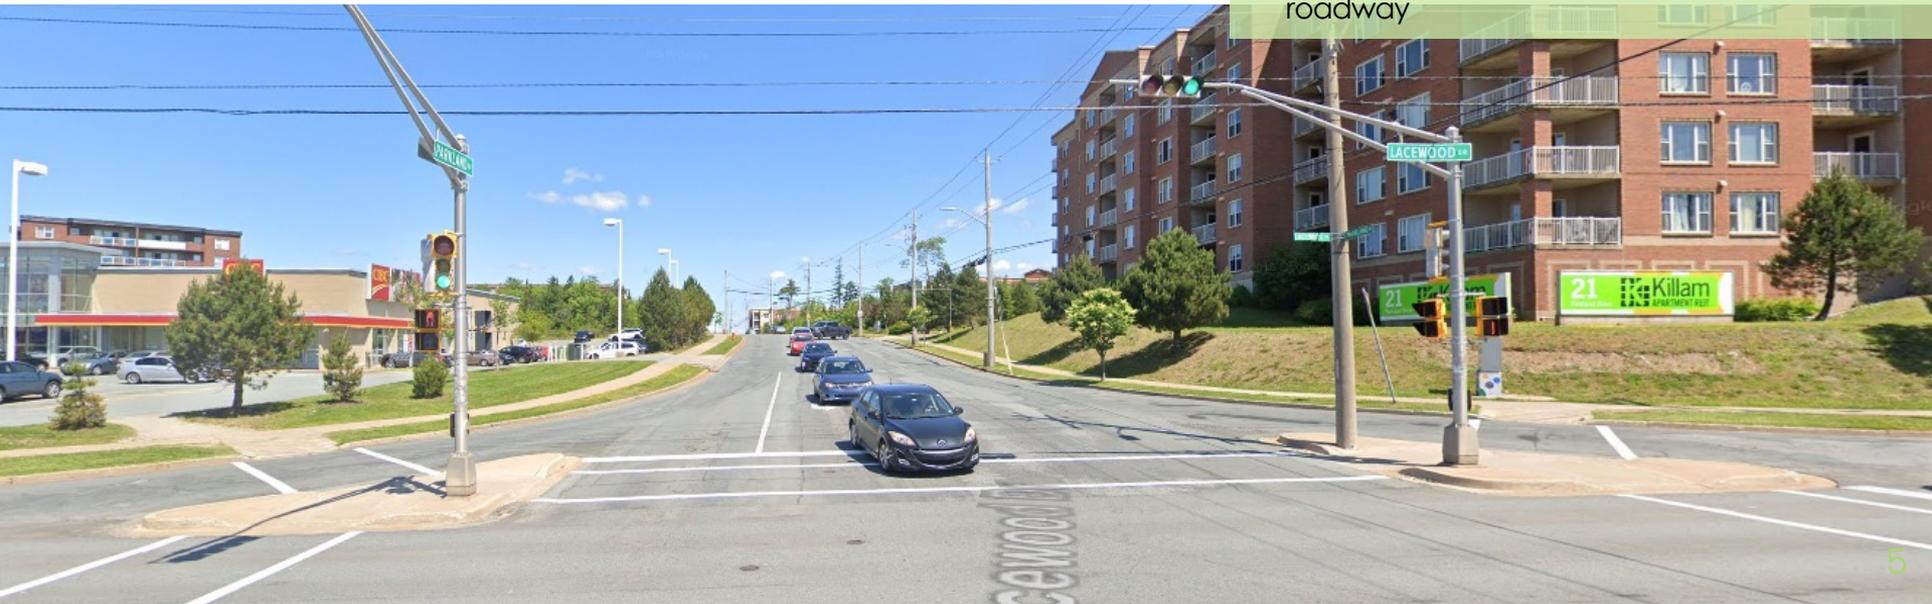
Parkland Dr. Looking North

- One through lane and a left turn auxiliary lane (receiving through lanes ~7m)
- Right turn channelization islands
- 50 km/h posted speed limit
- Three signal heads NB and SB (one nearside each)
- Left turn signalization: permissive only
- No reflective back plates on signals
- Sidewalks on both sides of the intersection with boulevard separation
- Nearside transit stop NB
- Hydro poles located <0.5m away from the roadway

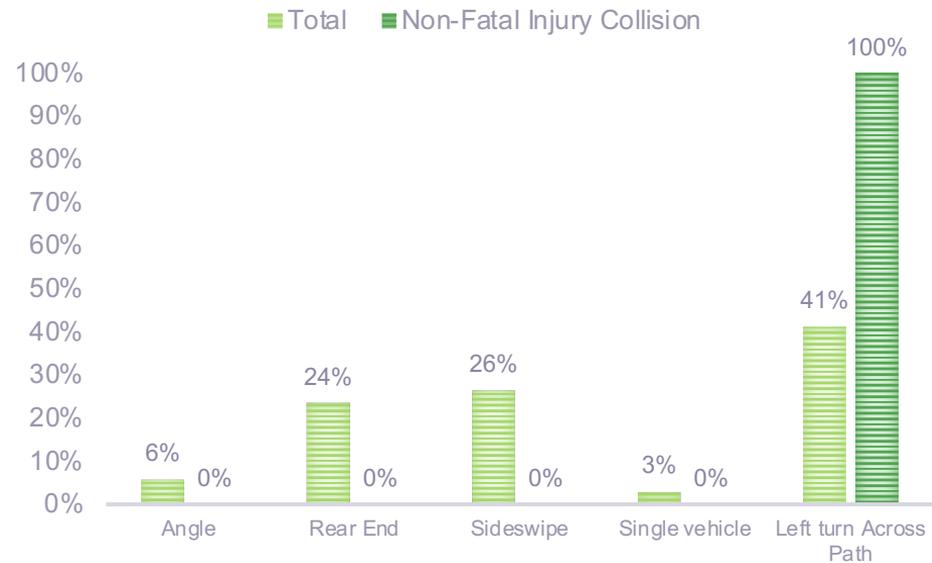
CONFIGURATION DISTRIBUTION OF COLLISIONS

- The provided collision data included 34 collision records January 1, 2018 to April 12, 2021. Of the 34 records, 6% were classified as non-fatal injury collisions and 94% as property damage only collisions.
- The collisions were classified into the general descriptions shown in the adjacent figure based on the initial impact type and provided directional information.

- Left turn across path collisions represent 41% of total collisions and 100% (2 events) of the non-fatal injury collisions. The directional distribution was 36%, 21%, 36% and 7% for Eastbound-left, Westbound-left, Southbound-left and Northbound-left respectively.
- Rear End collisions represent 24% of total collisions. 50% of these collisions were in the westbound direction.
- Sideswipe collisions represent 26% of total collisions. More than 50% of these collisions were in the southbound direction.

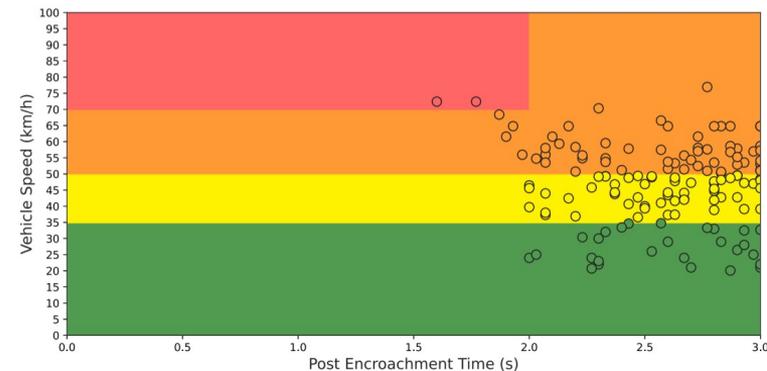
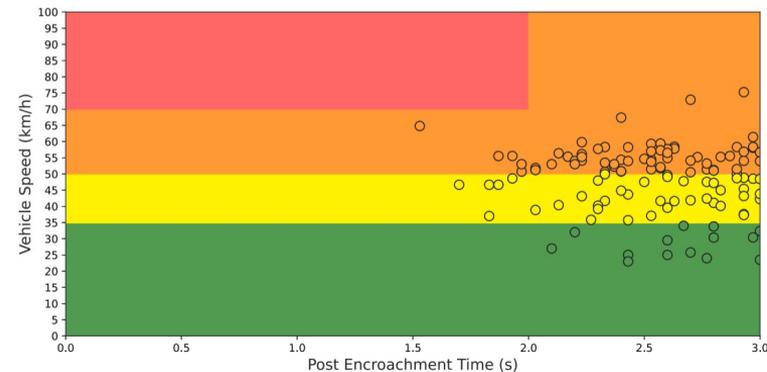
East-left vs West-through (above) and West-Left vs East-through (below) conflict data shows several conflicts occurring with through vehicle speeds exceeding the 60 km/h posted speed limit (up to 75 km/h).

At impact speeds above 60 km/h, opposing drivers have a >65% chance of a severe injury (MAIS 3+), which increases to >90% at 75 km/h.

Key Issue	Recommendation
<p>Left Turn Across Path (LTAP):</p> <ul style="list-style-type: none">• LTAP collisions make up 41% of all collisions and 100% of non-fatal injury collisions (these events primarily involve Eastbound-Left and Southbound-Left vehicles).• 356 LTAP conflicts were detected during the 74-hour analysis period, with several occurring at vehicle speeds exceeding posted speed limits.• Left turn signalization is permissive/protected for WBL/EBL and permissive only for NBL/SBL. Left turning drivers are required to select adequate gaps in oncoming traffic during permissive phases.	<p>The historical collision count is low but the conflict count for LTAP is high, and there were a few concerning LT vs ped collisions. This may be an opportunity to proactively install protected left turns based on surrogate safety before the crash data escalates.</p>
<p>Pedestrian Safety:</p> <ul style="list-style-type: none">• Approximately 700 pedestrians crossed the intersection in a day (in November).• Right-hook conflicts at the channelization islands were not measured but several left-hook conflicts were detected.• Many conflict clips indicate that permissive left turning drivers did not initially observe pedestrians crossing with the right-of-way and encroached on their crossing area.• General improvements to pedestrian visibility at the crossing would be valuable, especially considering the large volumes of pedestrians and surrounding multi-family residential and commercial areas.	<p>Implement zebra crossing strips</p> <p>Implement left turn traffic calming by extending centerlines with vertical delineators. These can go up to the crosswalk and also be placed at inside edge of crosswalk to constrain left turn radius.</p> <p>Consider LPIs for movements that are not covered to protected left.</p>

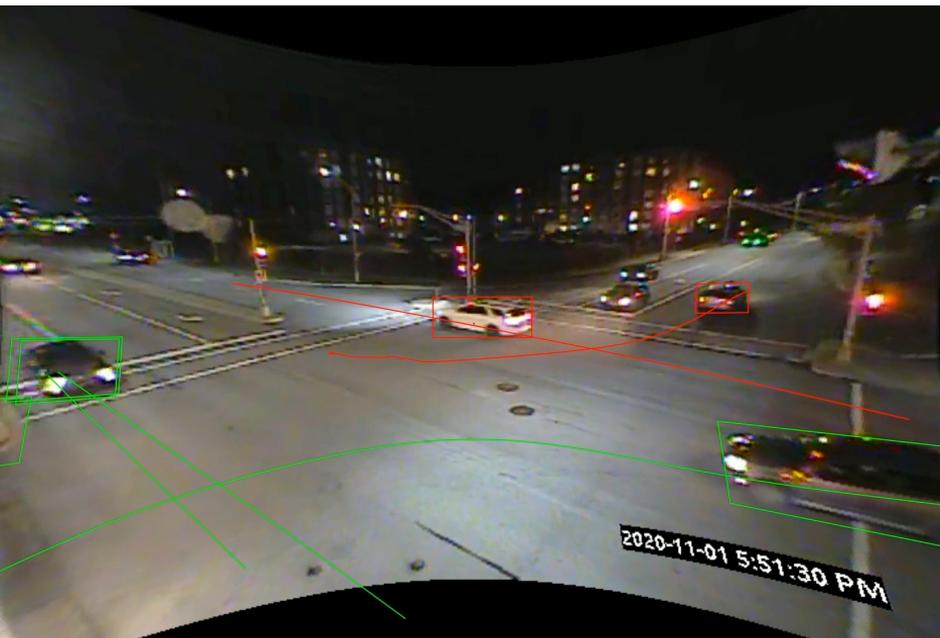
West-Left vs East-Through: PET = 1.5s, vehicle speed = 65 km/h

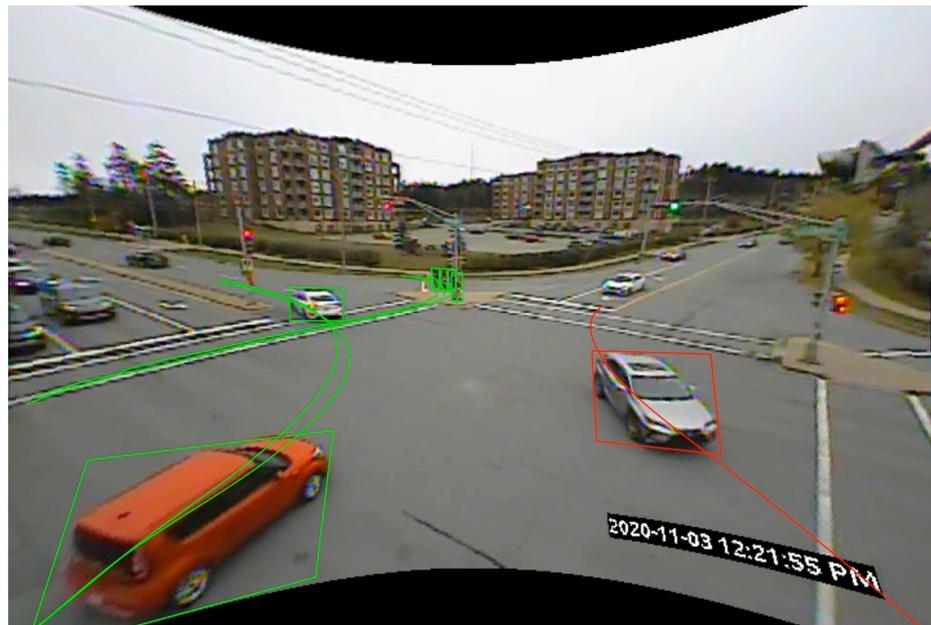
North-Left vs South-Through: PET = 2.3s, vehicle speed = 50 km/h

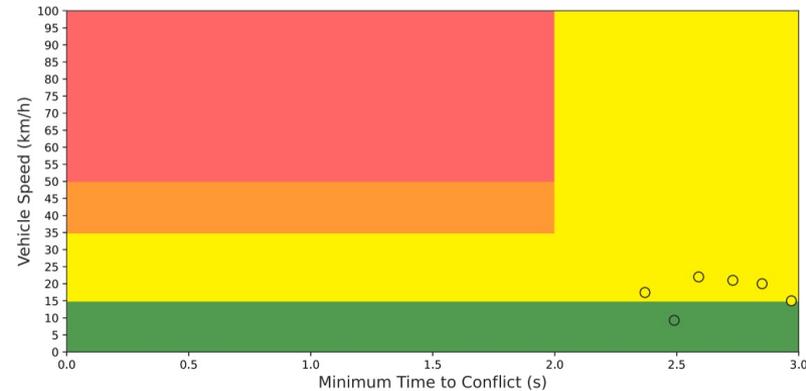
Pedestrian North-Left Hook conflict data show conflicts occurring with through vehicle speeds >20 km/h. At impact speeds of 20 km/h, pedestrians have a 10% chance of a severe injury (MAIS 3+).

- On multiple occasions, the left turning driver did not notice the crossing pedestrian until they initiated their left turn movement. As vehicles eventually yield to the right-of-way pedestrian, they become exposed to a potential conflict with oncoming through vehicles.
- Drivers do not give crossing pedestrians much space or separation.

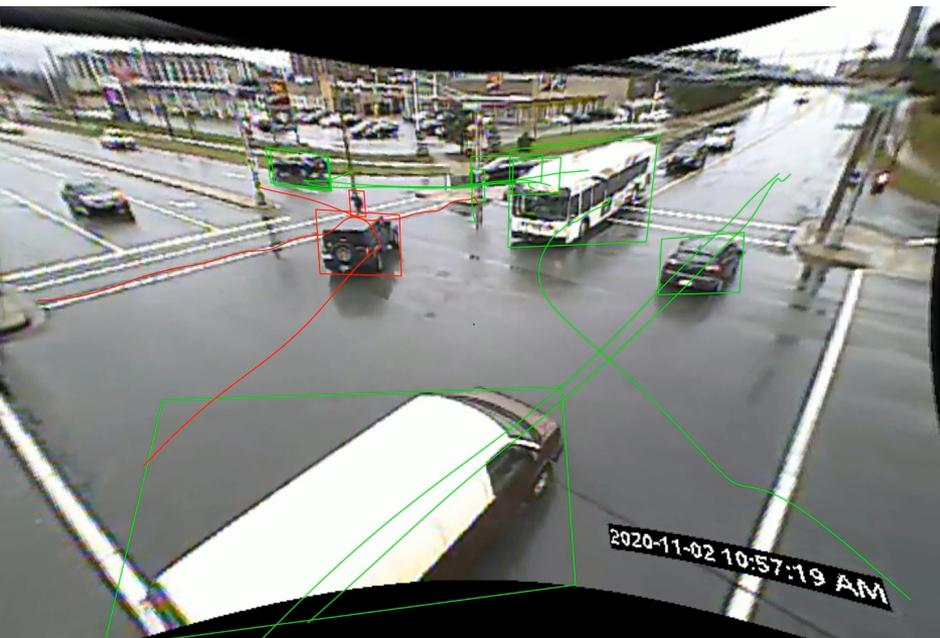
Pedestrian North Left-Hook: $T_2 = 2.4s$, vehicle speed = 17 km/h

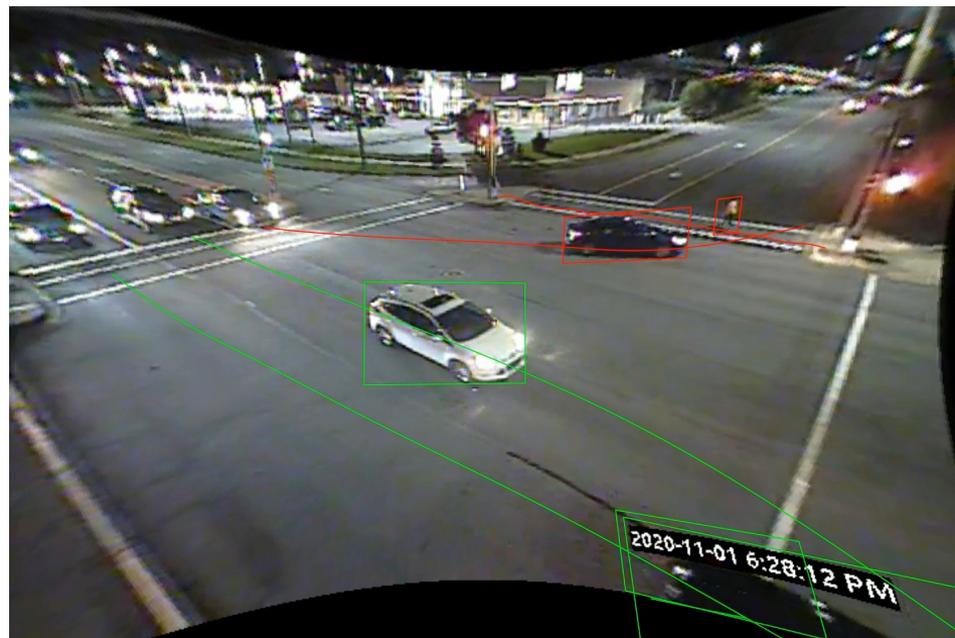
Pedestrian East Left-Hook: $T_2 = 2.9s$, vehicle speed = 23 km/h

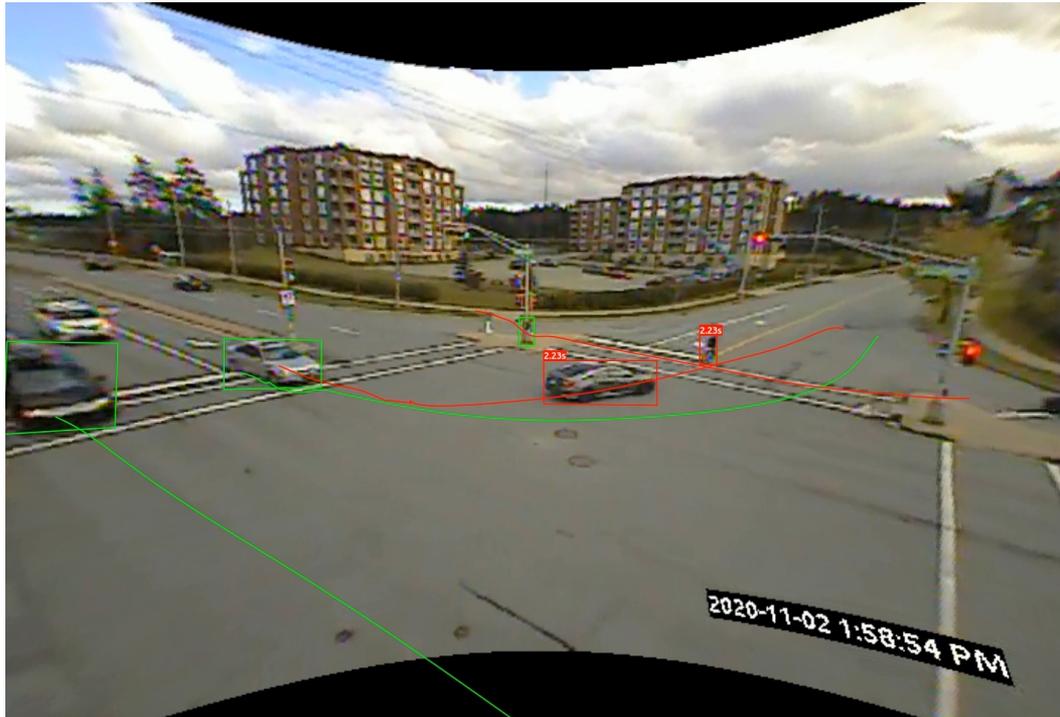
Pedestrian West Left-Hook: $T_2 = 2.2s$, vehicle speed = 11 km/h
