Inaccessible Bus Stop Guide

Metro Transit

Halifax Regional Municipality

November 2011

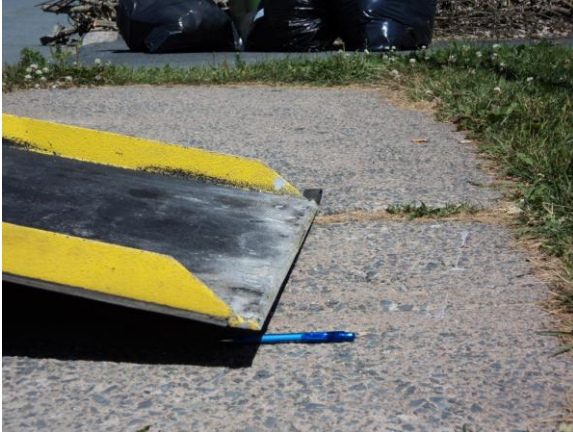
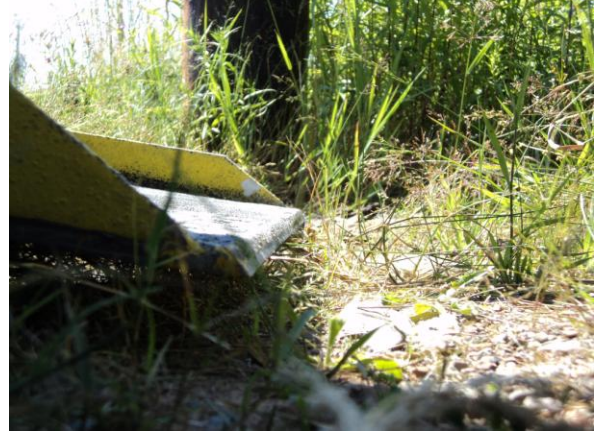
In the two examples below, the deploy cycle is complete, but due to the micro-geography of the area and the condition of the pavement, the ramp was not flush with the ground. Therefore, these stops were designated as **Inaccessible Bus Stops**.

This was interpreted to mean that the end of the ramp must be able to rest flat on the ground and no object (greater than ½ cm) is able to be placed between the ramp and the ground. Furthermore, no obstructions can be located in the area where the ramp is deployed. When the end of the ramp does not rest flat on the ground, there is the potential for the ramp to bend, wobble or crack from the strain placed on it. This would constitute damage to the ramp. Therefore, the ability for the ramp to lay flush with the ground is the largest factor in determining damage.

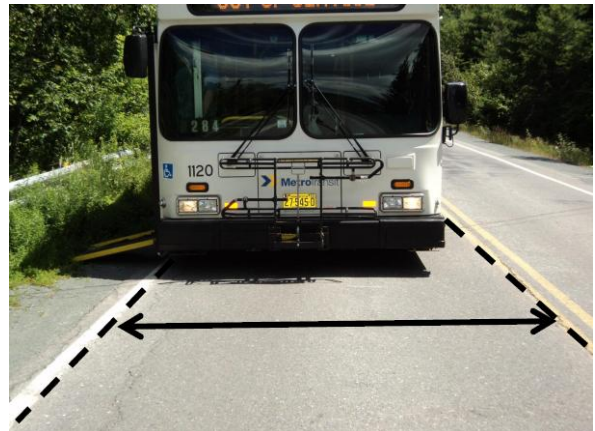
Also, when determining Inaccessible Bus Stops, relevant sections of the Province of Nova Scotia's 'Motor Vehicle Act' (NS-MVA) were reviewed and taken into consideration. In some instances, the end of the ramp could lie flat, but the bus would have to be positioned in a way that would result in the operator being in contravention of a section of the NS-MVA. Therefore, stops where the operator would have to position the bus (to make the ramp lie flat), such that it would result in a contravention of the NS-MVA were determined to be inaccessible.

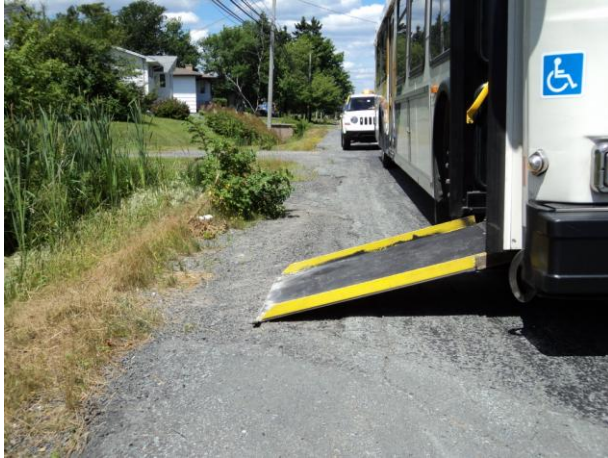
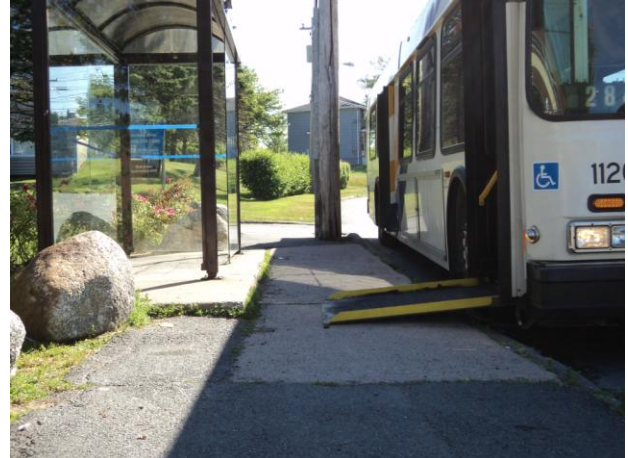
In the example to the below-left, the bus is positioned so it is in compliance with Section 129 (1) of the NS-MVA. The ramp can be safely deployed without damage to it, but there is insufficient room for a mobility-impaired customer to manoeuvre on or off the ramp. For there to be sufficient room, the operator would have to position the bus in contravention of the NS-MVA, therefore, it was determined to be inaccessible.

In the example above-left, the ramp is deployed but the location of natural impediments. The adjacent ditch combined with the slope and material of the ground makes the potential great for a customer embarking/disembarking at this location to lose their balance while on the ramp. This could cause it to bend or tip causing damage to the bus. In the example above-right, the ramp is deployed. However, it cannot be expected that the operator will find the same conditions at this bus stop year round. Due to the numerous impediments (rock, dirt etc) located in the bus stop zone. Therefore, these stop would be designated inaccessible.

Other considerations used included the potential for natural (hill, rocks etc.) or man-made (guardrails, benches, trees), impediments to be located within the bus waiting area. If impediments were located in the part of the waiting area that's required for accessible (1.5m x 2.5m behind the bus stop sign), then that stop was deemed inaccessible.

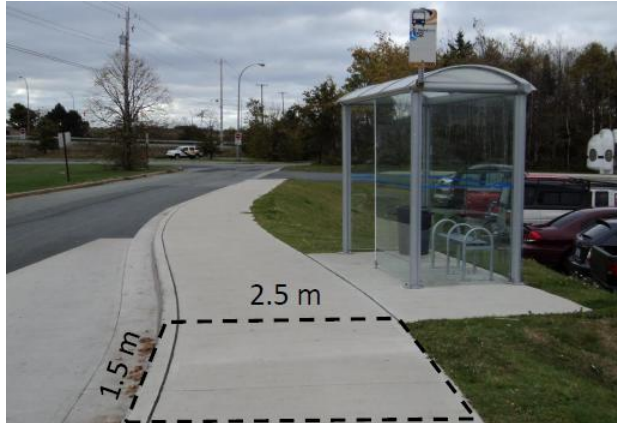
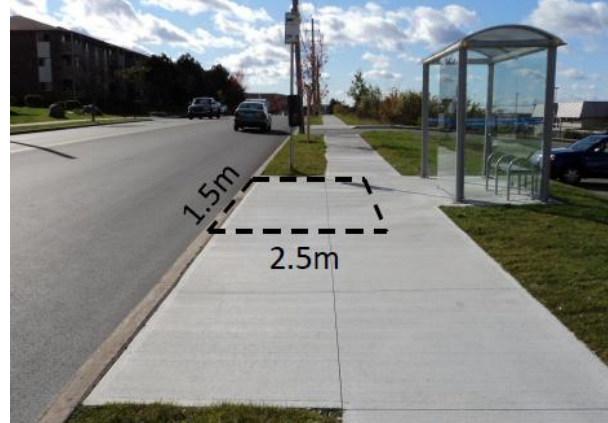
As a comparison, the examples below show bus stops that meet Metro Transit's standards for accessibility. Both provide a flat, open area that is free of obstacles that may cause damage to the ramp. It also provides the minimum required space for ramp operation, plus sufficient space for the customer to manoeuvre on and off the ramp.

A stop is labelled as a **Standard ALF bus stop** when a concrete landing pad is provided with the minimum dimensions of 1.5m wide (along the curb) by 2.5m deep (away from the curb) and the pad is connected to a sidewalk.
