Maritime Project No.: 13512

**RE: Wetland Determination and Delineation –
Charleswood Drive and Cumberland Way, Windsor Junction, NS**

At your request, Maritime Testing (1985) Limited (Maritime) has conducted a wetland verification and delineation program on the above mentioned property to assess for the presence of wetlands that could pose limitations to development. A site location Google earth image is presented below. A wetland delineation sketch is attached.

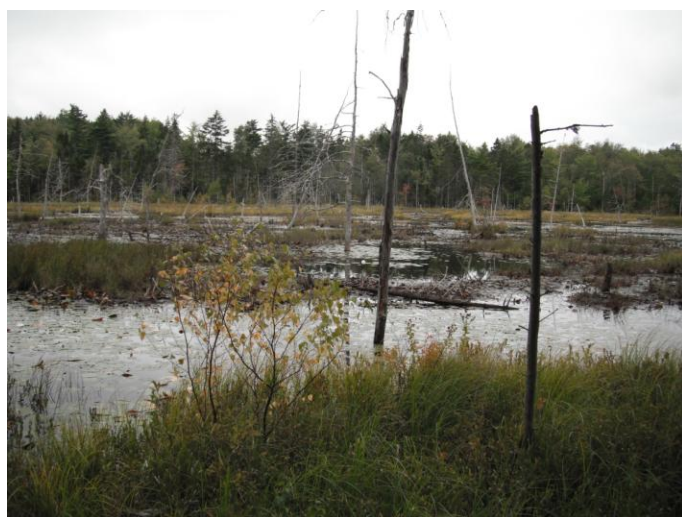
Wetland 1

An open water marsh was observed north of Windgate Drive on the southwest portion of the property. The wetland was observed to be fed by a small watercourse that enters from the southeast. According to provincial mapping, a watercourse also enters the northern part of the wetland. The wetland discharges via a watercourse to Second Lake, to the south. The swamp is

present on provincial 1:10,000 mapping. At the soil probe location, the hydrology was consistent with wetlands (i.e. saturation within 12 inches of the ground surface). The dominant vegetation was hydrophytic (i.e. either tolerant of or requiring wet conditions), with more than 50% of the dominants being FAC or wetter. Additionally, the water table was within 12 inches. This site meets all wetland criteria and therefore we consider this site to be a wetland. The three required wetland criteria are present and described below.

Tree Layer - black spruce (*Picea mariana*, FAC), and red maple (*Acer rubrum*, FAC) along wetland edges.

Shrub Layer – leather leaf (*Chamaedaphne calyculata*, OBL), black spruce (*Picea mariana*, FAC) red maple (*Acer rubrum*, FAC), and wire birch (*Betula populifolia*, FAC) on edges.

Herbaceous Layer – white water lily (*Nymphaea odorata* Soland. In Ait.-OBL), sphagnum moss (*Sphagnum spp.*, OBL), Virginia Cotton-grass (*Eriophorum*

virginicum L., OBL), and sedges (*Carex spp.*– Most are FAC to OBL).

Hydrogen sulphide odour; 8 inches peat over rock at wetland edge.

Saturated surface and standing water.

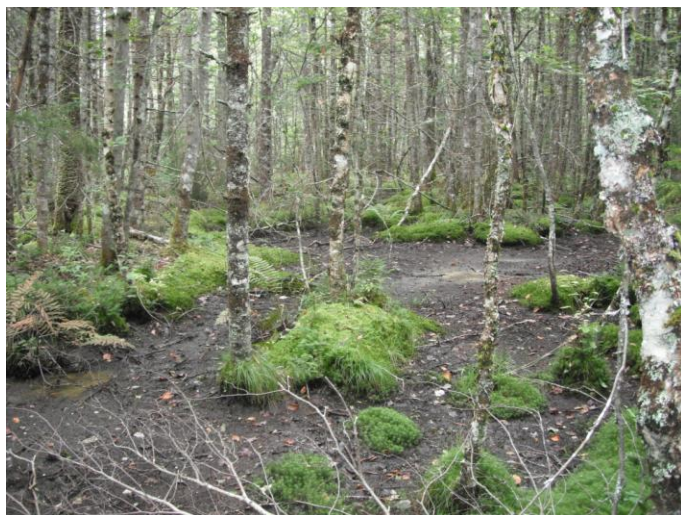
Wetland 2

A treed fen was observed on the western side of the property. The wetland is located in a depression between two ridges with an intermittent watercourse flowing throughout. The watercourse enters to the north of the wetland and exits to the south. The wetland and watercourse are not present on provincial mapping. At the soil probe location, the hydrology was consistent with wetlands (i.e. saturation within 12 inches of the ground surface). The dominant vegetation was hydrophytic (i.e. either tolerant of or requiring wet conditions), with more than 50% of the dominants being FAC or wetter. Additionally, the water table was within 12 inches. This site meets all wetland criteria and therefore we consider this site to be a wetland. The three required wetland criteria are present and described below.

Tree Layer - black spruce (*Picea mariana*-FACW), yellow birch (*Betula alleghaniensis*, FAC), fir (*Abies balsamea*-FAC), and red maple (*Acer rubrum*, FAC) with raised roots.

Shrub Layer – saplings of black spruce (*Picea mariana*-FACW), yellow birch (*Betula alleghaniensis*, FAC), fir (*Abies balsamea*-FAC), and red maple (*Acer rubrum*, FAC).

Herbaceous Layer – sphagnum moss (*Sphagnum spp.*-OBL), sedges (*Carex spp.*– Most are FAC to OBL), and northern starflower (*Trientalis borealis*-FAC); an unidentified moss/liverwort was also present throughout much of the wetland.

0-6” - peat and organic silt, hydrogen sulphide odour

6-11” -mucky silt/clay, tight, wet, 2.5Y 3/1

11-13” -silty sand, compact, wet, Gley1 5/10Y

Saturated surface and standing water, intermittent watercourse.

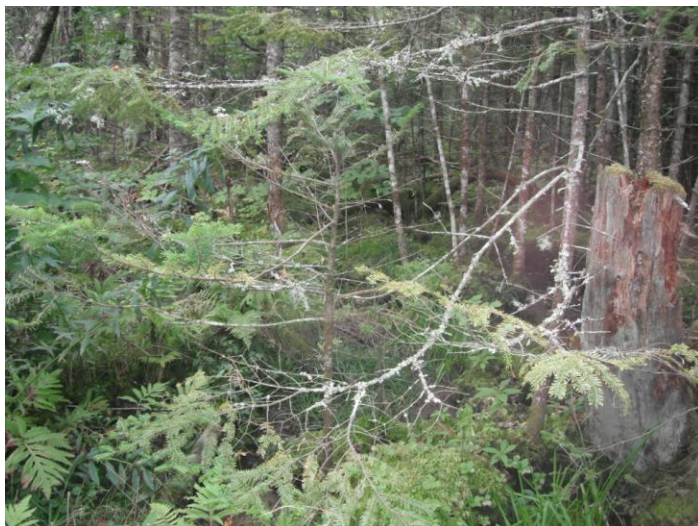
Wetland 3

A treed fen was investigated at the east side of the property near Charleswood Drive. The wetland receives water from an intermittent watercourse which enters from the north. Another watercourse enters from the west in the south portion of the wetland. The wetland drains via a watercourse located on the eastern side of the wetland and another watercourse to the south. The wetland is not present on provincial mapping. At the soil probe location, the hydrology was consistent with wetlands (i.e. saturation within 12 inches of the ground surface). The dominant vegetation was hydrophytic (i.e. either tolerant of or requiring wet conditions), with more than 50% of the dominants being FAC or wetter. Additionally, the water table was within 12 inches. This site meets all wetland criteria and therefore we consider this site to be a wetland. The three required wetland criteria are present and described below.

Tree Layer - yellow birch (*Betula alleghaniensis*-FAC), and fir (*Abies balsamea*-FAC) with raised roots.

Shrub Layer – saplings of yellow birch (*Betula alleghaniensis*-FAC) and fir (*Abies balsamea*-FAC), and Canada holly (*Ilex verticillata*-FACW).

Herbaceous Layer – sphagnum moss (*Sphagnum spp.*-OBL), sedges (*Carex spp.*– Most are FAC to OBL), sensitive

fern (*Onoclea sensibilis*, FACW), marsh fern (*Thelypteris thelypteroides*-FACW), interrupted fern (*Osmunda claytoniana L.*-FAC), and northern starflower (*Trientalis borealis*-FAC),.

0-3”- peat, hydrogen sulphide odour

3-6”-mucky silt, tight, wet, 2.5Y3/2

6-12”-silt/clay, tight, wet, 10YR4/3, redox masses present

Saturated surface and standing water, intermittent watercourses.

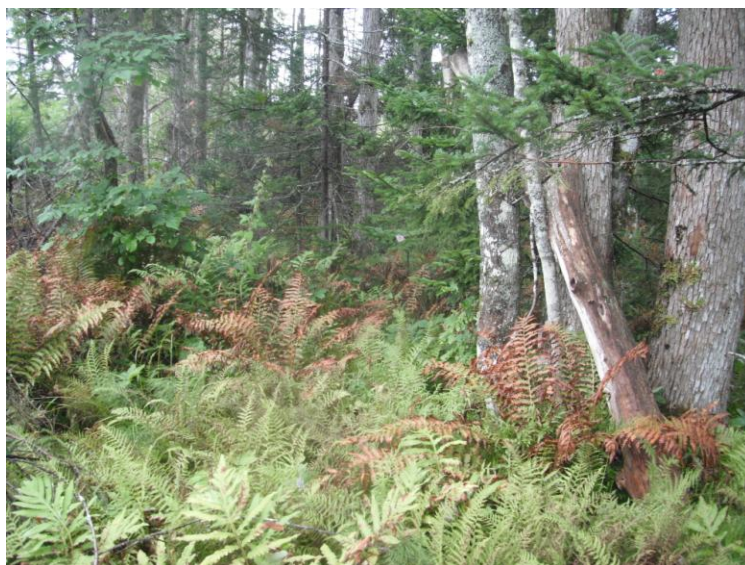
Wetland 4

A treed fen was observed to the north of Wetland 3. The wetland is located in a depression between two ridges and has an intermittent watercourse which enters from the north and discharges to the south towards Wetland 3. The wetland is not present on provincial mapping. At the soil probe location, the hydrology was consistent with wetlands (i.e. saturation within 12 inches of the ground surface). The dominant vegetation was hydrophytic (i.e. either tolerant of or requiring wet conditions), with more than 50% of the dominants being FAC or wetter. Additionally, the water table was

within 12 inches. This site meets all wetland criteria and therefore we consider this site to be a wetland. The three required wetland criteria are present and described below.

Tree Layer – black spruce (*Picea mariana*-FACW), white ash (*Fraxinus Americana* L.- FAC), fir (*Abies balsamea*-FAC), and red maple (*Acer rubrum*, FAC).

Shrub Layer – saplings of black spruce (*Picea mariana*-FACW), white ash (*Fraxinus Americana* L.- FAC), fir (*Abies balsamea*-FAC), red maple (*Acer rubrum*, FAC), and striped maple (*Acer pensylvaicum*-FACU) .

Herbaceous Layer – sphagnum moss (*Sphagnum spp.*-OBL), horsetail (*Equisetum spp.*- FAC to OBL), sensitive fern (*Onoclea sensibilis*, FACW), cinnamon fern (*Osmunda cinnamomea*, FACW), ostrich fern (*Matteuccia struthiopteris* (L.) Todaro-FACW), and marsh fern (*Thelypteris thelypteroides*-FACW).

0-2' peat over rock, hydrogen sulphide odour.

Saturated surface and standing water, intermittent watercourse.

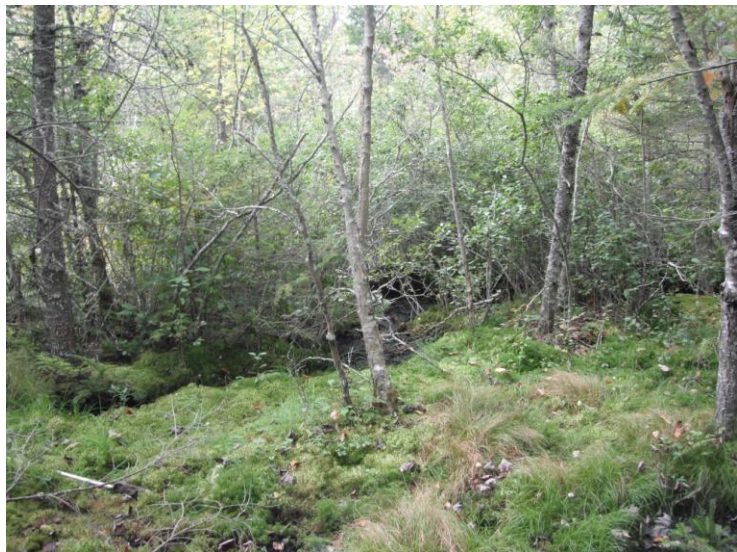
Wetland 5

A treed bog was investigated in the northern portion of the property and south of a provincially mapped watercourse. The wetland appeared to receive water from precipitation and discharged to the south in groundwater and an intermittent drainage channel. The wetland is not present on provincial mapping. At the soil probe location, the hydrology was consistent with wetlands (i.e. saturation within 12 inches of the ground surface). The dominant vegetation was hydrophytic (i.e.

either tolerant of or requiring wet conditions), with more than 50% of the dominants being FAC or wetter. Additionally, the water table was within 12 inches. This site meets all wetland criteria and therefore we consider this site to be a wetland. The three required wetland criteria are present and described below.

Tree Layer - larch (*Larix laricina*-FACW), wire birch (*Betula populifolia*, FAC), red maple (*Acer rubrum*, FAC), yellow birch (*Betula alleghaniensis*-FAC), and red spruce (*Picea rubens*-FACU) with raised roots.

Shrub Layer – saplings of larch (*Larix laricina*-FACW), wire birch (*Betula populifolia*, FAC), red maple (*Acer rubrum*, FAC), yellow birch (*Betula alleghaniensis*-FAC), and red spruce (*Picea rubens*-FACU), Canada holly (*Ilex verticillata*-FACW), and rhodora (*Rhododendron canadense*-FACW).

Herbaceous Layer – sphagnum moss (*Sphagnum spp.*, OBL), Virginia Cotton-grass (*Eriophorum virginicum* L., OBL), cinnamon fern (*Osmunda cinnamomea*, FACW), and sedges (*Carex spp.*– Most are FAC to OBL).

0-4"- peat/organic silt

4-6"-silt, compact, wet, 10YR4/1

6-10"-sandy silt, tight, wet, 10YR6/1 (redox 10YR6/8) over rock.

Saturated surface and standing water.

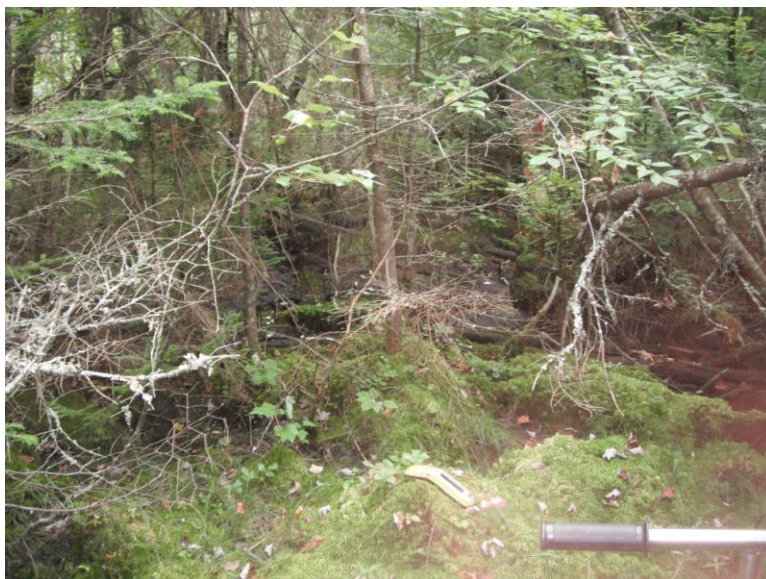
Wetland 6

A treed bog was observed north of the corner of Carriage Road and Chartwell Road. The wetland receives water from a culvert to the south and an intermittent watercourse that enters to the north and discharges to the west. The watercourse eventually discharges to Wetland 1. The wetland is not present on provincial mapping. At the soil probe location, the hydrology was consistent with wetlands (i.e. saturation within 12 inches of the ground surface). The dominant vegetation was

hydrophytic (i.e. either tolerant of or requiring wet conditions), with more than 50% of the dominants being FAC or wetter. Additionally, the water table was within 12 inches. This site

meets all wetland criteria and therefore we consider this site to be a wetland. The three required wetland criteria are present and described below.

Tree Layer - black spruce (*Picea mariana*-FACW), red maple (*Acer rubrum*, FAC), yellow birch (*Betula alleghaniensis*-FAC), fir (*Abies balsamea*- FAC) with raised roots.

Shrub Layer – saplings of black spruce (*Picea mariana*-FACW), red maple (*Acer rubrum*, FAC), yellow birch (*Betula alleghaniensis*-FAC), fir (*Abies balsamea*- FAC), Canada holly (*Ilex verticillata*-FACW).

Herbaceous Layer – sphagnum moss (*Sphagnum spp.*, OBL), sensitive fern (*Onoclea sensibilis*-FACW), cinnamon fern (*Osmunda cinnamomea*, FACW), sedges (*Carex spp.*– Most are FAC to OBL).

0-4"-sand

4"-2'- peat/muck over rock, hydrogen sulphide odour.

Near surface, intermittent watercourse.

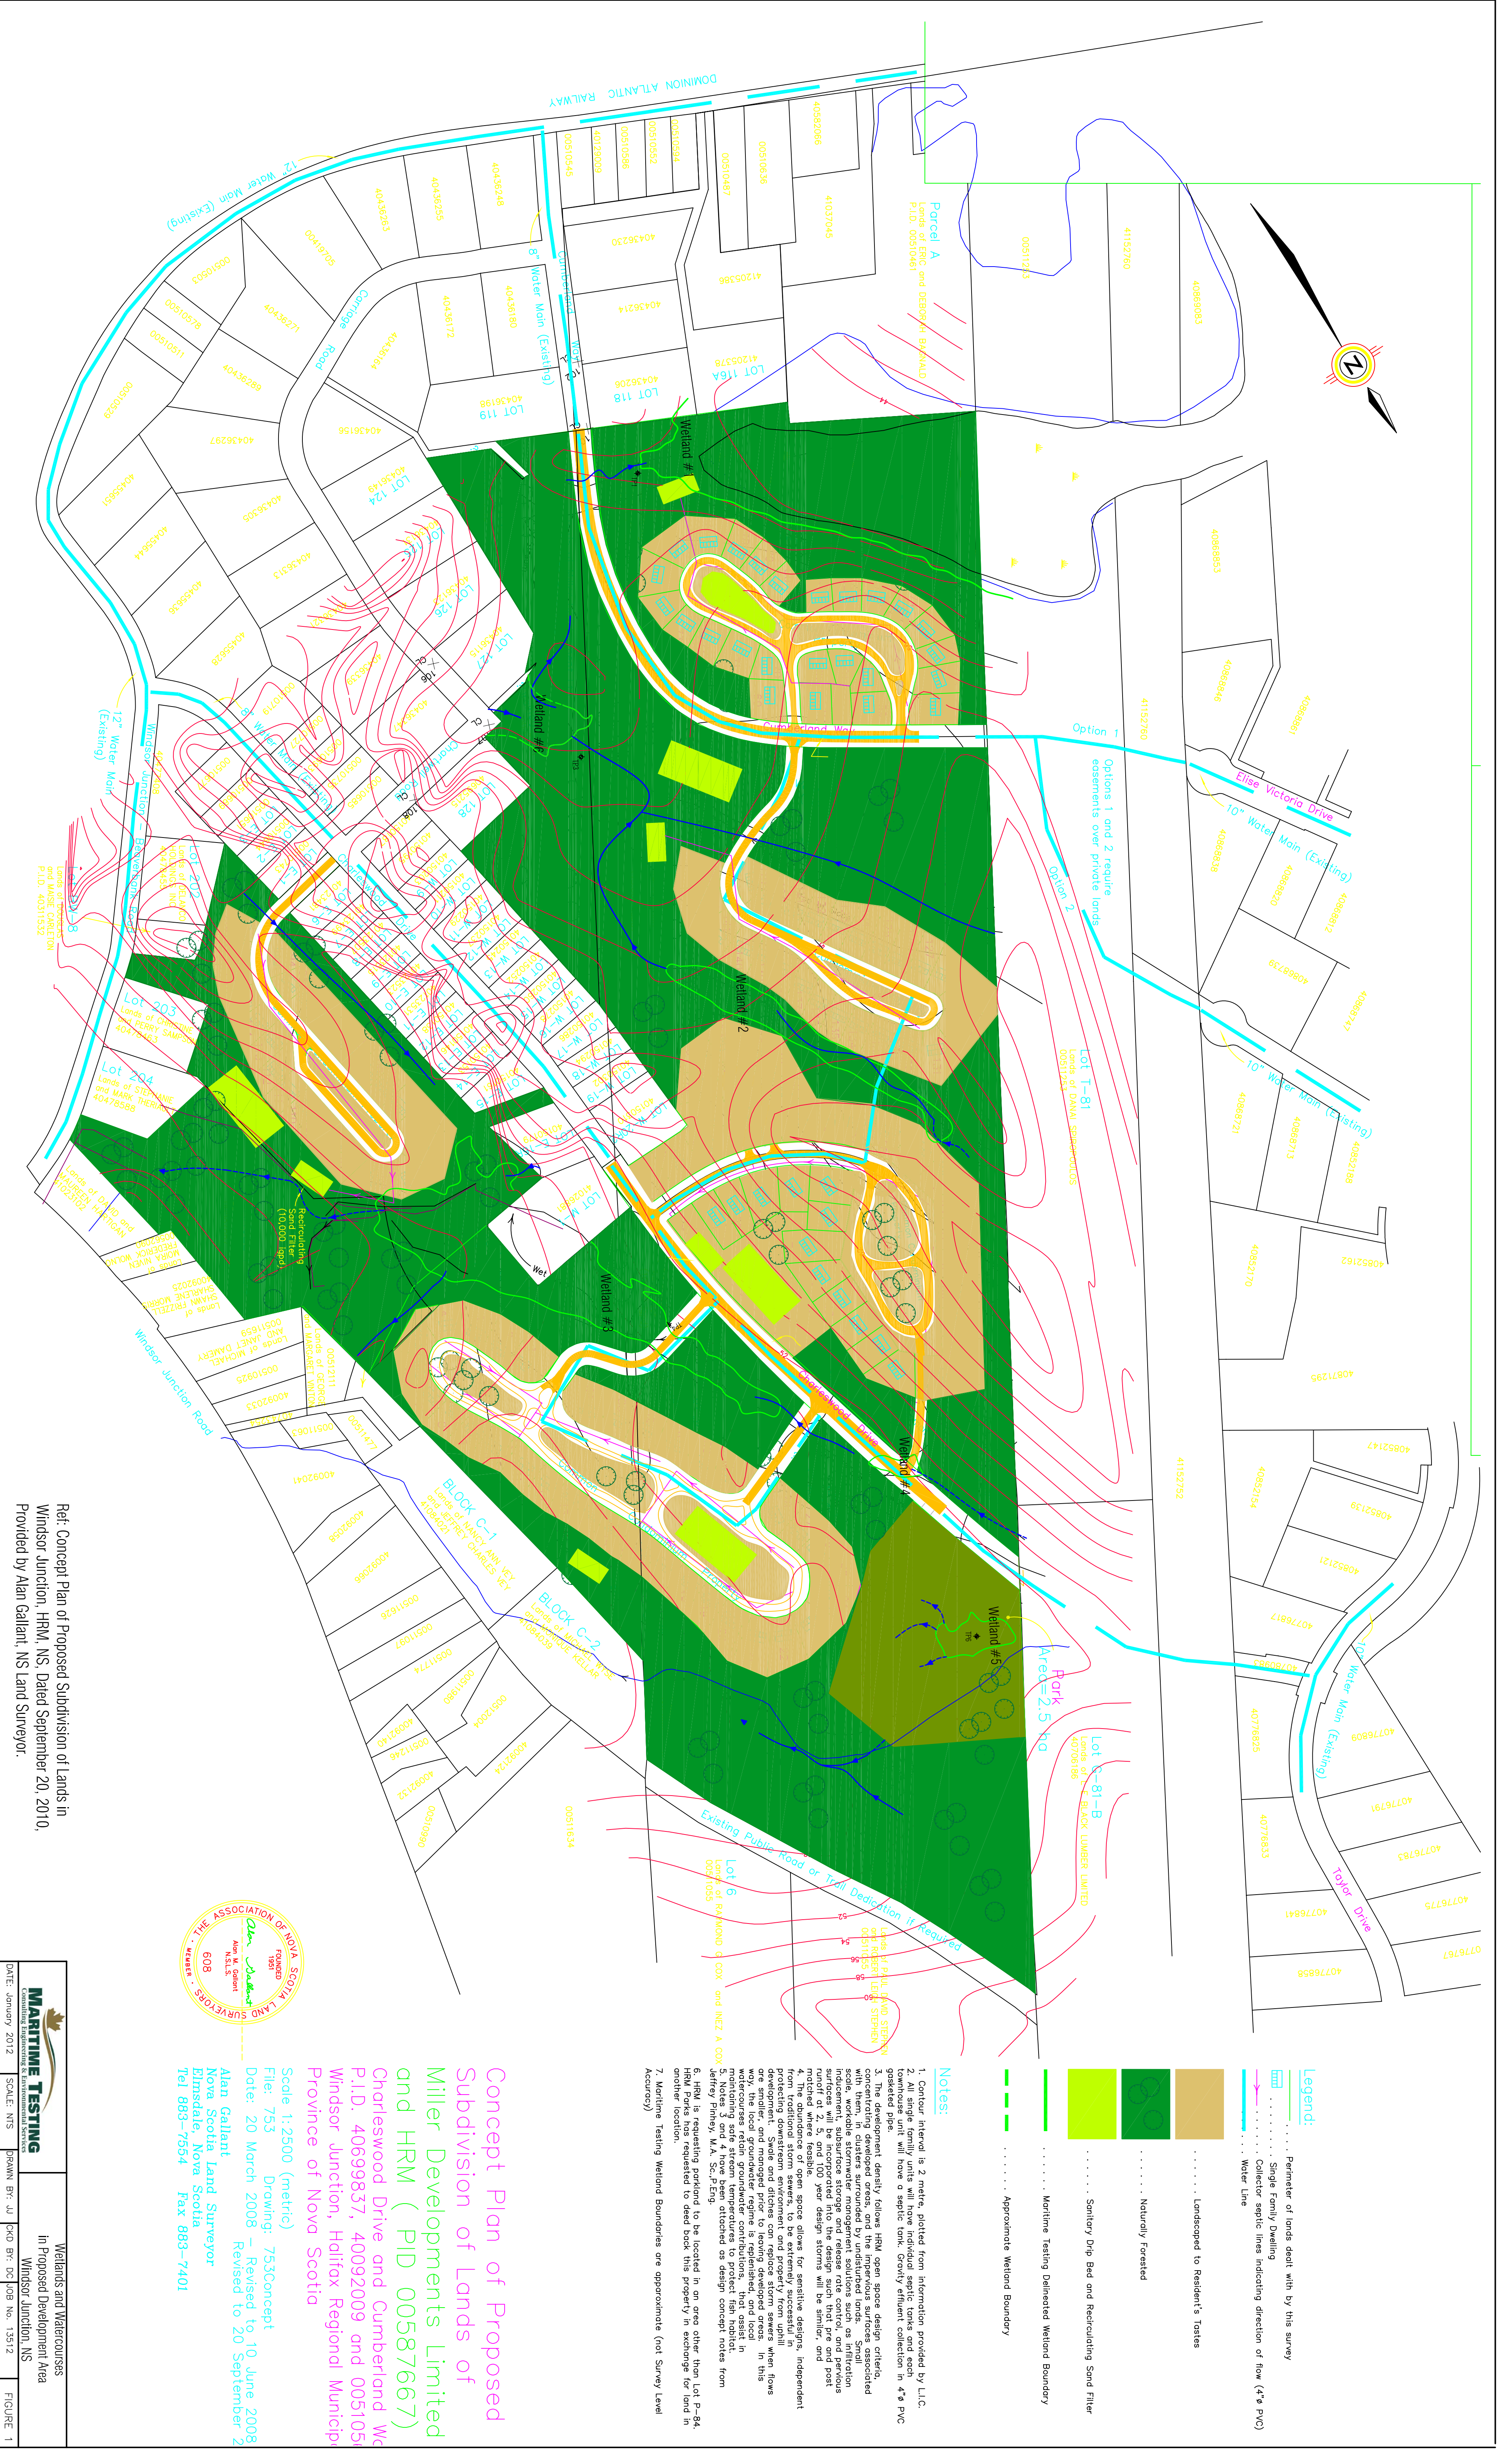
Ref: Concept Plan of Proposed Subdivision of Lands in Windsor Junction, HRM, NS, Dated September 20, 2010, Provided by Alan Gallant, NS Land Surveyor.

Field reconnaissance was conducted on September 6 to 8 and 13, 2011. At encountered wet areas within the sites, Maritime evaluated the three criteria, vegetation, hydrology and soil, which are necessary for wetland determinations. Soil probes and vegetation surveys were conducted at all of the potential wetlands. Where all required wetland characteristics were present, the wetland boundaries were determined by Maritime, delineated with flagging tape, and the positions were acquired with a handheld GPS unit. The wetlands and watercourses identified by Maritime are presented with the development concept plan in Figure 1, attached.

Six wetlands were identified and delineated on the property, as well as several watercourses. The wetlands and watercourses are presented with the development concept plan, Figure 1, attached.
