H00479 - 6215 Coburg Road

Request to Include Property in the Registry of Heritage Property for the Halifax Regional Municipality

Heritage Advisory Committee December 9, 2020

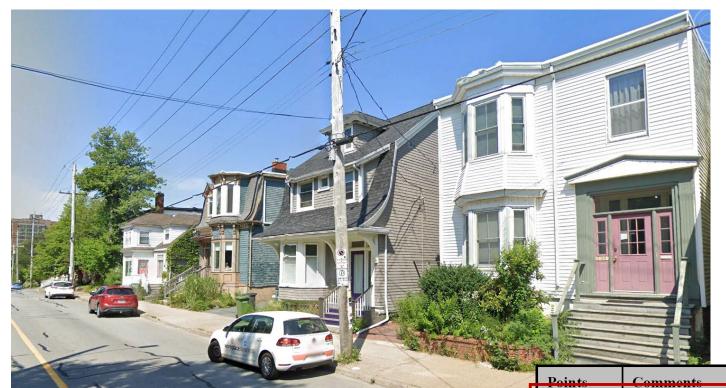
6. Relationship To Surrounding Area

The immediate area was once estate lands, but today its characterized by a series of late-Victorian dwellings

The dwelling largely maintains its original appearance and is adjacent to other Second Empire dwellings

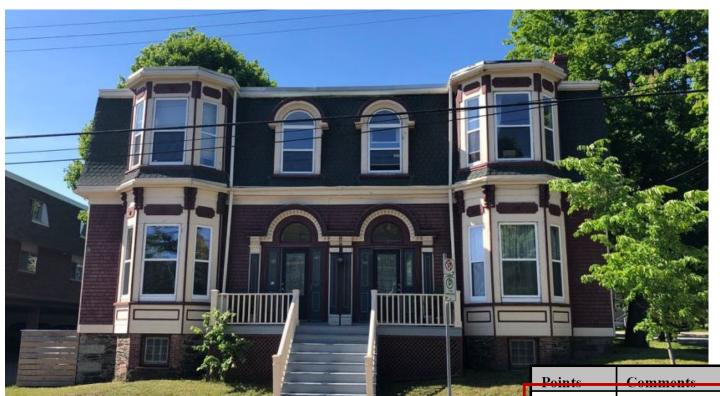
6. Relationship To Surrounding Area

The immediate area was once estate lands, but today its characterized by a series of late-Victorian dwellings

The dwelling largely maintains its original appearance and is adjacent to other Second Empire dwellings
