Heritage Impact Statement (Update) 2438 Gottingen Street 17 May 2021

Prepared for Joseph Arab

Prepared by

Fathom Studio 1 Starr Lane Dartmouth, Nova Scotia 902 461 2525 fathomstudio.ca

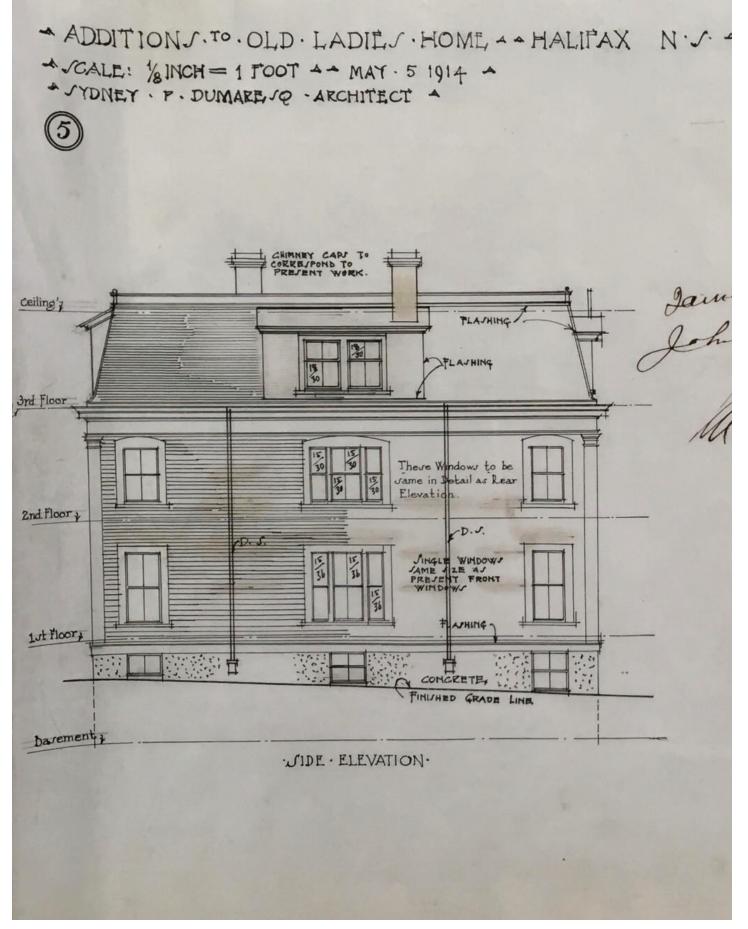
Fig. 2 Side Elevation of Victoria Hall 1914 Addition Source: Nova Scotia Archives

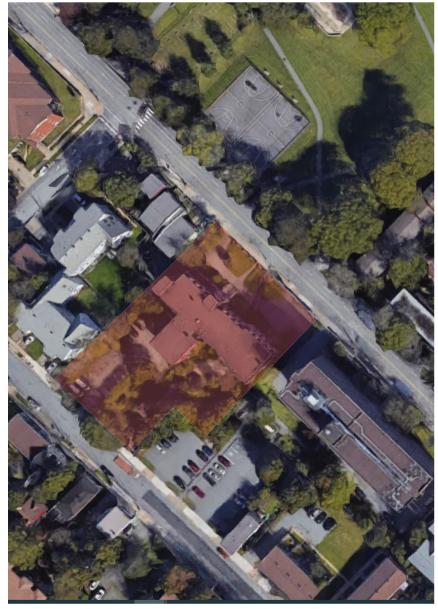
Fig. 3 Aerial map showing the Development Site location in red Source: Google maps, annotated by Fathom Studio

The Development Site, comprised of the property municipally known as Victoria Hall, is located at 2438 Gottingen St. It is a through-lot that extends from Gottingen St to Creighton St. The Development Site contains one registered municipal heritage property and is not part of any heritage conservation district at the time of this application. The surrounding context includes a mixture of building types and uses including civic buildings such as the Halifax North Memorial Library, the Mi'kmaw Native Friendship Centre, as well as old and new residential buildings such as Uniacke Square and the Velo. Victoria Hall was registered as a municipal heritage building in 1990.

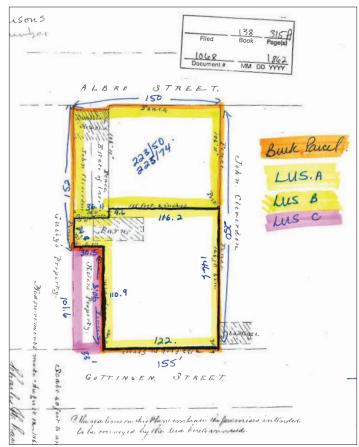
Fig. 9 Map of Lot obtained from title deed search. Annotations by unknown.

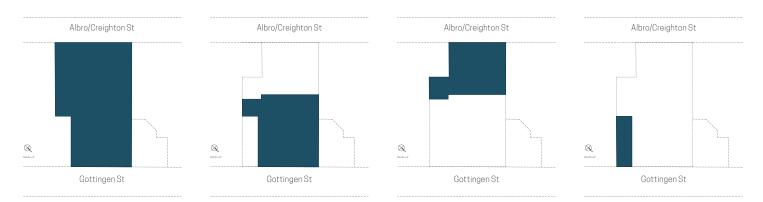
Fig. 13 Progression of lot aquisition by the Home Source: Fathom Studio

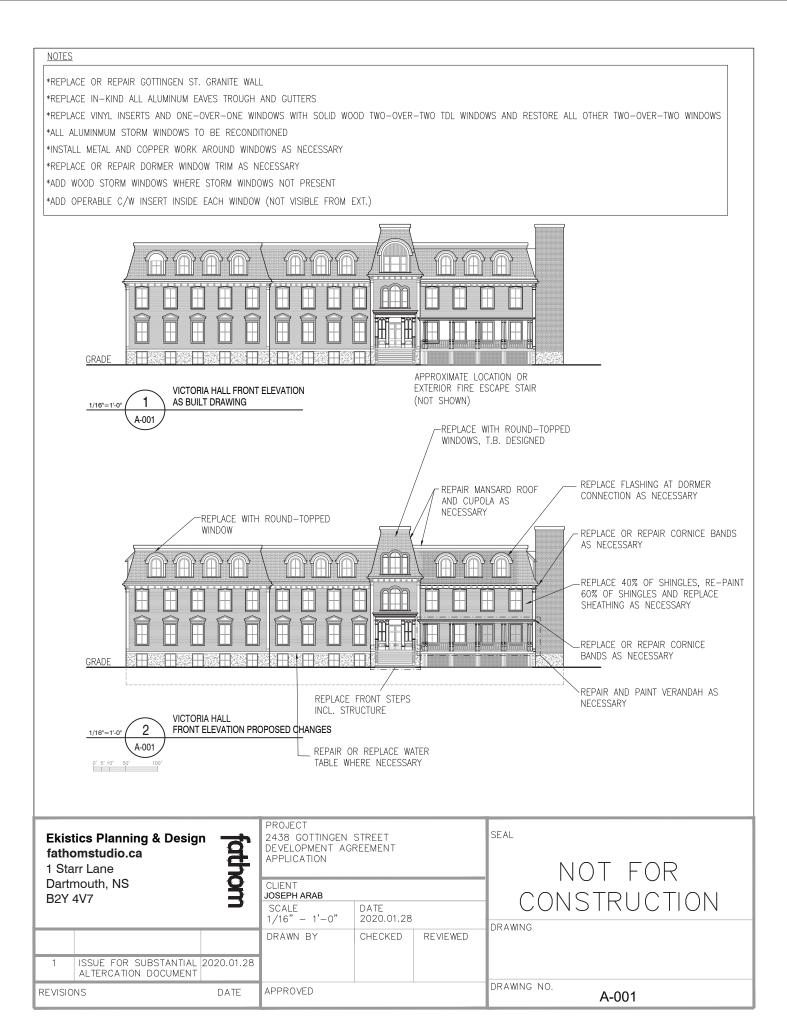
*REPLACE OR REPAIR GOTTINGEN ST. GRANITE WALL

*ADD OPERABLE C/W INSERT INSIDE EACH WINDOW (NOT VISIBLE FROM EXT.)

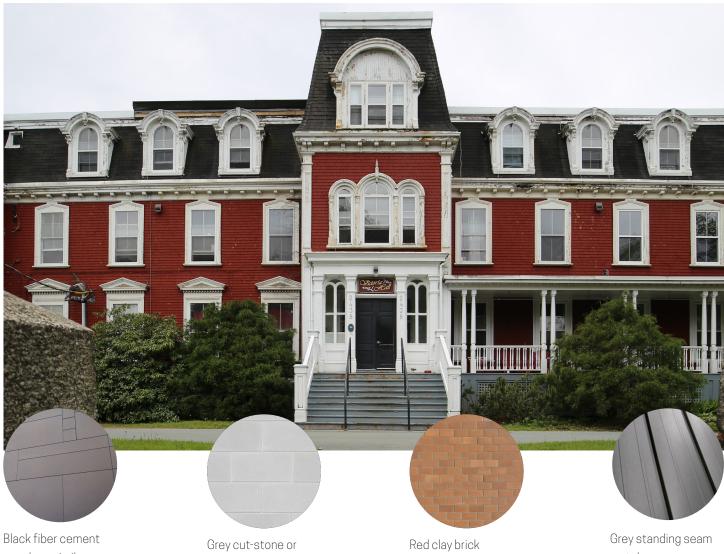
panels or similar Fig. 29 Color palette is derived from Victoria Hall

The materials selected for the new design have been carefully chosen to help the building remain distinct from and subordinate to Victoria Hall while also fitting into the scale of the surrounding context, especially on Creighton St. It was important to create a building that was of its time yet also physically and visually compatible with the heritage building. The 3-storey podium on Creighton St is clad with red-clay brick and a dark standing seam metal mansard roof which picks up on the red shingles of Victoria Hall, the black mansard roof and the human scale of materials at grade. This brick-clad podium and Victoria hall are separated by the main part of the mid-rise tower thus preventing the podium from detracting from Victoria Hall's presence on Gottingen St. The mid-rise tower is clad in dark high-density fiber cement and light grey cut-stone masonry with dark windows. The location of materials is carefully thought out to minimize the presence of the new building on Gottingen St as well as to break up the scale of the mid-rise building so that it relates well within its context. The interplay of color on the Gottingen St facade is a quiet inversion derived from Victoria Hall which has a dark mansard roof with white windows. The new design picks up on this but inverts the colors so as to silence the facade. The interaction between the dark windows and the light grey cut-stone further helps to break up the facade thus giving the building a befitting scale to its surroundings.

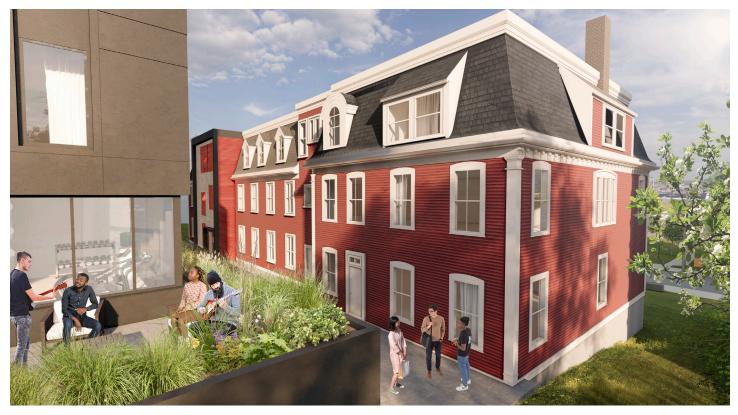
Fig. 31 View of Victoria Hall indicating the separation between the 2 buildings.

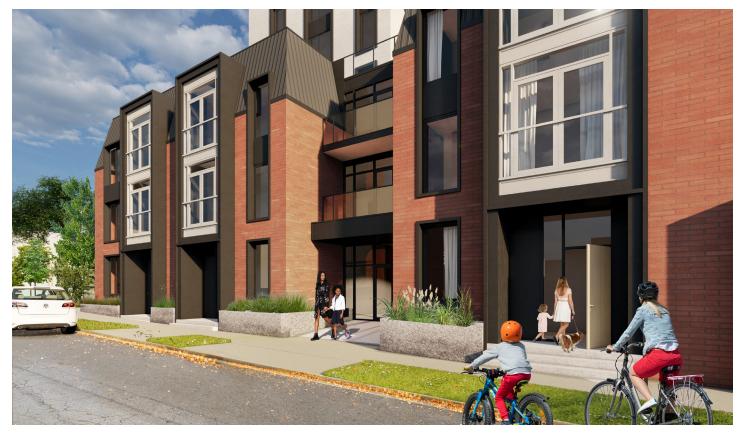
Fig. 32 View of Creighton St Highlighting the use of red brick to drawn design connections between the new building and Victoria Hall. Tower is stepped back to reduce the presence of the tower on the street.

The tower is subordinate to Victoria Hall in its location to the west of the building. This allows Victoria Hall to maintain its current street presence on Gottingen St. The tower portion of the building is set back $125'-0\frac{1}{2}$ " from Gottingen St, with the three storey penthouse stepped back an additional 22'-0" to reduce the perceived presence of the building from the street.

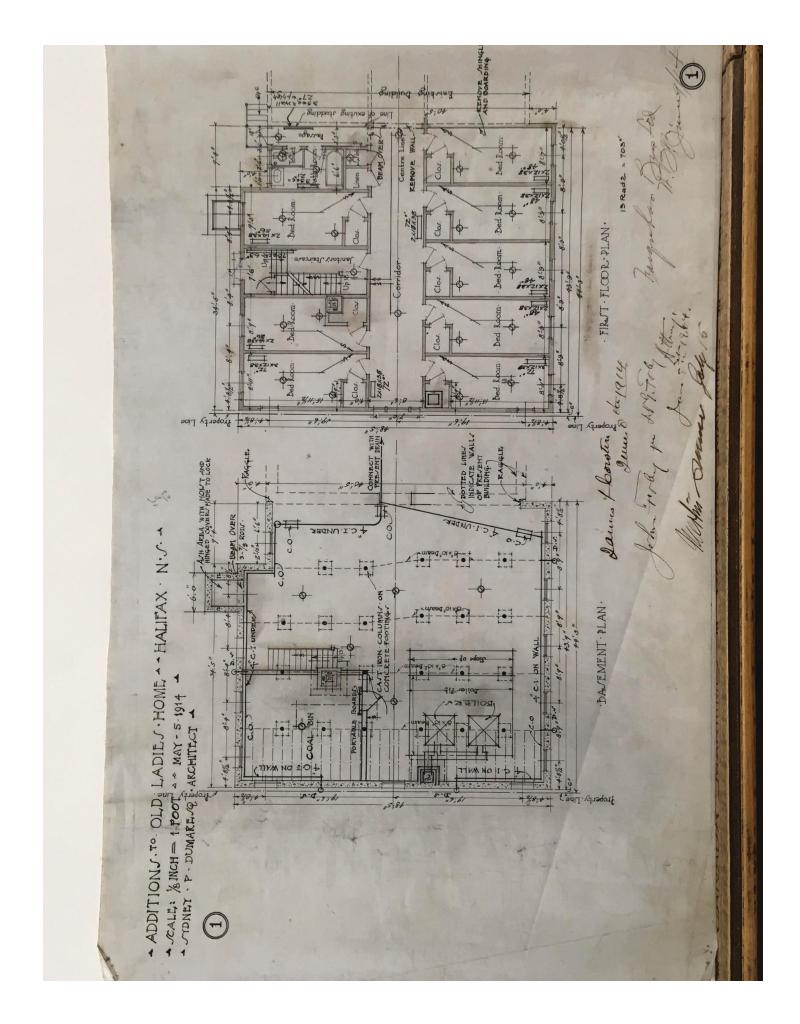
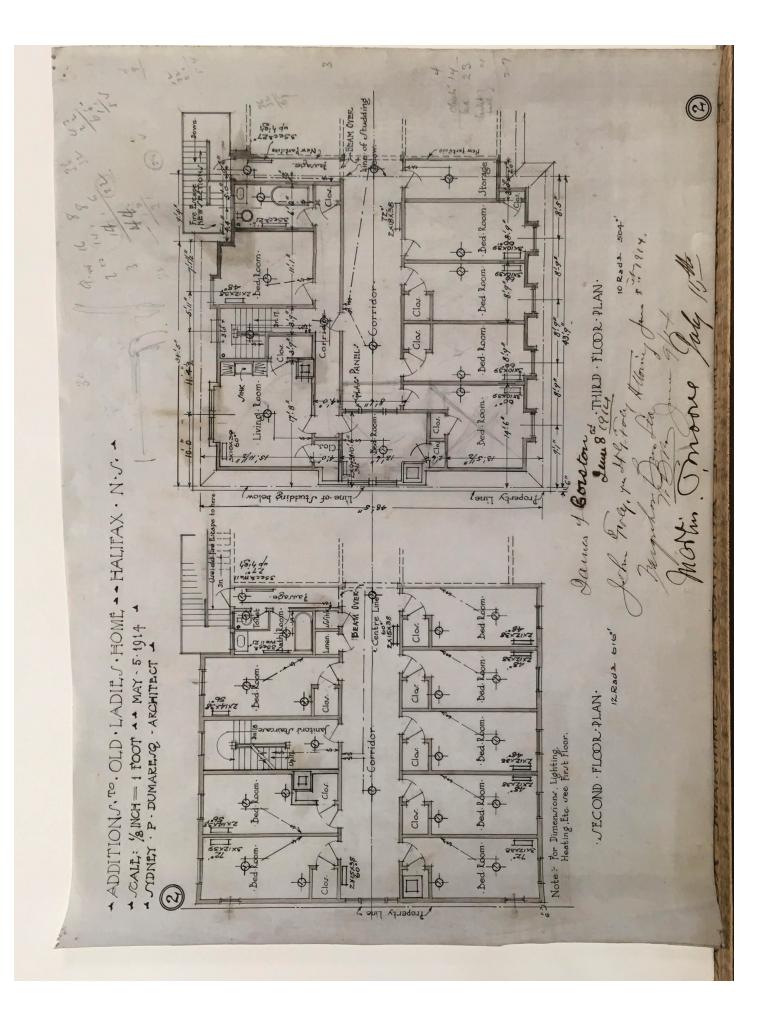
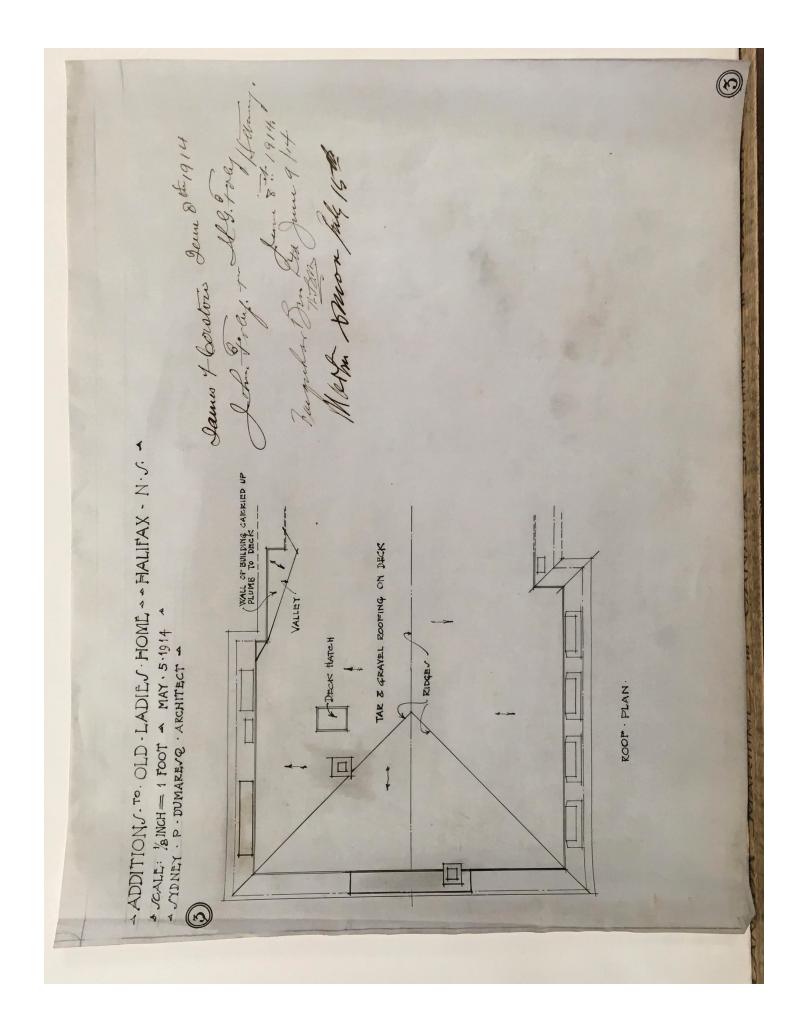
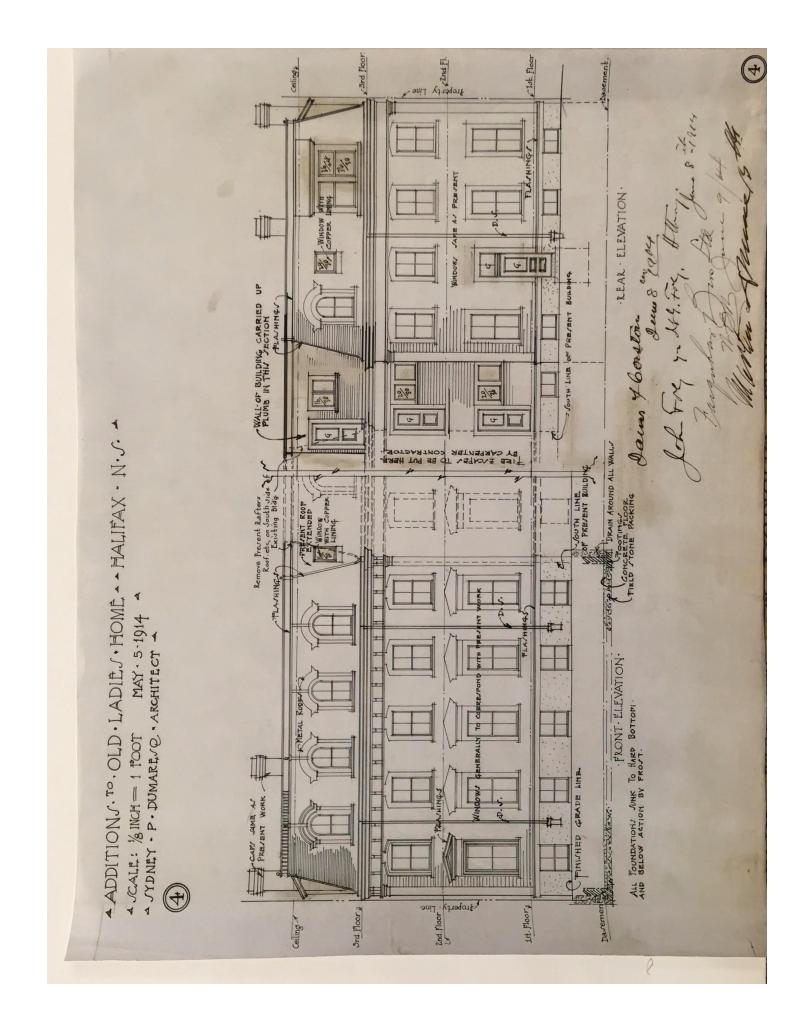
+181 " 8 -Hen. Jaines & Conster Sun Stort gut intry you define ▲ ADDITION S.TO. OLD . LADILS . HOME, ~ + HALIPAX N.J. ~ ows to be cail as kear CONCETE S SINGLE WINDOWS JAME A 2.E 4J PREJENT FRONT INIJHED GRADE * CALE: %INCH = 1 FOOT * MAY 5 1914 * FLAJT - PHINA SFL AUHING .S. 9-15 15 Theve Wir 10 15 15 Vame in D Theve W . CIDE . ELEVATION. COURNEY CAPU TO COURSELENT WORKS. 10/100 7/12 2/8 1/2 2,2 ----barement 1 ut floory 2nd Floor & 3rd Floor Ceiling'

The present need is to conserve Victoria Hall's historic fabric at three different spatial scales: a portion of the building, the whole building and specific elements. This work will be guided by Dumaresq's set of 1914 drawings of the south side addition along with discussions with the current owner about the work that has been done over the past decade: insulation of the building's walls and roof, installation of a gas fired mechanical plant and roof repairs.

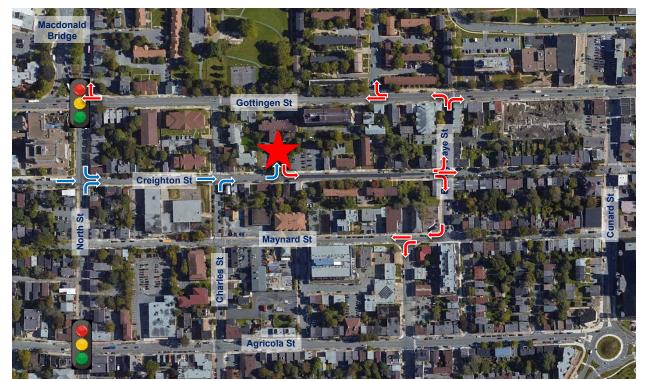
Figure 3-3: Traffic Distribution

All traffic entering the site will do so as an eastbound left turn from Creighton Street and all exiting traffic will make a southbound left turn onto Creighton Street. Upstream and downstream of these movements, there are numerous route options that drivers can select depending on their origins and destinations as shown in the figure below. Note that only the movements immediately upstream and downstream are indicated and beyond these intersections are a wide variety of other options.

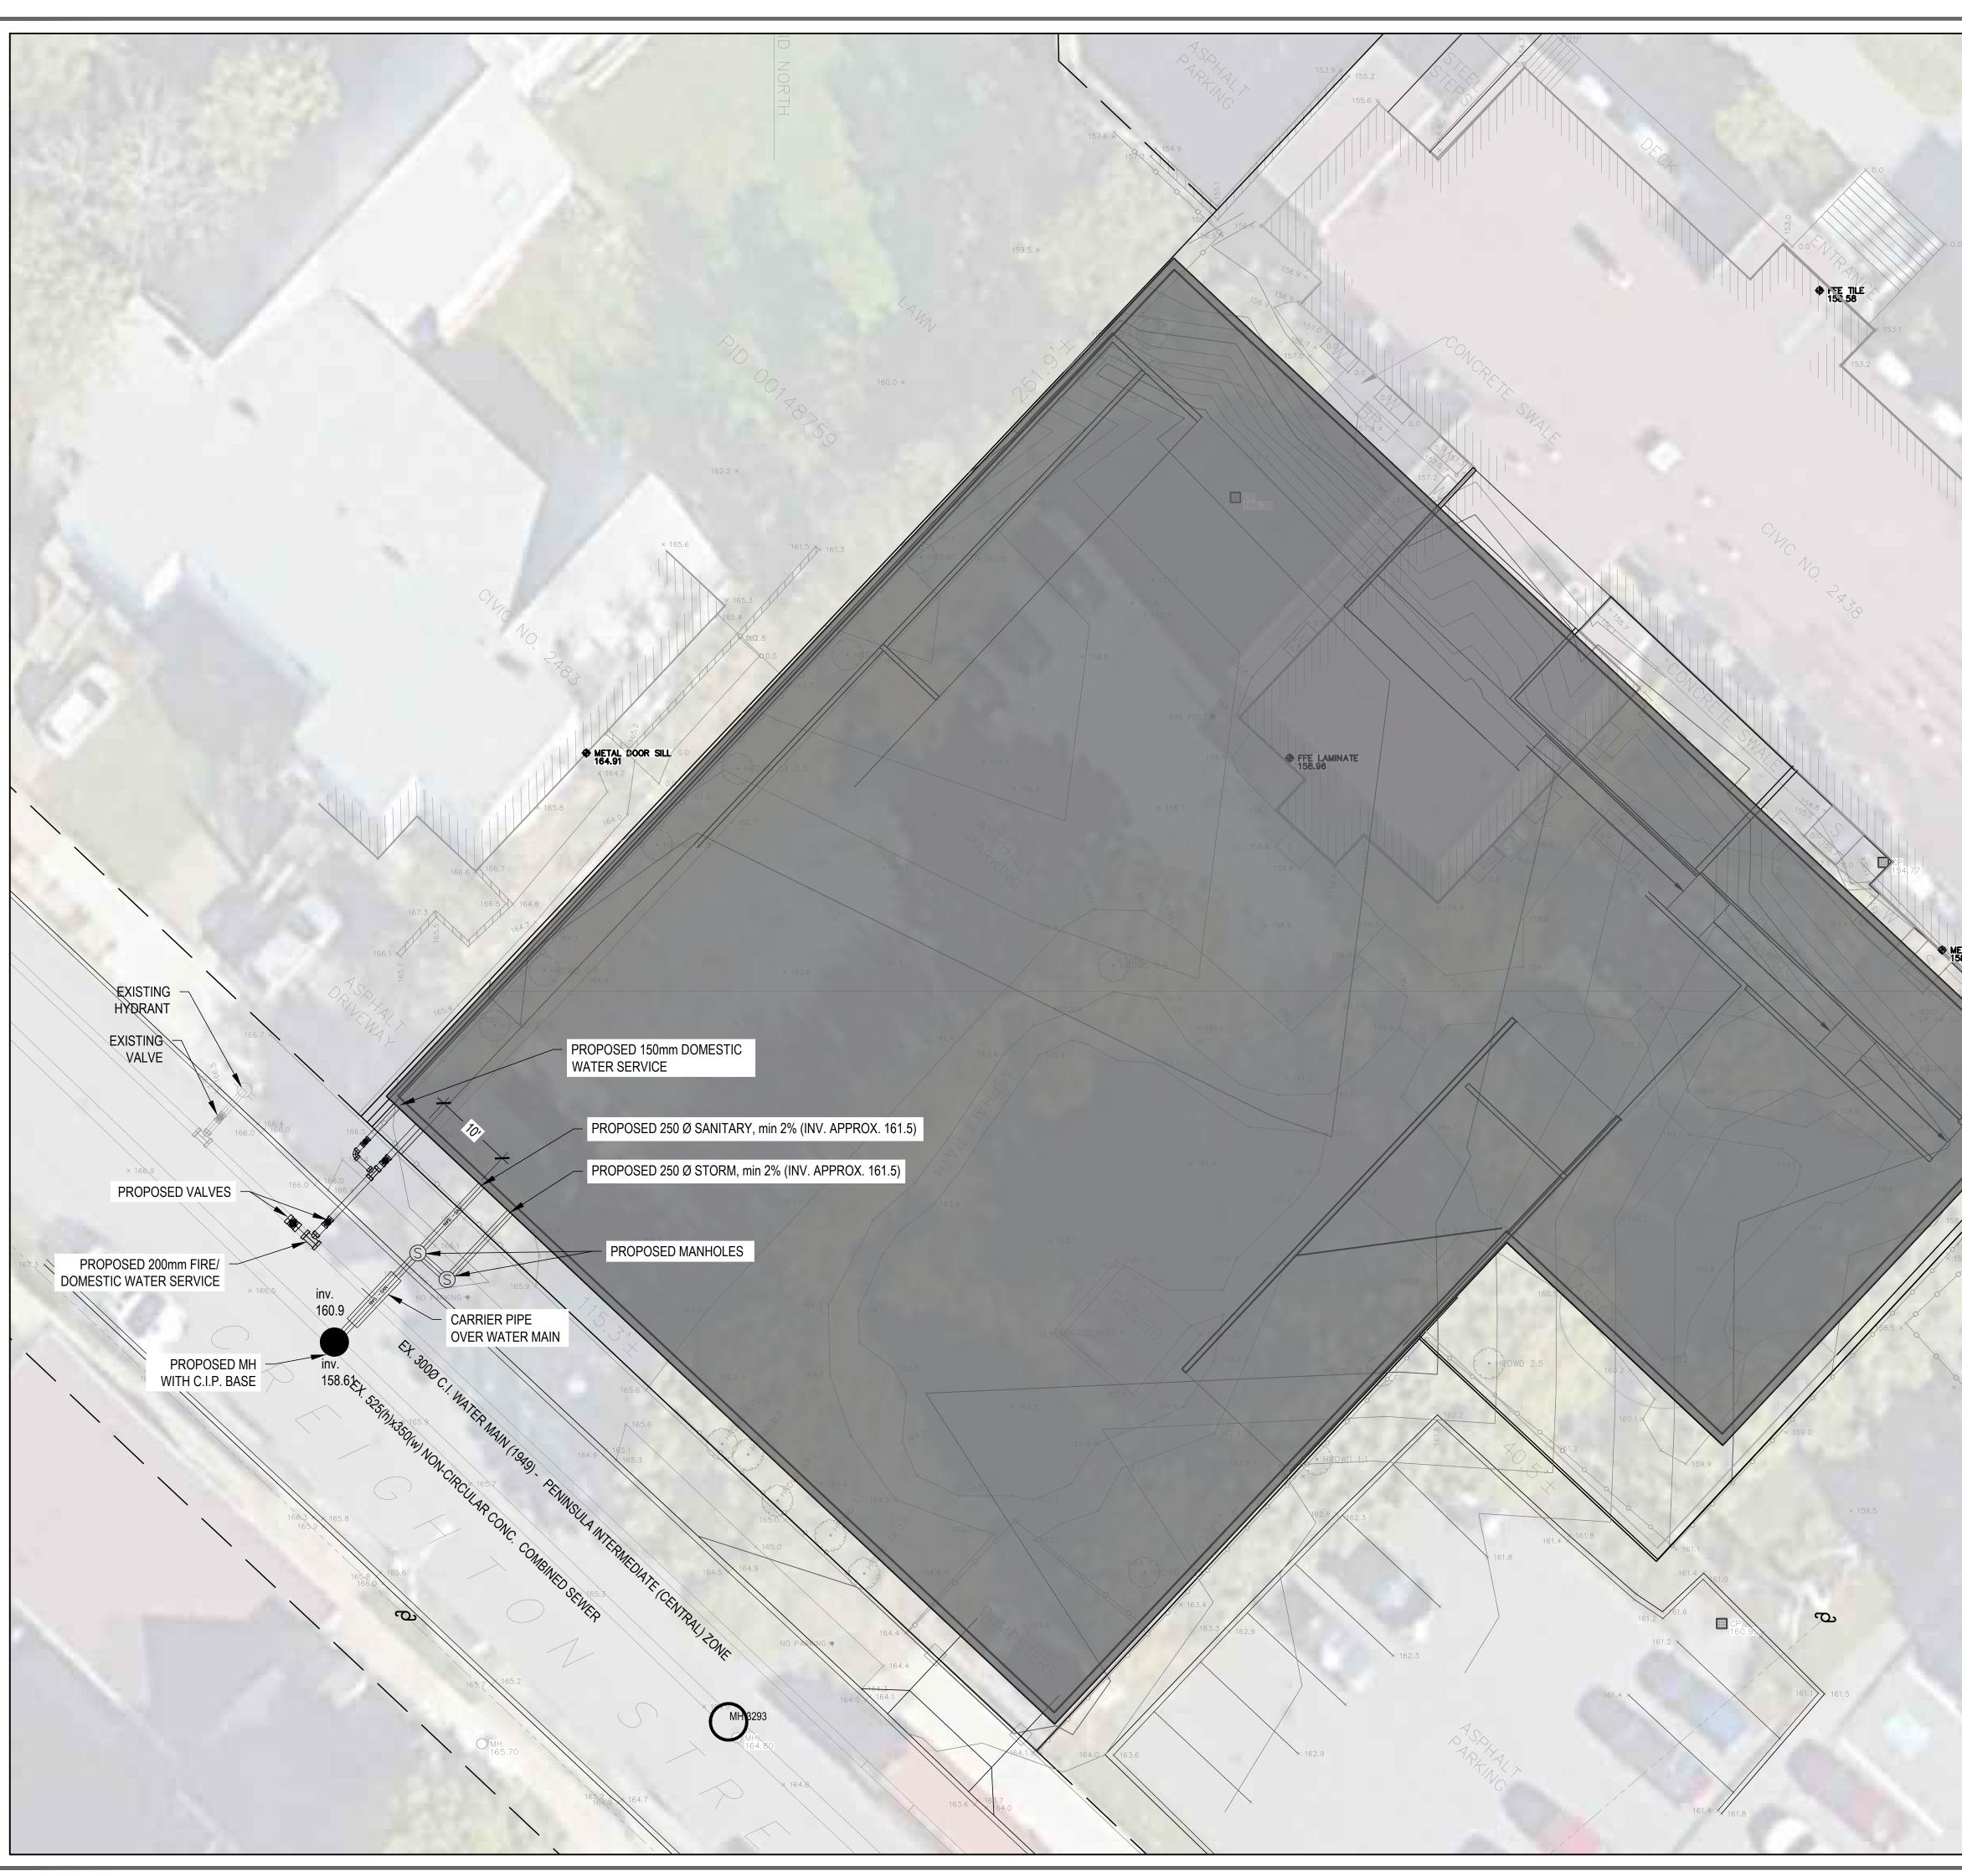
KEY PLAN
		EKISTICS PLANE 1 STARR LANE, DARTH T: (902)461-2525 W: Landscape A Engine Environment Visual Impact General Notes:
	× 153	 EXISTING UTIL PROVIDED BY PIPE SIZES AN CONFIRMED D DESIGN. DEPTH OF WA CREIGHTON T
NETAL DOOR SILL 0 0 0 0 0 0 0 0 0 0 0 0 0 0 0 0 0 0 0	147.8 147.8 147.8 154.2	NOT CONSTR
		1 ISSUED FOR DEVELOPME NO. REVISION CLIENT PROJECT 2438 GOTTINGEN STF
* * * 158.3		HALIFAX NOVA SCOTIA DRAWING CIVIL SERVICING SC
		1"=10' DRAWN BY CHECKED RNB
ND 007 X88000	PRELIMINARY SANITARY CALCULATIONS:	APPROVED RNB
× OCO	TOTAL UNITS = 138	SEAL
	(No Commercial or Retail) 138 units @ 2.25 p/unit = 311 people	CONSTR
	DESIGN FLOW = q = 5.52 L/s a = 93 cu.m./day	DEPT. PROJECT NO.
	M = 4.07 Assumed I/I area = 1000 sq.m.	CONSULTANT'S NO.
	PIPE CAPACITY: Approx. 100 I/s	TENDER NO.
