Item No. 9.1.1
Heritage Advisory Committee
Special Meeting
August 25, 2021

SUBJECT: Case H00509: Request to Include 173 Crichton Avenue, Dartmouth in the

Registry of Heritage Property for the Halifax Regional Municipality

Research Report

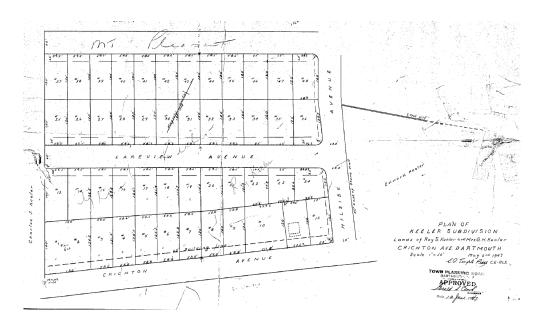
Figure 3: Plan of Keeler Subdivision dated 1947 by Joseph Piers

Charles J. Keeler passed away in 1928, leaving most of his property to his son Ernest (Book 669, Page 401). In 1933, Aubrey C. Duncan purchased 173 Crichton Avenue from Ernest (Book 689, Page 1093), and is listed as living at the property by Might's 1938 Halifax-Dartmouth City Directory. Ernest and Mabel had moved to Charles former house at 177 Crichton Avenue. The large portion of the Keeler family land to the east of 173 Crichton Avenue was eventually subdivided in 1947 by Roy S. Keeler and Mrs. G.H. Keeler (Figure 3).

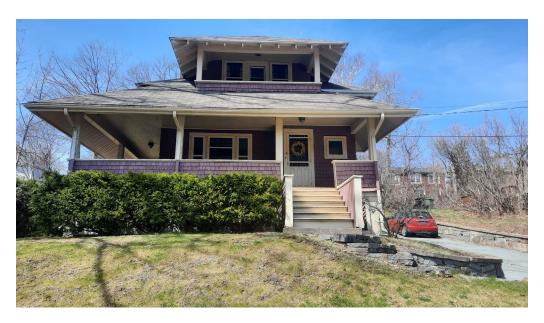
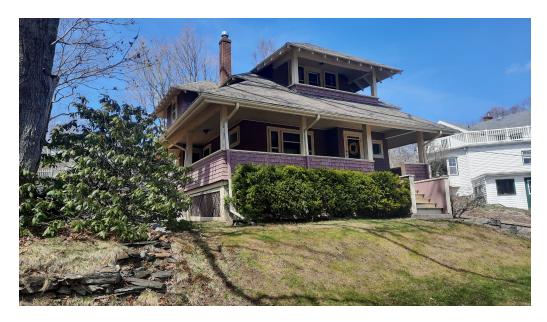
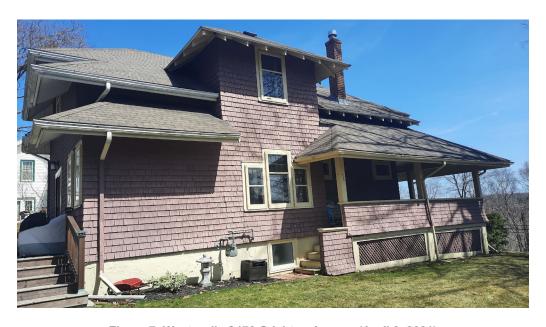
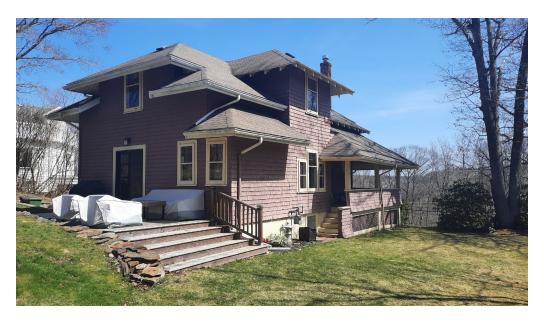
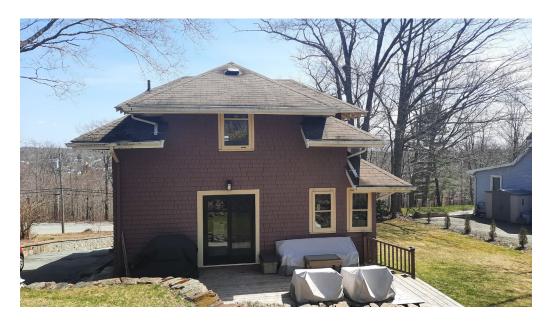
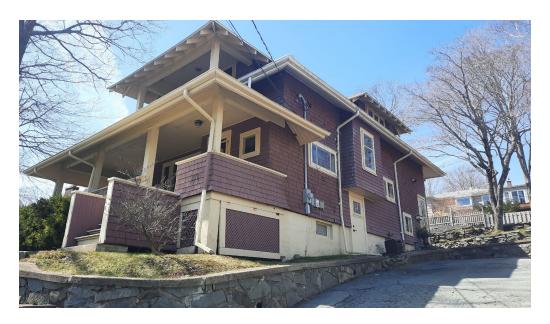
The house is a unique example of the Craftsman Bungalow architectural style (Figure 5 to Figure 10). The single-detached, one-and-a-half storey house has a square plan and partial above ground basement and is clad in wood shingles. The tiered hipped roof has four hipped roof dormers with overhanging eaves. Three of the dormers have the original rafter tails. In some areas of the roof, the rafter tails have been removed and replaced with plain vinyl soffit. A single brick chimney is located offset left.

The windows have various shapes and sizes but generally are covered by one-over-one storm windows with plain flat trim. There is a square window on the façade, a Palladian style window and two piano windows on the west wall, and three piano windows on the east wall. There is an upper storey sleeping porch on the façade. The off-centre, one-leaf main entrance is located on the façade and is accessible by a small set of wood stairs with railing. The entrance is located underneath a wrap around veranda with a half wall and plain piers. There are four additional single-leaf entrances: one in the sleeping porch; one on the west wall; and two on the east wall. There is a double door on the rear wall that leads onto a wood deck.

Figure 5: Façade of 173 Crichton Avenue (April 9, 2021)

Figure 6: Front and west wall of 173 Crichton Avenue (April 9, 2021)

Figure 7: West wall of 173 Crichton Avenue (April 9, 2021)

Figure 8: West and north (rear) walls of 173 Crichton Avenue (April 9, 2021)

Figure 9: North (rear) wall of 173 Crichton Avenue (April 9, 2021)

Figure 10: Front and west wall of 173 Crichton Avenue (April 9, 2021)

The 1.5-storey dwelling is a unique example of the Craftsman Bungalow architectural style. The home has a square plan, an offset brick chimney, and a tiered-hipped roof with four hipped dormers and overhanging eaves. The majority of the roof and three dormers have the original rafter tails, though others have been replaced with plain vinyl soffit.

Most of the original wood windows remain. The windows have various shapes and sizes but are generally covered by one-over-one storm windows with plain flat trim. There are prominent square windows on both storeys of the façade, a Palladian style window and two piano windows on the west wall, and three piano windows on the east wall. The façade is largely defined by a wrap around veranda with an off-centre, single-leaf entryway that is accessed by a wooden stairway, in addition to an upper storey sleeping porch. The dwelling has several secondary entryways, though not all are original.

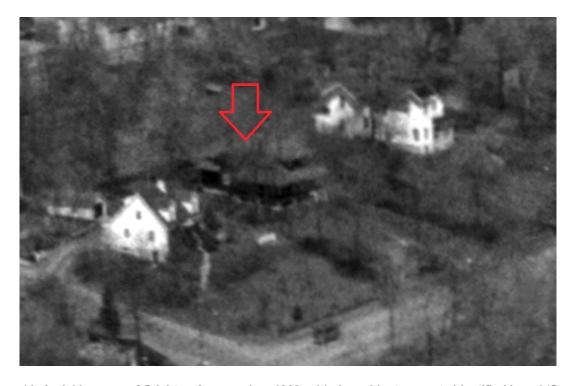
The house at 173 Crichton Avenue has a strong degree of integrity. Overall, the distinguishing features of the Craftsman Bungalow style are still evident, the use of vinyl is minimal, and most of the original features are still intact including original wood windows. The clarity of existing aerial imagery of the area was limited but depict that the overall form of the house has remained consistent (Figure 11).

Figure 11: Aerial imagery of Crichton Avenue circa 1969, with the subject property identified in red (Source: Halifax Municipal Archives 101-80C-1-6.23)

The dwelling has a high degree of architectural integrity, as its historic appearance and details have largely been preserved. Old aerial photographs illustrate that the dwelling's overall form and profile have remained constant over time. Many, if not all, of the original wooden windows are still intact as are other character defining elements, like the tiered hipped roof, dormers, and verandah. While the house has a strong level of integrity, some modifications are evident:
