**Subject: Preliminary Wetland Delineation Survey
Civic Nos. 1226 Cole Harbour Road, and 73 and 77 Bissett Road (PID Nos. 00403014,
00402453 and 00402768), Cole Harbour, NS
Englobe reference: 2109987.000**

Preliminary Wetland Delineation

Wetland Sketch

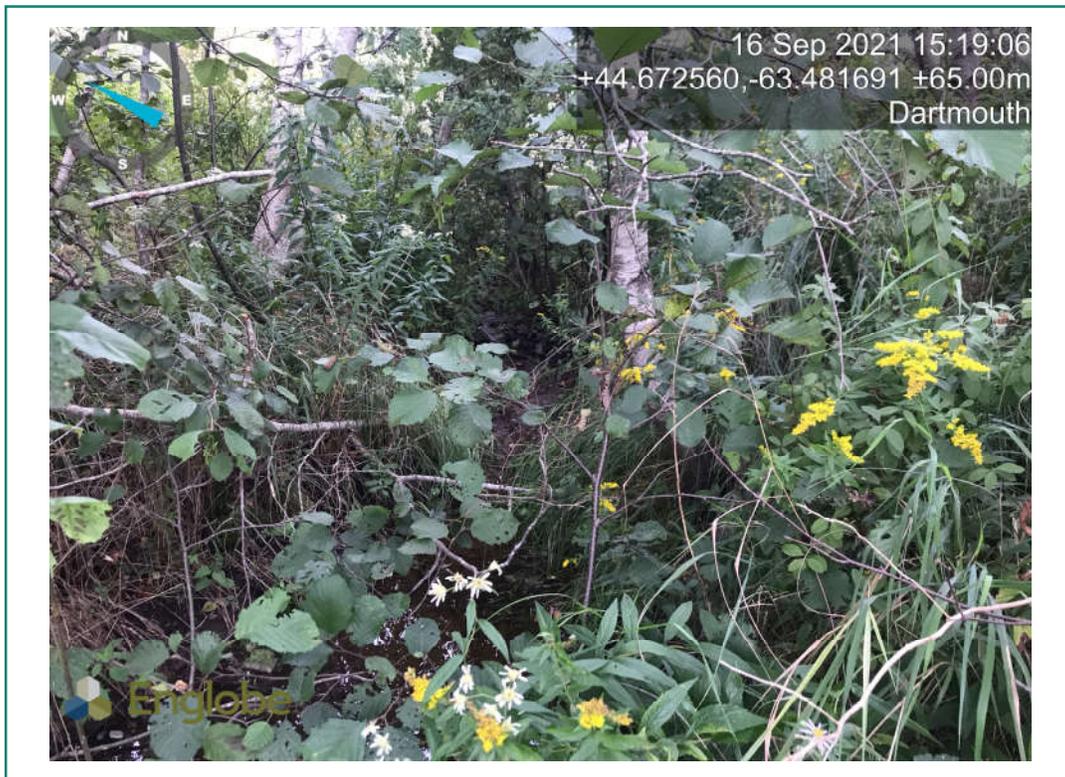
Photo 2: Possible inlet/outlet to the large watercourse west of Wetland 1.

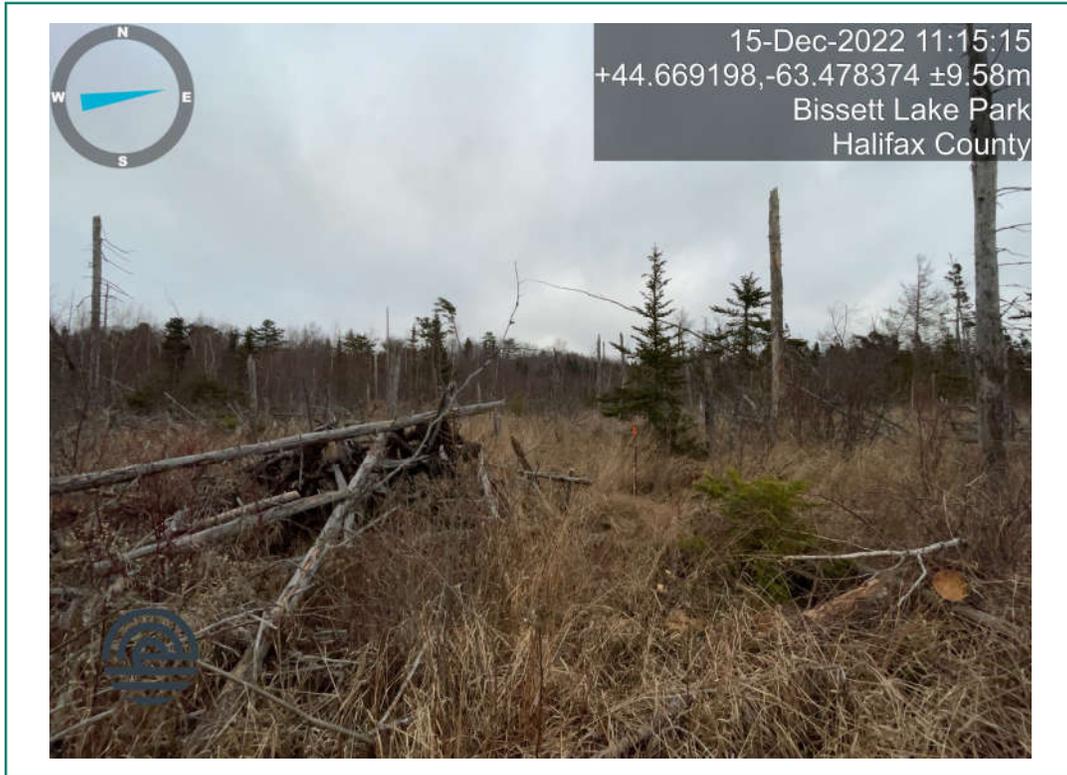
Wetland 2 is located in the centre to western portions of the Bissett Road properties and was delineated (within the confines of the subject site) on December 15, 2022. The wetland was identified as a riparian swamp. It is bordered by a relatively large watercourse along the western boundary and a small tributary along the northwestern boundary (adjacent to PID No. 00403014). Soils in Wetland 2 were generally saturated muck. Saturation was observed within 5 cm of the ground surface. Standing water and stressed vegetation were noted throughout. The approximate on-site wetland size is 18,000 square meters. The wetland extends offsite to the south, but no attempt was made to delineate the wetland on others' properties.

Photo 3: Wetland 2 in the centre portion of Civic Nos. 73 and 77 Bissett Road.

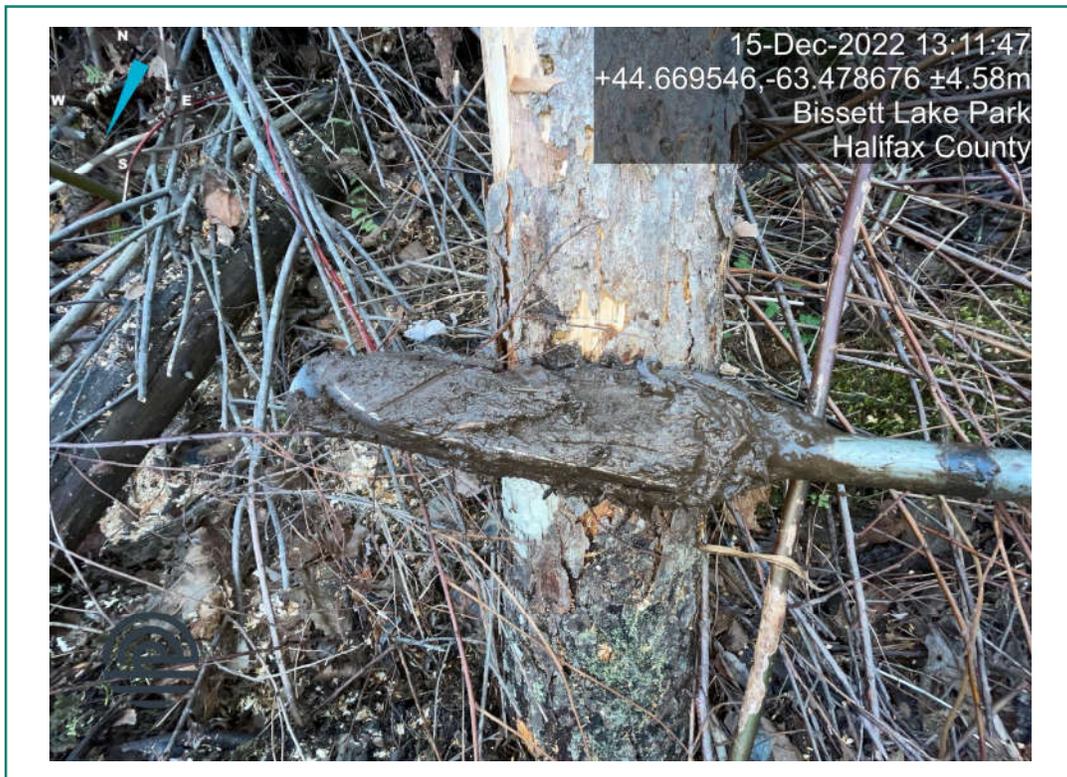
Photo 4: Auger sample of the saturated muck in Wetland 2.

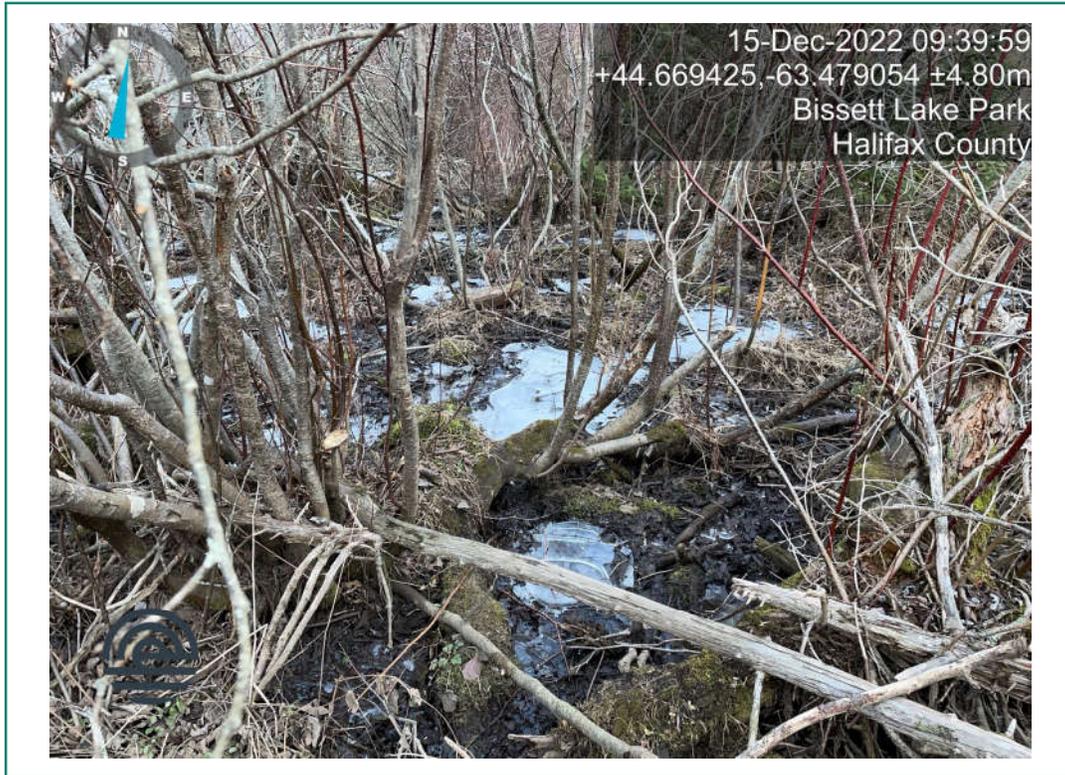
Photo 5: Standing water in Wetland 2.

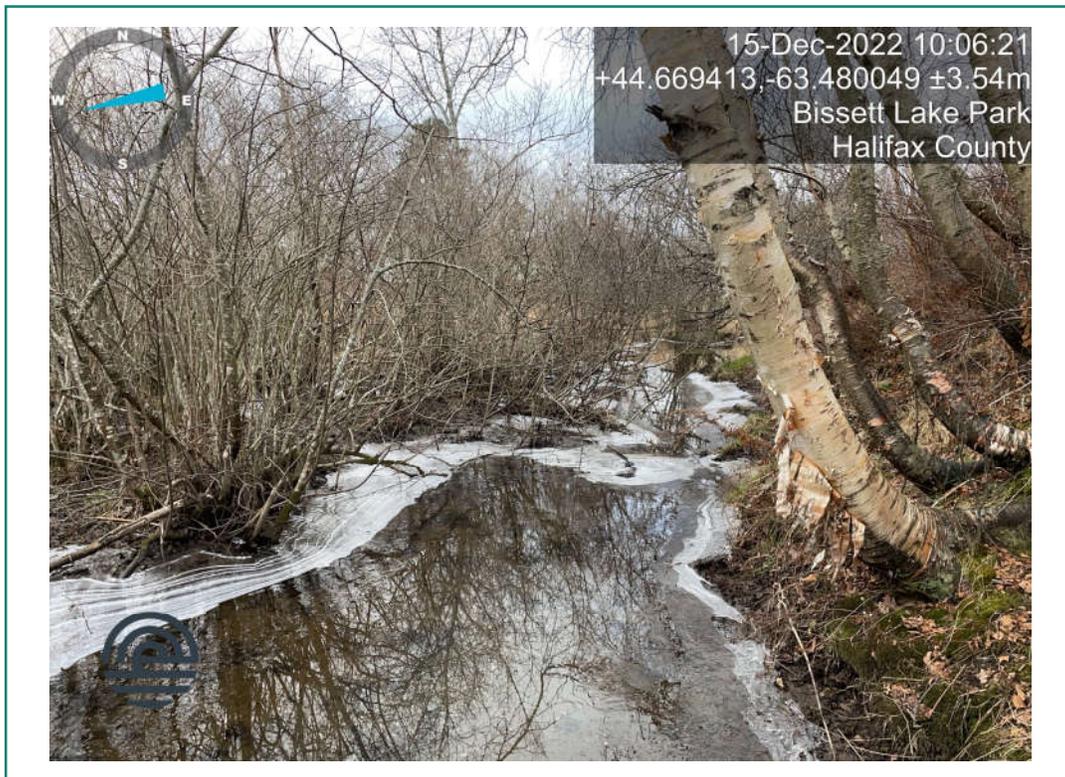
northwestern boundary of Wetland 2 is a branch of the other, larger, western watercourse. No attempt was made to assess or survey any potential watercourses outside of the subject wetlands.

Photo 6: A portion of the small tributary along the northwestern boundary of Wetland 2.

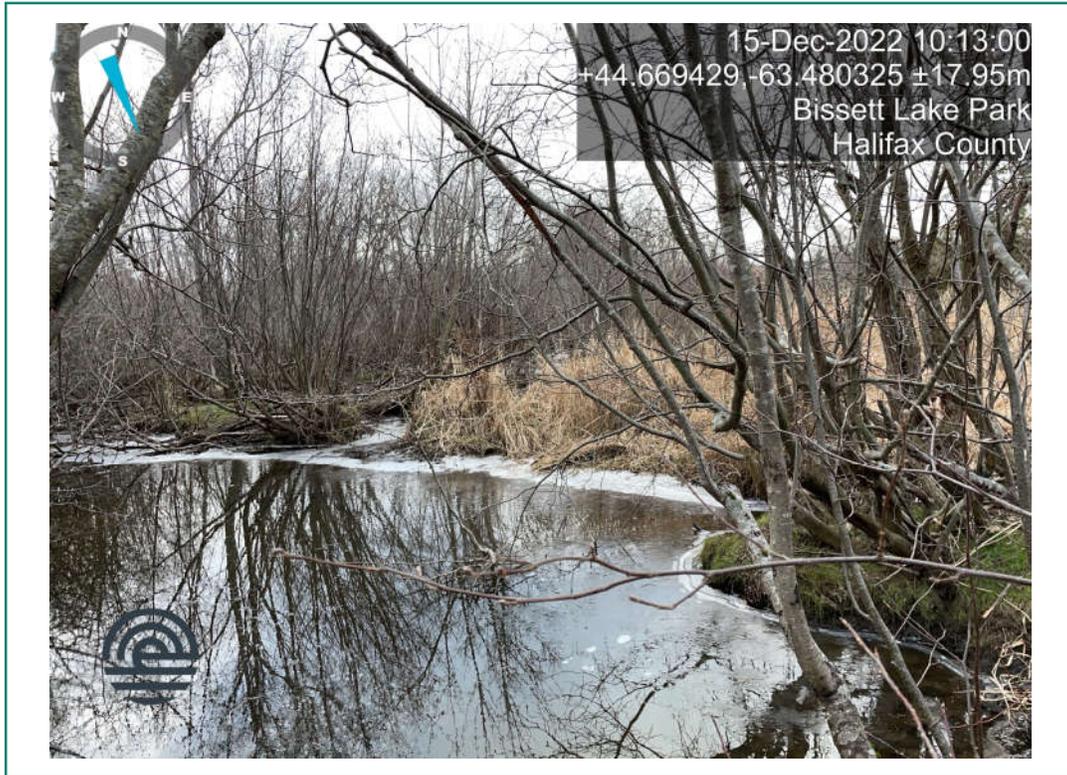
Based on available mapping, the watercourse along the western boundary of the site initiates off-site from the north, flowing north to south, eventually discharging into Bissett Lake. The tributary along the

Photo 7: A portion of the large watercourse along the western boundary of Wetland 2.

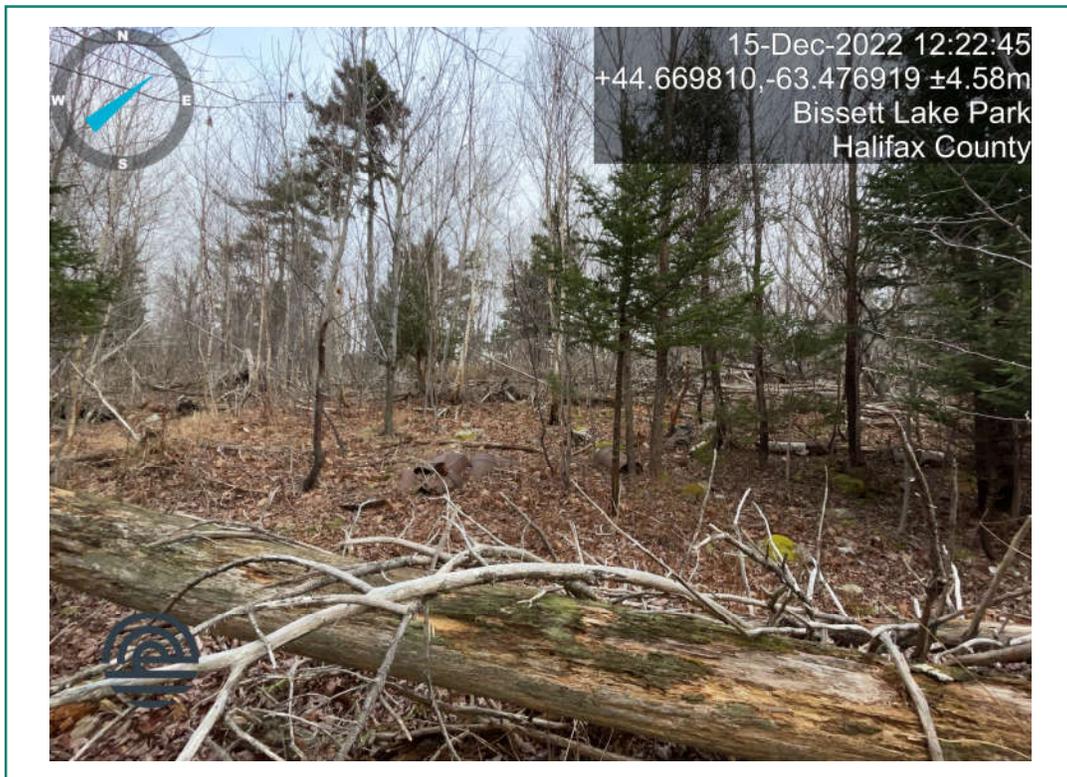
The upland areas of the property were differentiated from the wetlands by the topography, changes in vegetation community, and hydrology indicators (i.e. no standing water or saturation).

Photo 8: Upland area in the eastern portion of Civic Nos. 73 and 77 Bissett Road.
