Crombie REIT

August 14, 2013

Wetland and Watercourse Delineation Report (PID# 40789323)
Dartmouth, Nova Scotia
GENIVAR FILE: 131-15798

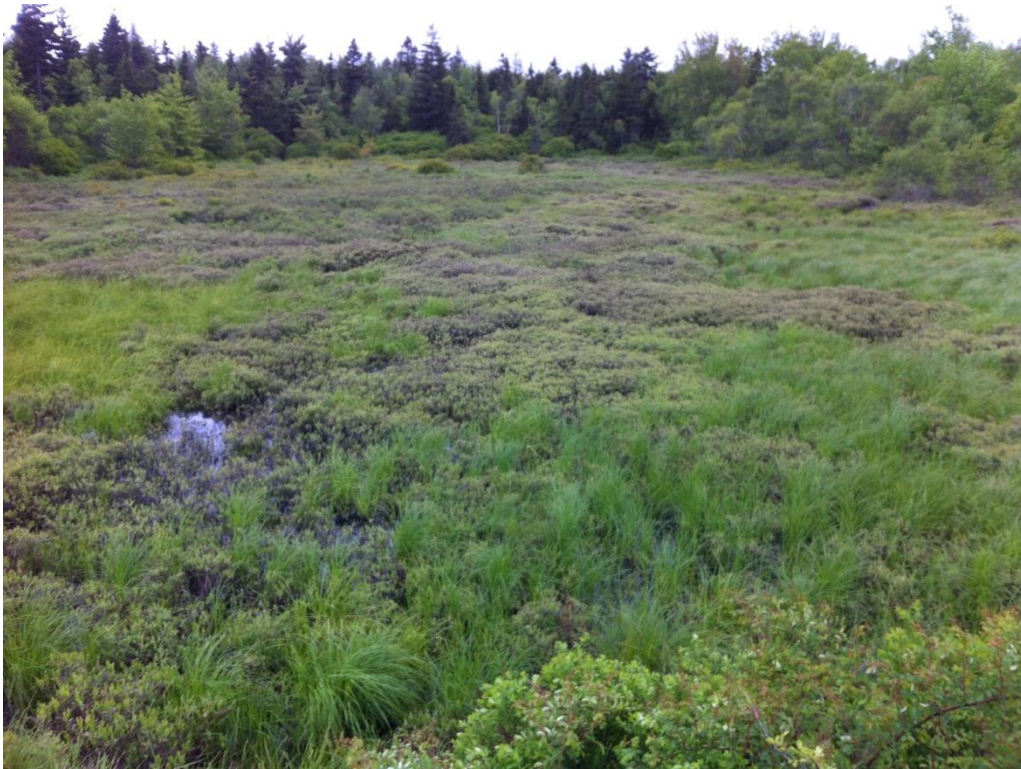
Wetlands WL1 and WL2 were identified as shrub bogs during site inspections. Tree stratum vegetation was most prominent along the wetland edges and was dominated by red maple (*Acer rubrum*). A dense shrub layer was observed, dominated by mountain holly (*Nemopanthus mucronatus*) and rhodora (*Rhododendron canadense*). Dominant herbaceous species identified were reedgrass (*Calamagrostis stricta*) and sphagnum moss (*Sphagnum spp.*) ground cover.

Wetland WL1 - Shrub Bog

We recommend the findings of this investigation should be considered during the design process to minimize or eliminate the need for alterations to wetlands on the Site. Should wetland alterations be necessary, approval from NSE will be required prior to the commencement of work.

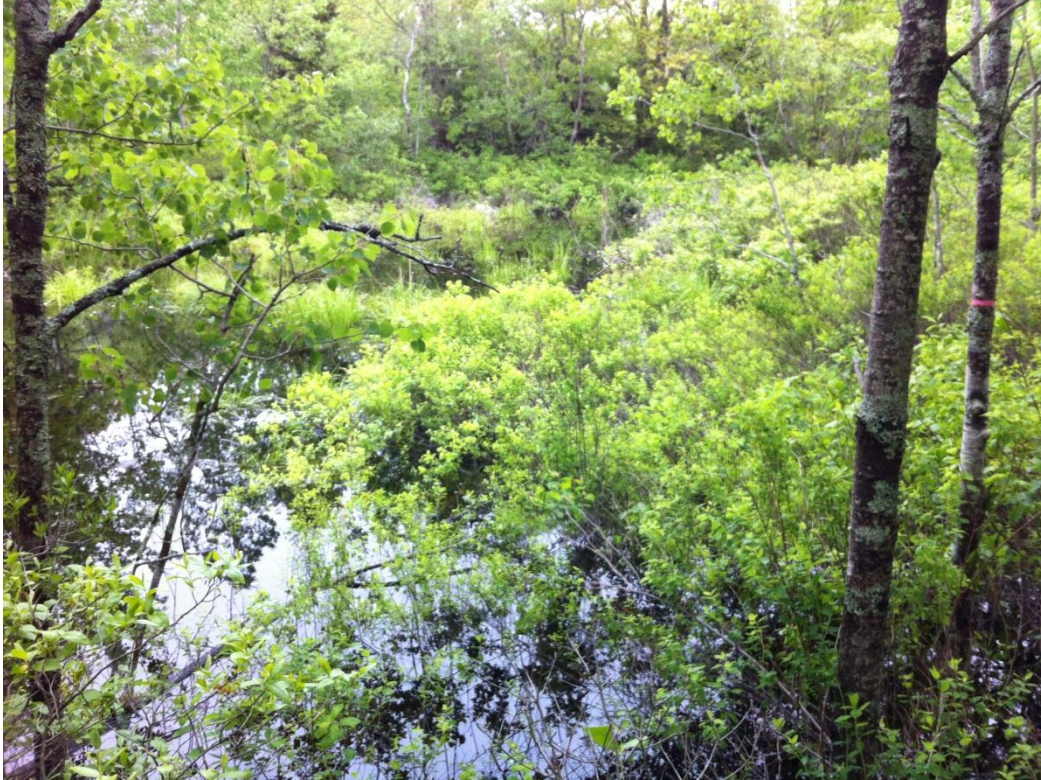
Wetlands WL1 and WL2 are classified as shrub bogs, although wetland WL2 was flooded and contained significantly more surface water than WL1. Neither wetland is contiguous with a watercourse. This is important to note as Halifax Regional Municipality (HRM) planning by-laws provide a riparian buffer of 20 metres, in which development cannot take place, for wetlands which are contiguous with a watercourse. This buffer zone also applies to all watercourses on the property.

Wetland WL2 – Flooded Shrub Bog

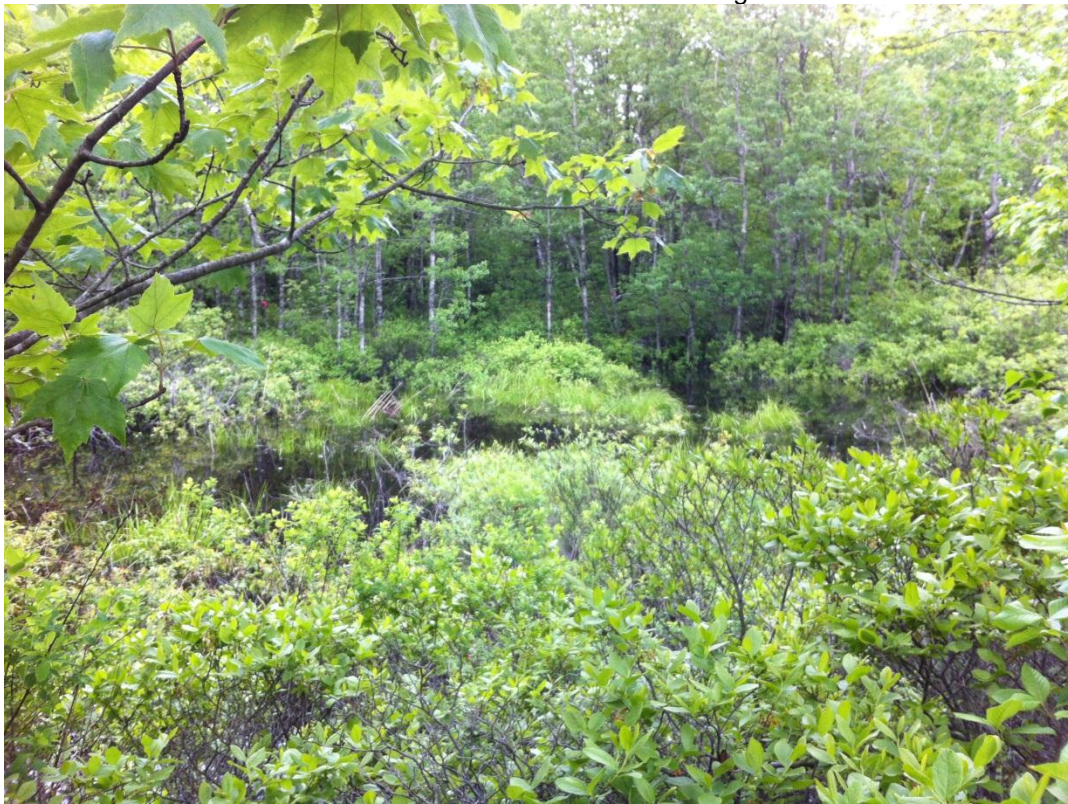
Wetland WL2 – Flooded Shrub Bog
