RE: HRM, Parks Bridge – Nichols Lake Trail

CBCL Limited (CBCL) was retained by Halifax Regional Municipality (HRM) to provide preliminary options, costs and recommendations for a structure to cross Nichols Run, Halifax, NS. Nichols Lake Trail is part of the Western Common Wilderness Common Master Plan. Phase 1 of the regional park is currently under construction with roughly 2240 meters of trail completed thus far ending at two water courses. This report is intended to identify possible crossing types and associated costs for one of the crossings. It is assumed that the trail will be completed to Nichols Run up to the same standard of trail that Phase 1 is currently constructed which essentially entails a contractor completing the trail to subgrade.

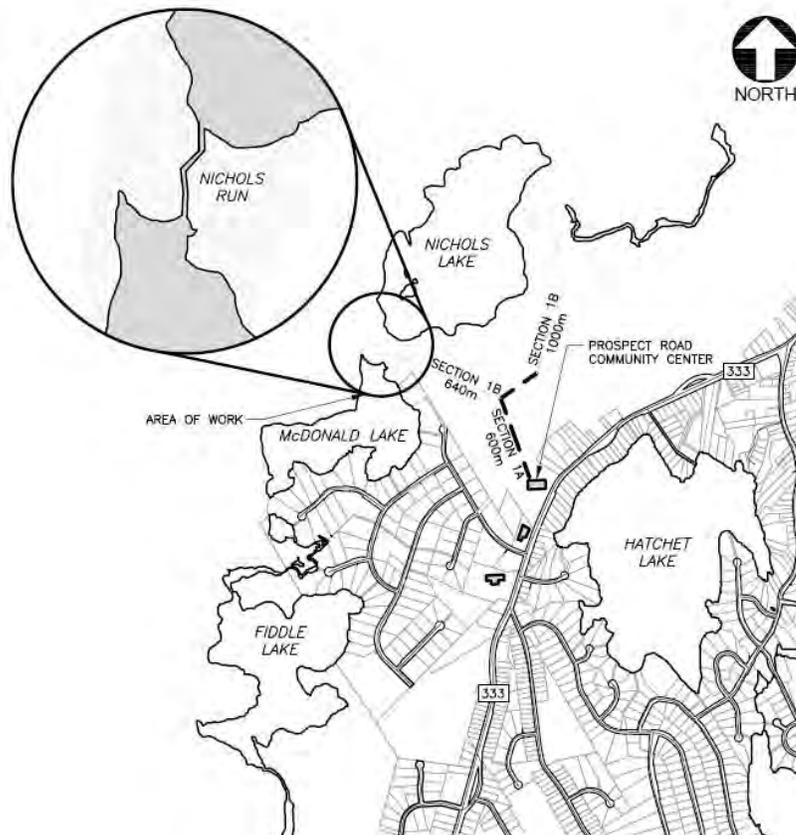
Figure 1 - Nichols Lake Trail and Surrounding Area

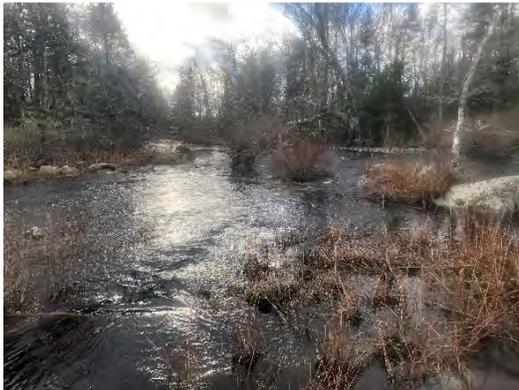
*Picture 1 - South from Nichols Lake*

The watercourse entrance is wide and relatively shallow compared to just downstream where the channel narrows, see Picture 1. The river bottom consists of medium to large size boulders which made accurate depth measurements unobtainable. The depth varied greatly throughout ranging from a few inches to several feet between boulders. The watercourse just downstream from Nichols Lake was measured at 17m wide directly beyond the existing trail and is the preferred crossing location, see Picture 2. The temporary construction area where the trail currently ends can be incorporated to the regional park as a trail destination or resting area completed with benches or picnic tables and scenic views of Nichols Lake.

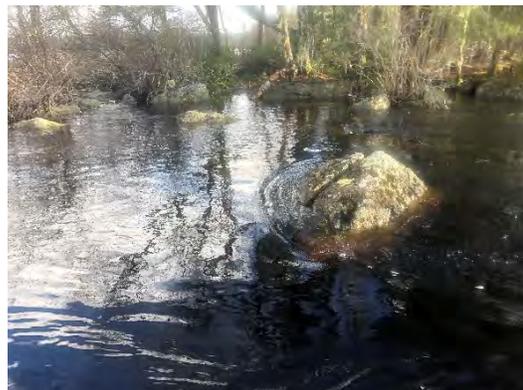
*Picture 2 - Crossing Location looking east*

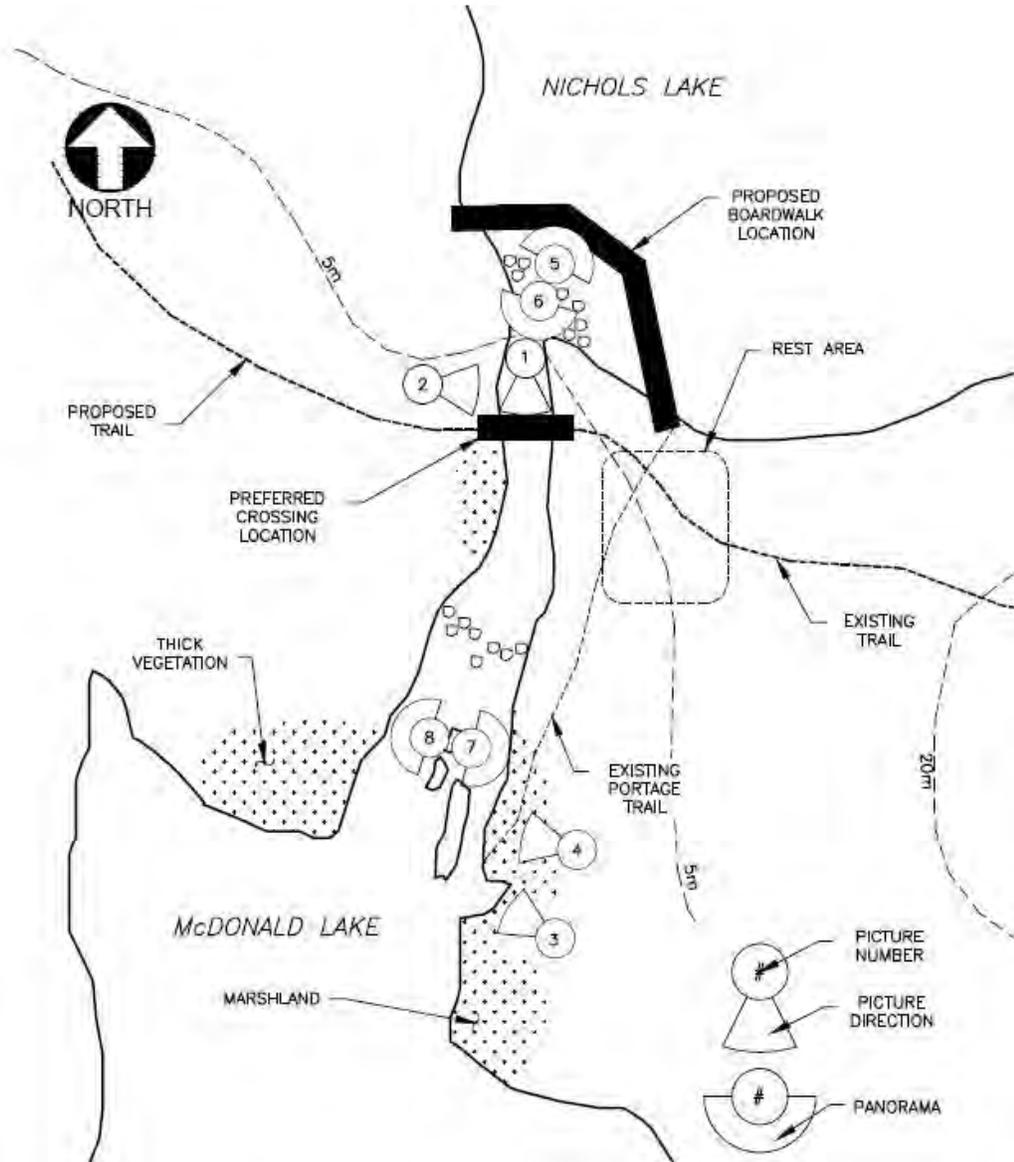
Figure 2 - General Arrangement and Picture Locations

At the time of the inspection, mid-November, the water levels appeared to be in the higher part of its range. The high water mark was hard to recognize on adjacent trees, boulders and surrounding landscape. It is possible the water level could rise during spring and could flood portions the approach areas. Several photos were located in an online trail review, [www.halifaxtrails.ca](http://www.halifaxtrails.ca), showing Nichols Run during the summer months. The photos show the lower water levels as the watercourse mostly dry, see Pictures 9, 10 and 11 located at the end of the report. See Figure 2 for the general arrangement and picture locations.

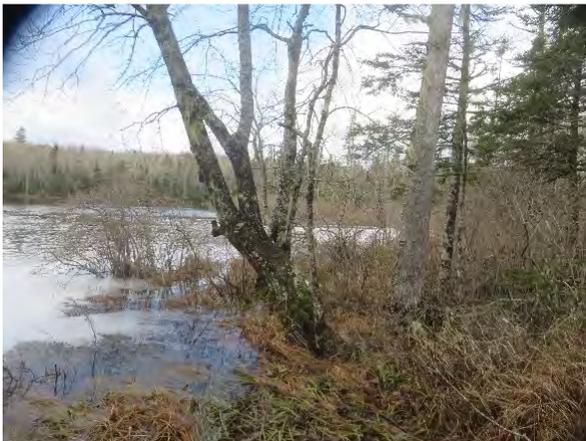
Picture 3 - Entrance to McDonald Lake

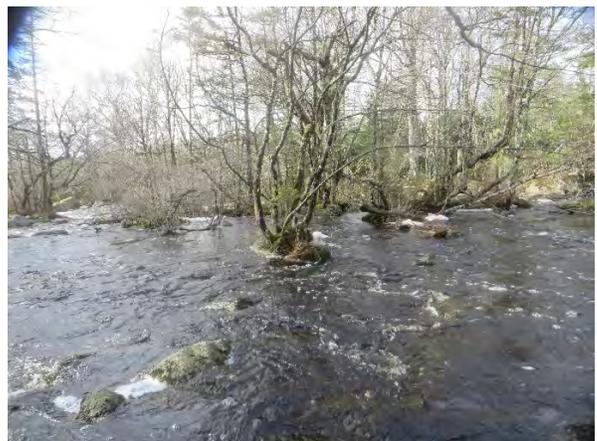
Picture 4 - Lower reach of Nichols Run

There is a string of very large boulders located roughly half way between the two bodies of water. The lower reach of the watercourse separates and forks around several small island land masses created by trees, shrubs and boulders. The watercourse is considerably wider in the lower half increasing the span lengths and number of piers required to cross, see Picture 3. The watercourse exit into McDonald Lake is wide with thick vegetation on either side, see Picture 4. The flow on the east was shallow and weaves through low areas between trees. A canoe portage path connecting Nichols Lake to McDonald Lake was also located on the east side of Nichols Run. Pictures 7 and 8 are panoramic views of the East and West river banks taken in the lower reach of Nichols Run.

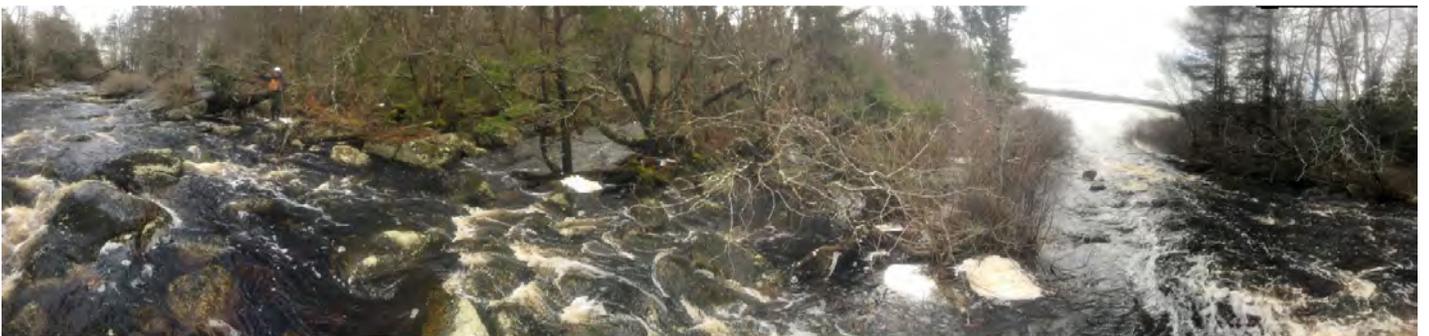
*Picture 7 - Nichols Run East - Panoramic*

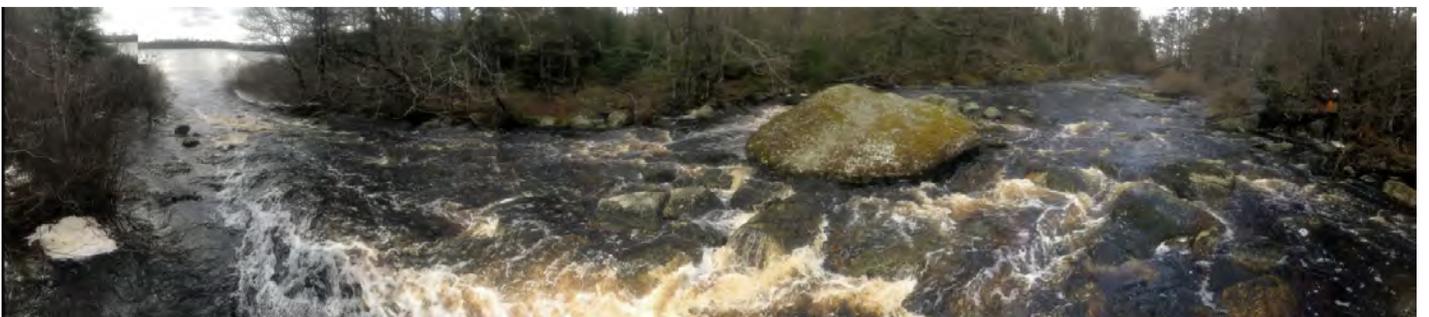
*Picture 8 - Nichols Run West - Panoramic*

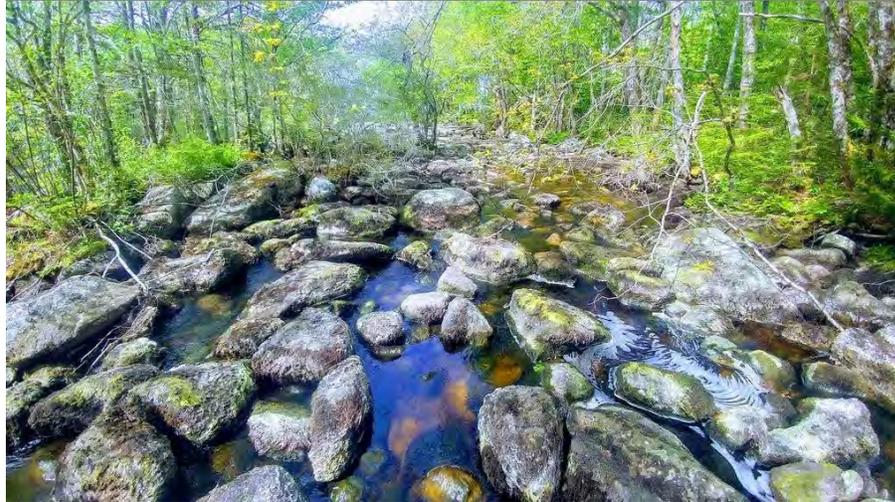
*Picture 9 – Low water levels - taken from [www.halifaxtrails.ca/](http://www.halifaxtrails.ca/)*

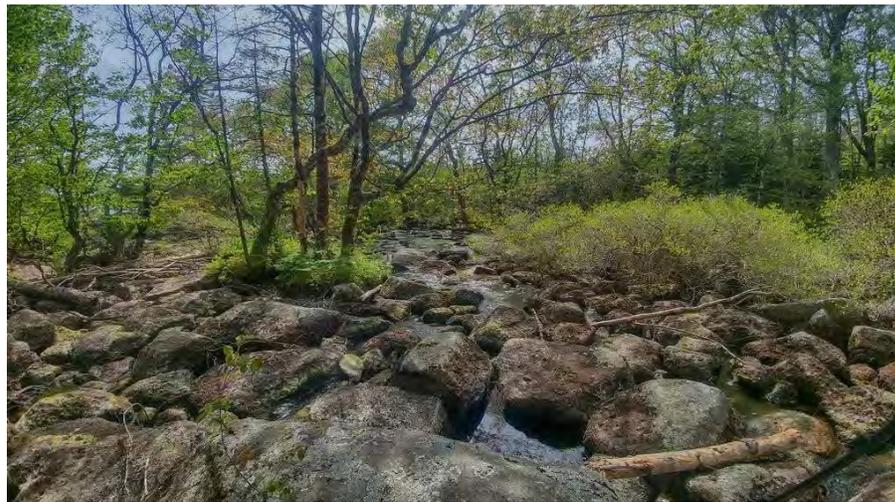
*Picture 10 – Low water levels - taken from [www.halifaxtrails.ca/](http://www.halifaxtrails.ca/)*

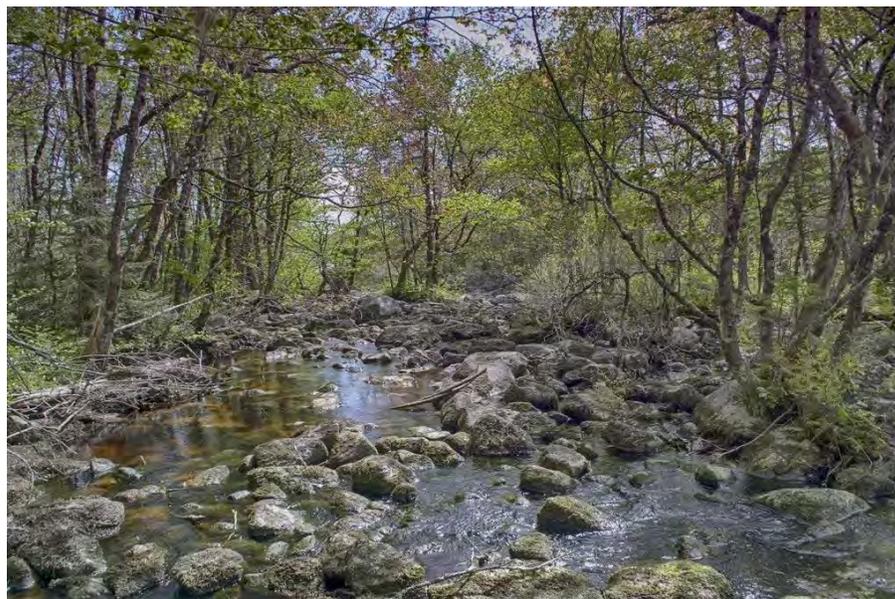
*Picture 11 – Low water levels - taken from [www.halifaxtrails.ca/](http://www.halifaxtrails.ca/)*
