Item No. 14.6.2
Halifax Regional Council
January 15, 2019

SUBJECT: **Case H00461: Substantial Alteration to municipally registered heritage properties at 1478, 1480, 1484 and 1494 Carlton Street, Halifax**

04 ADJACENT REGISTERED HERITAGE PROPERTIES

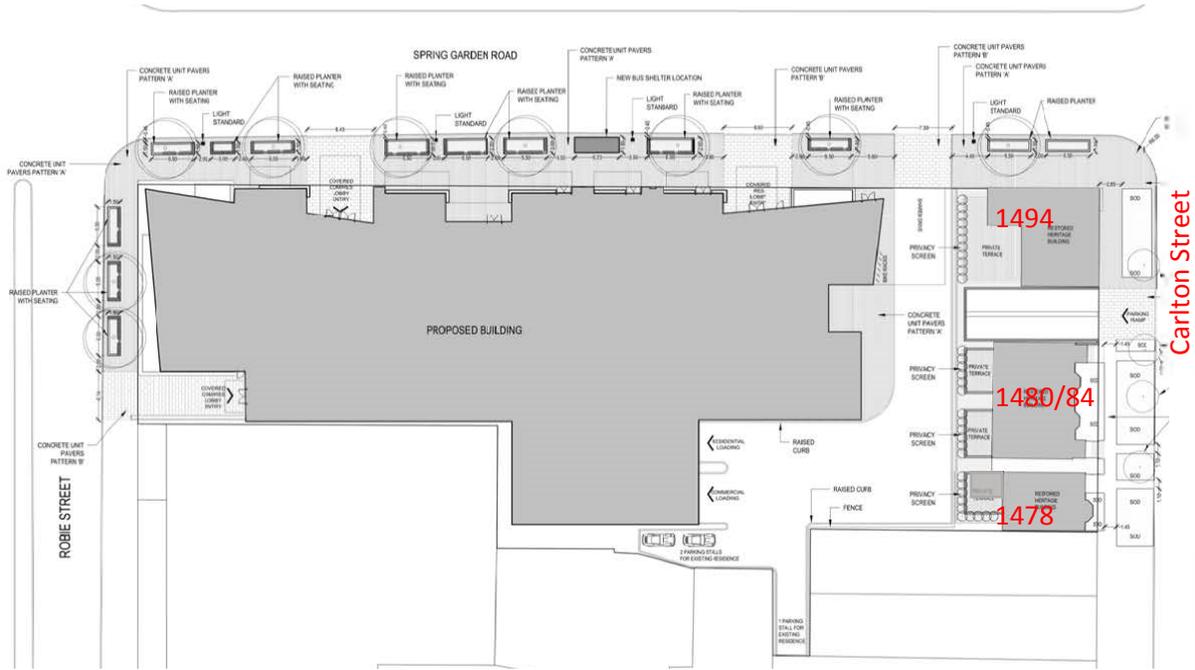
Site Plan, Dixel Architecture

The proposed project development application drawings have been previously submitted to HRM. They describe an east-west four storey podium base, with a thirty storey tower on the eastern end of the podium and a sixteen storey tower at its western end. Parking for approximately 380 cars would be located on four underground floors accessed via Carlton Street.

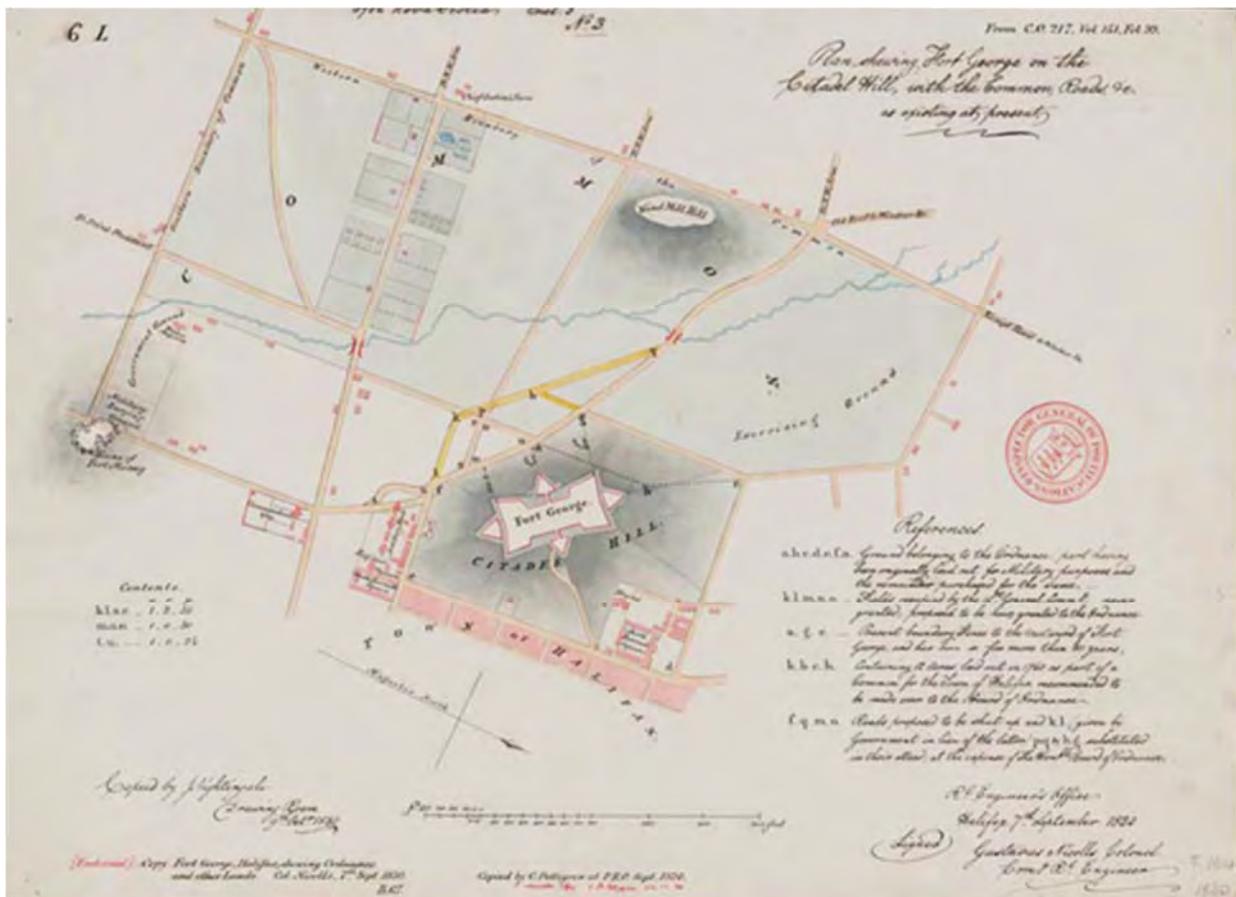
Plan of Fort George, Royal Engineers' Office, 1830. Common land in light green.

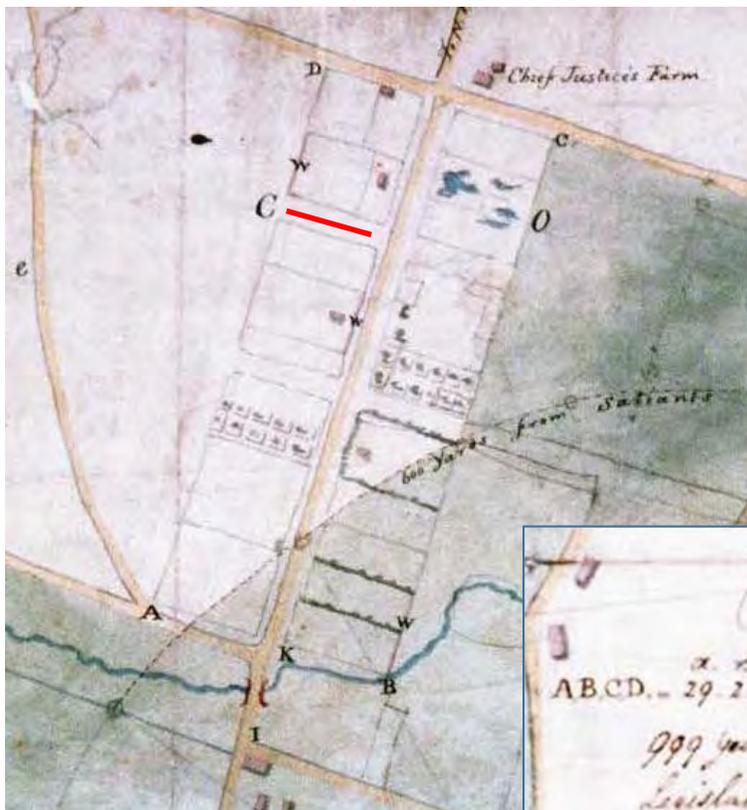
1830 Map Detail and reference note

Spring Garden Road was extended through the Common to Robie Street in 1818 and lots along either side leased to private citizens as an improvement of the lands and benefit to the public.^{7 8} The map of 1830 shows the early configuration of the Common and outlines the early division of the South Commons for these leased plots as defined by the letters A,B,C, and D. The reference for the plots on the map notes the original 1818 leases were not granted by the crown, but subsequently approved in 1829. The leases are noted as having a length of 999 years⁹. It should be noted that the map indicates the block layout for the site, garden walls, and buildings. Carlton Street highlighted in red. The planting of trees was a requirement of the initial lease.¹⁰

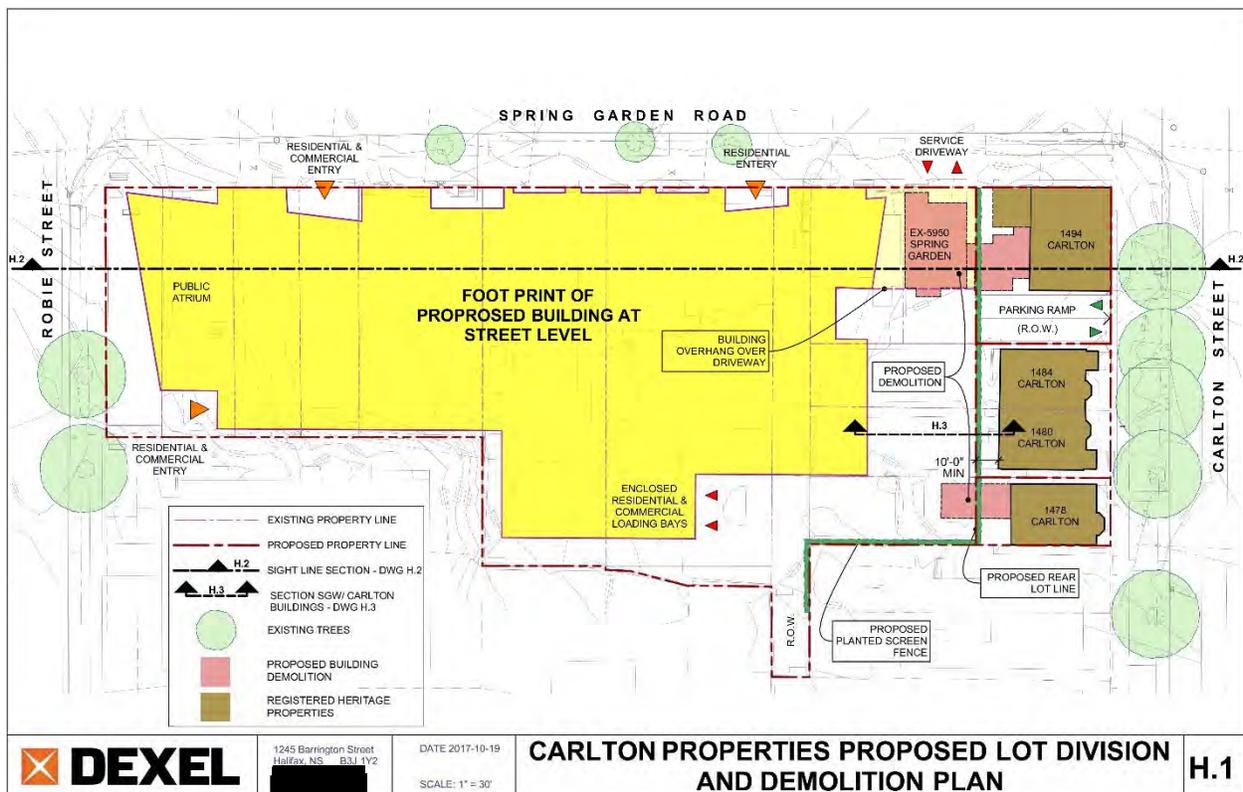
Plan showing proposed ground floor footprint of new building and adjacent Carlton St. heritage properties.

As described earlier, the development proposed under this application involves the construction of a large development consisting of two towers on a common podium on the northern half of the city block. The project proposes several direct changes to four adjacent registered heritage addresses on three properties, with working ranging from preservation, rehabilitation and restoration, to partial demolition. Work to each of the buildings will be discussed individually in sections to follow. In this section we will review the changes that affect the subject properties universally and the streetscape as a whole.

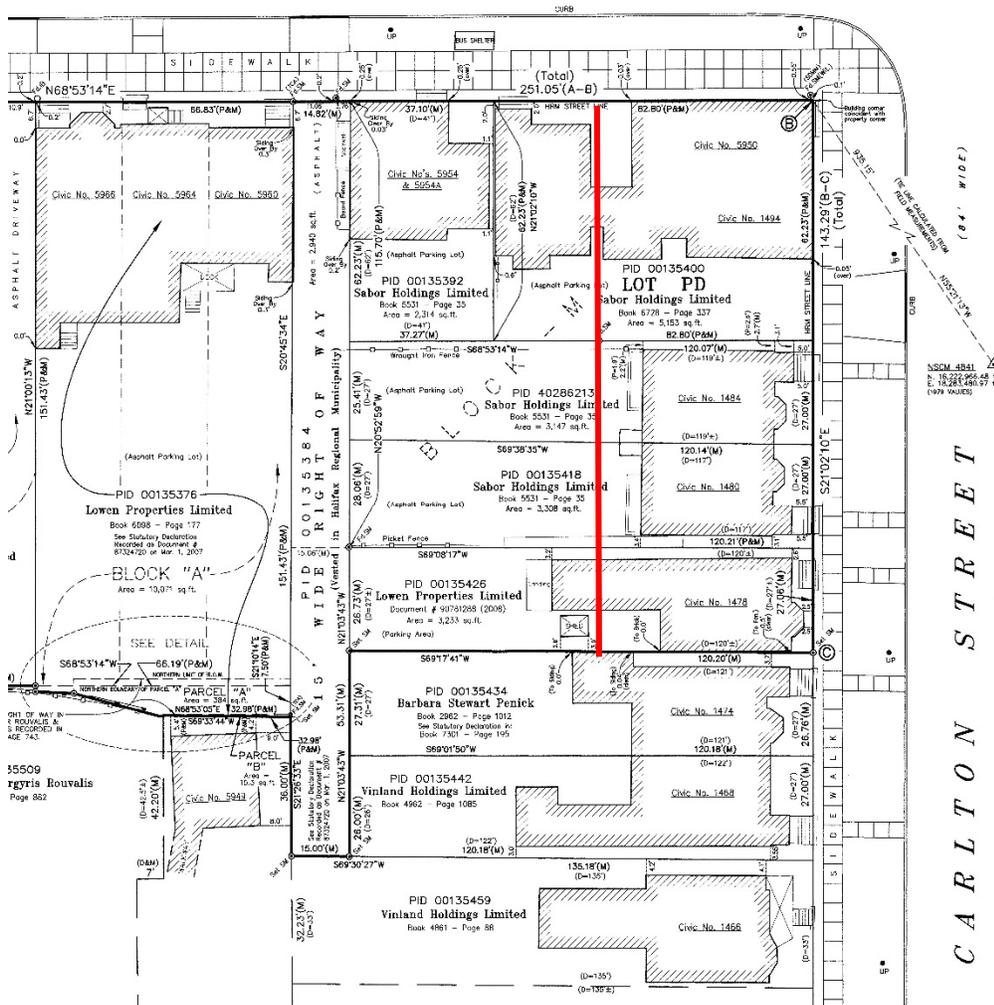
Site Plan with Proposed Adjusted Property Line

The proposed project would involve the subdivision of the three heritage properties such that portions of their existing rear yards could be consolidated into the larger development project. The proposed division line corresponds generally with the previous property line between the now connected buildings at 1494 Carlton Street and 5950 Spring Garden Road, running south to the northern boundary of 1474 Carlton. The yard shortening enables the extension of underground parking, western extension of the new above ground portions of the building, and maximizing of Spring Garden Road retail frontage while still providing service and right-of-way vehicle traffic off of Spring Garden.

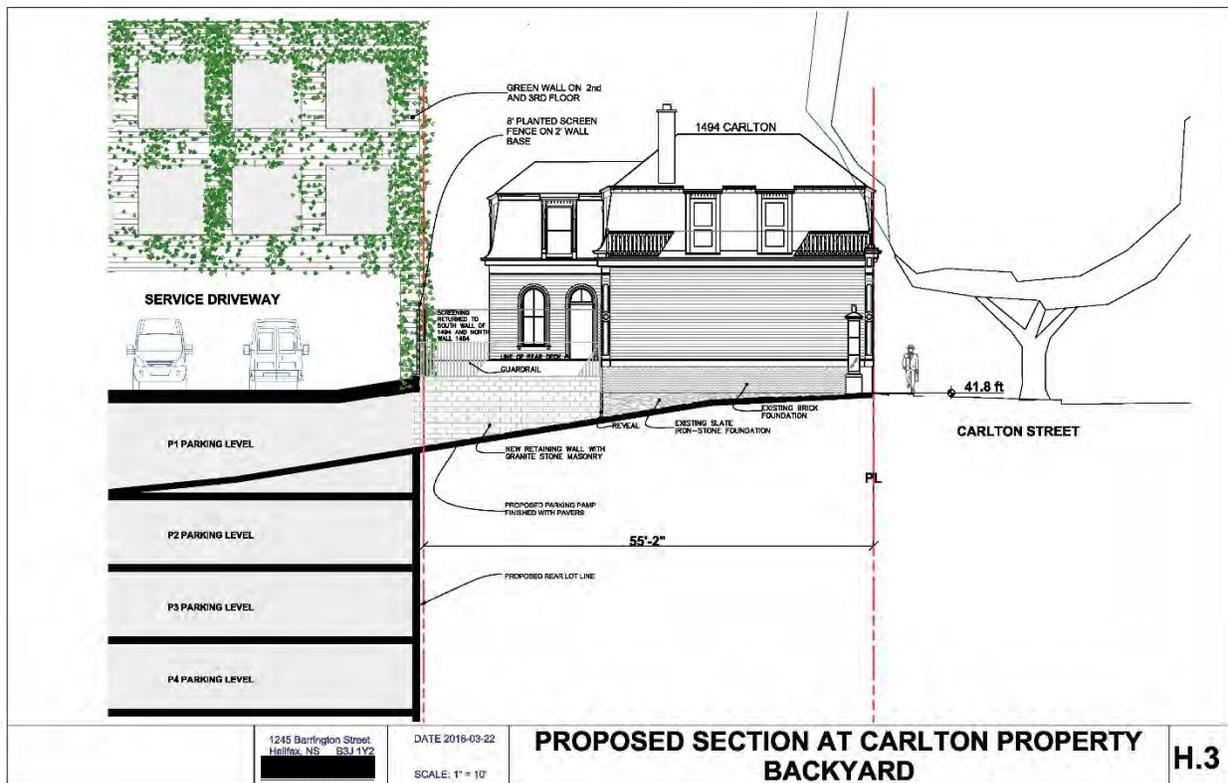
Section at New Property Line

Shoring of the existing walls would allow for deep excavations for the proposed parking levels of the property. It is a reasonably straightforward process of wall underpinning or retaining barriers as sub-soil conditions require. We do not believe it to be a long-term issue for the heritage value of the properties.

We propose that legal subdivision of the properties proceed upon issuance of a development permit for the project. Monitoring of any shored or underpinned heritage properties during construction would be a condition of the work.

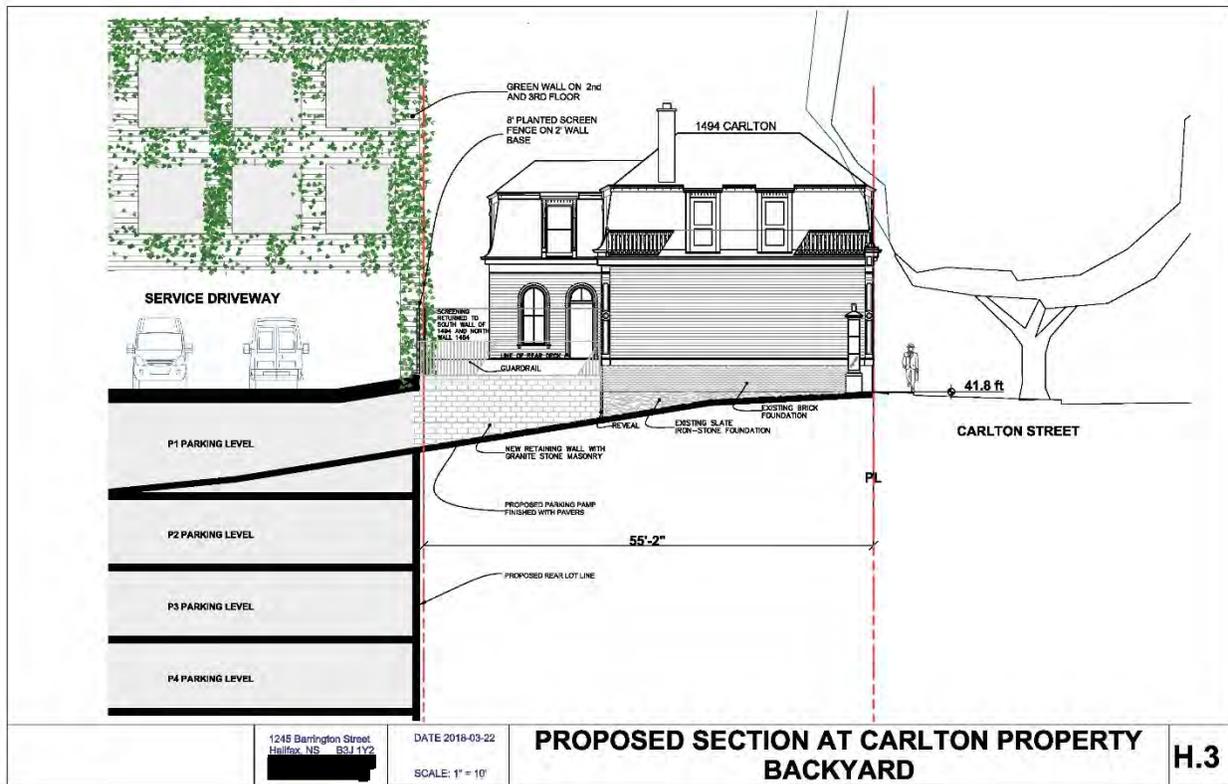
Residential Vehicle Ramp Section

The work would excavate between the two buildings expose portions of the below-grade iron-stone foundations of the adjacent buildings. These foundation walls would be which cleaned and repointed. Where retaining walls are required between the rear walls of the buildings and the relocated property line and face of the parking entrance, these walls would be delineated from the original buildings with a vertical reveal and then faced with iron-stone to match the adjacent buildings. Above grade, the privacy screening running along the back property line, would return to the back faces of the two heritage properties to screen the back yards from the parking entrance.

Some underpinning of the existing buildings may be required. This work is anticipated to remain below grade.

We repeat the previous site section drawing here to illustrate the proposed driveway.

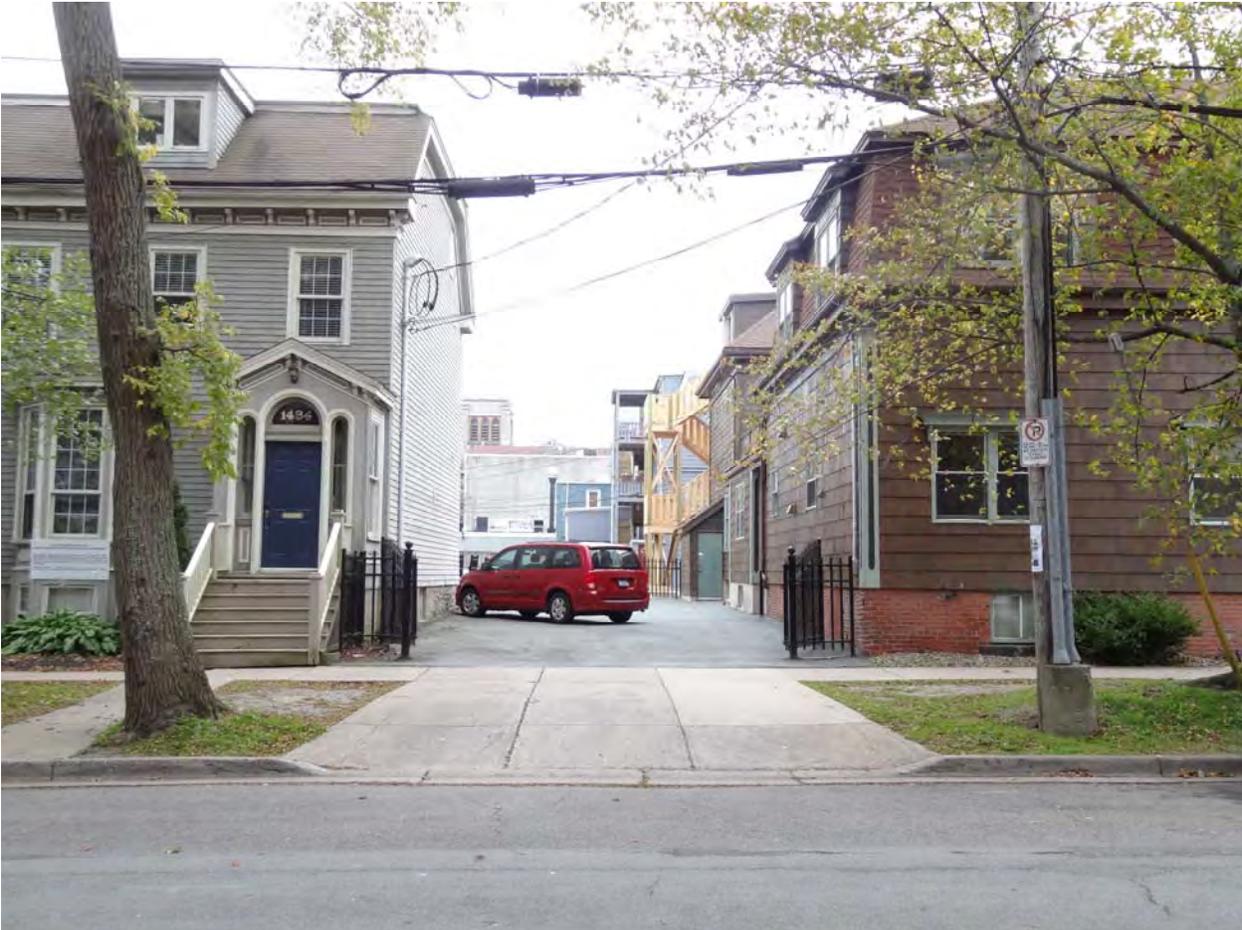
Existing driveway between 1484 and 1494 Carlton

The project proposes utilization of the existing driveway off Carlton between 1484 and 1494 Carlton Street as the principal residential access for the new development. The access would be as an easement to 1494 Carlton. The owner has engaged Ekistics Plan and Design to review the larger site portions for vehicle access. Their report can be found in the larger project submittal. It includes a review of three options for site access including the one proposed in this report, as well as full vehicle access off of Spring Garden Road, and finally access off of Robie Street. The report concludes that Robie Street access is not reasonable. Of the remaining two, the Carlton Street residential access was considered preferable based on capacity, geometry, and safety concerns.

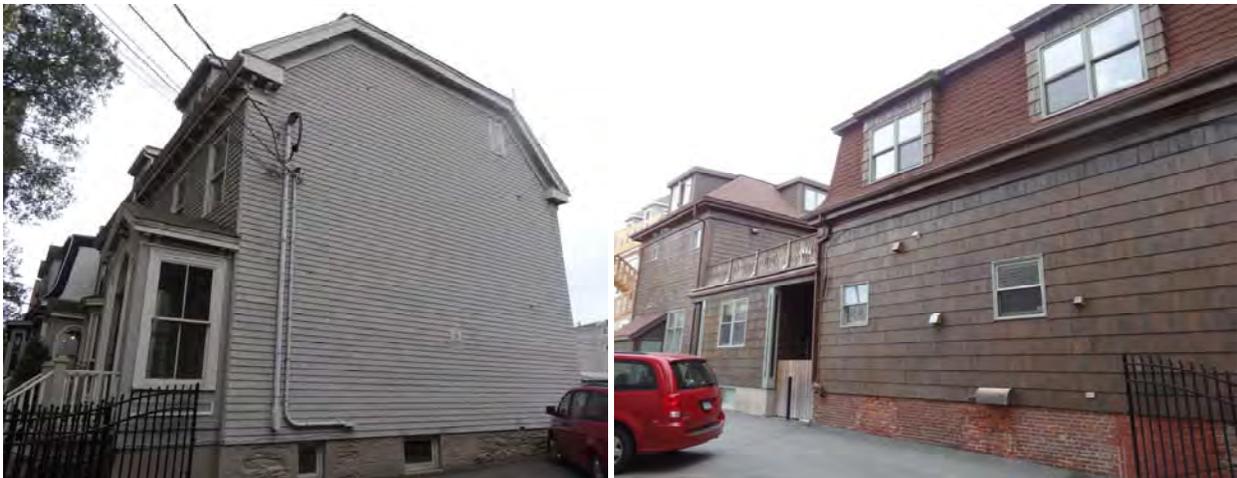
North Wall 1484 Carlton and South Wall 1494 Carlton

The side wall of 1484 Carlton only has two smaller basement, and one smaller top storey window overlooking the driveway. Historical photos show a previously removed side stair window and a second third floor window. This work does not propose their re-instatement. 1494 has ground and second floor windows overlooking the driveway. We believe the proposed removal of some of the existing ground floor windows, provision of new replacement windows for those remaining, and the interior renovation for the buildings will address sound concerns for the properties. We believe removal of the ground floor windows is supported by the 1990 'existing' elevations shown later in this report.

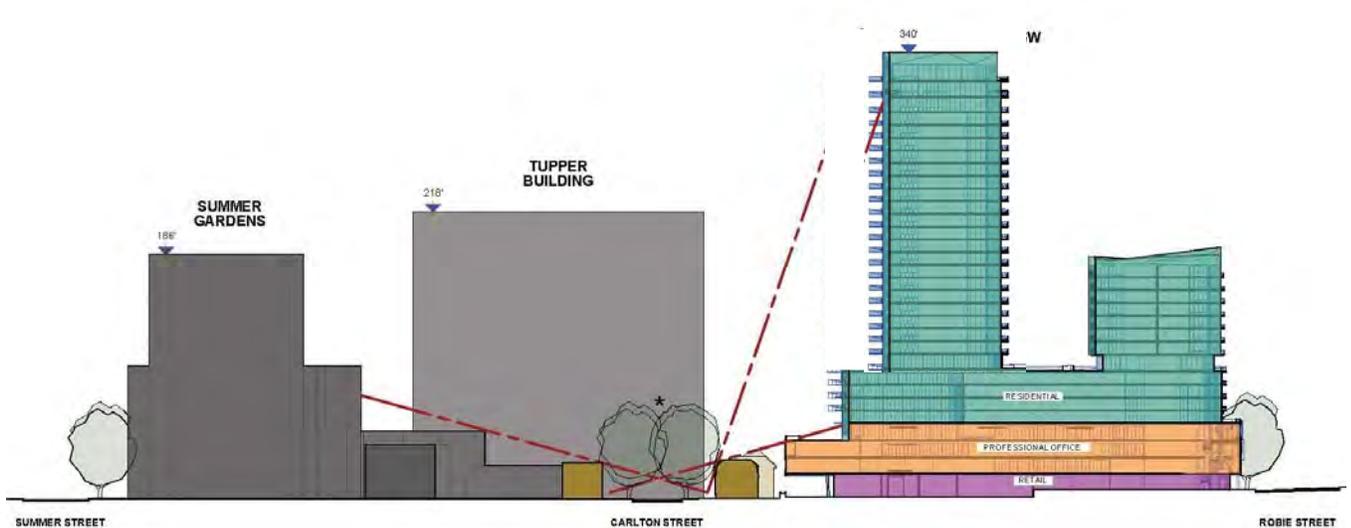
Carlton Street Section East-West Section

For the pedestrian on Carlton Street, the close proximity of the western sidewalk to the western buildings, generally would obscure the presence of the new eastern tower. From the eastern sidewalk, the tower will be visible above the opposite homes. This is seasonally mitigated somewhat by the dense tree canopy, and the general visibility of other tall buildings in the neighbourhood.

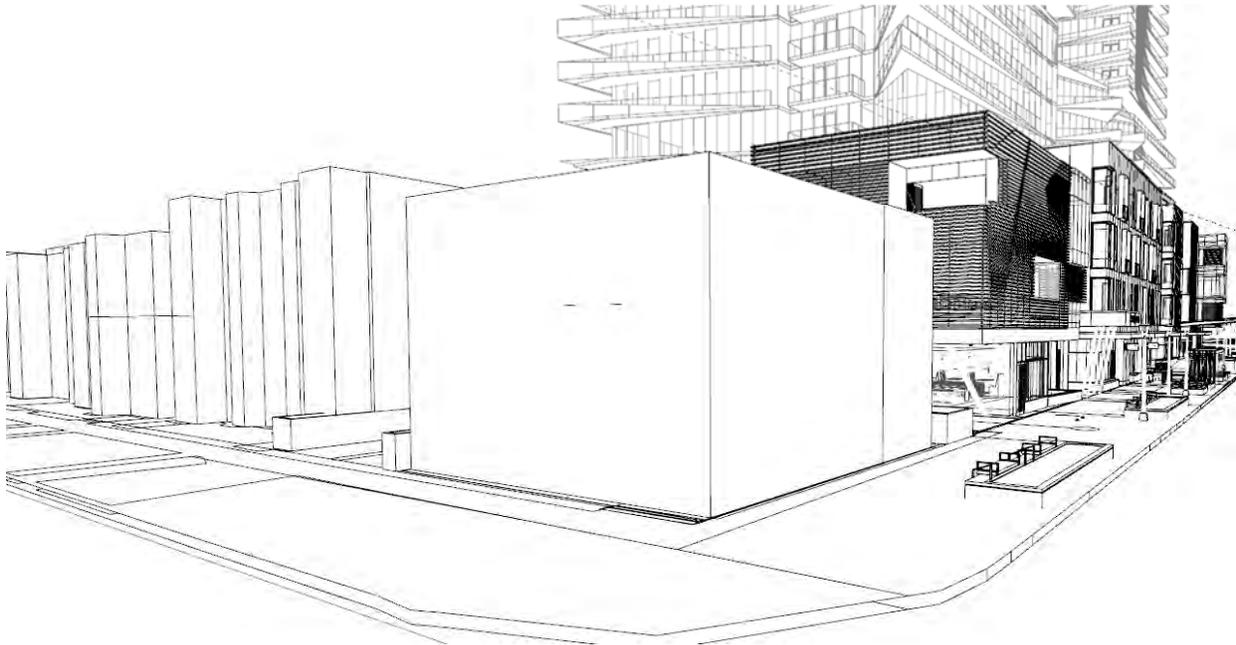
Transition Massing at 1494 Carlton Street

The new building is generally similar in height and mass to the newer, larger additions to the neighbourhood, continuing the trend of later developments, with a focus on active street front development, with high grain articulation and differentiation of the lower four story street wall, where storefronts reflect the pattern of the existing storefronts, and varied claddings and subtle pushing and pulling of the four storey massings suggest an engaging street scape. This articulated street wall plays an important role in mitigating the visual dominance of the towers, and in transitioning to the low rise Carlton Street street scape. At it's eastern end, aligning with the eastern end of the tower above, the street wall again steps down to three storeys where the new building abuts the two storey mass of 1494 Carlton.

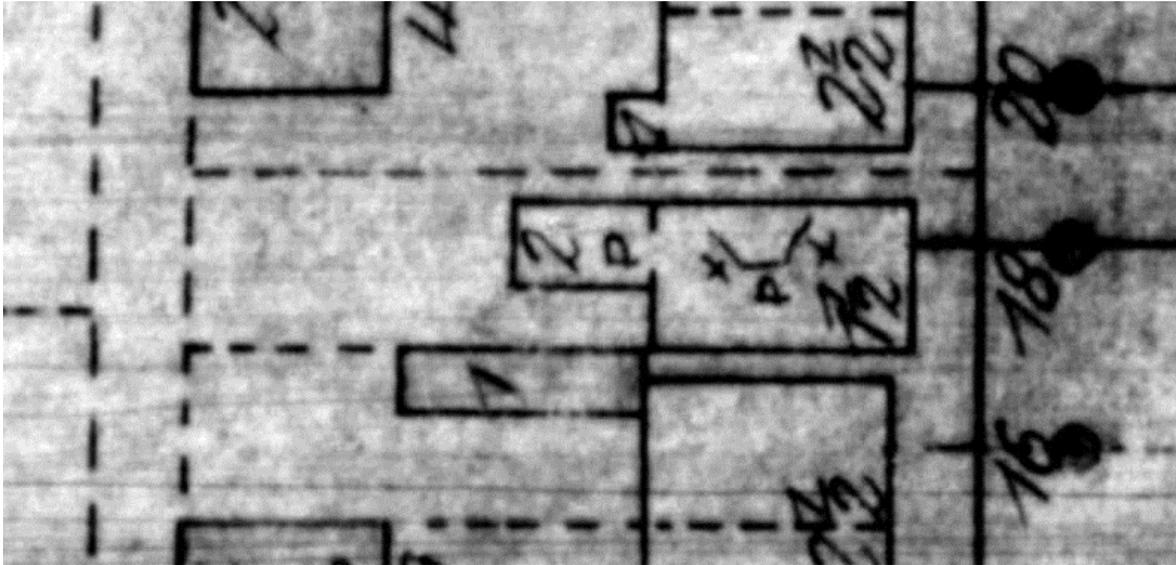
1889 Goad's Atlas, 1478 (18) detail

It should be noted that the proportions of the rear wing appear shorter than the currently existing wing. This may be due to a later addition to the wing, or it may be attributed to the proportions and positioning of the home being incorrect on the fire atlas plan.

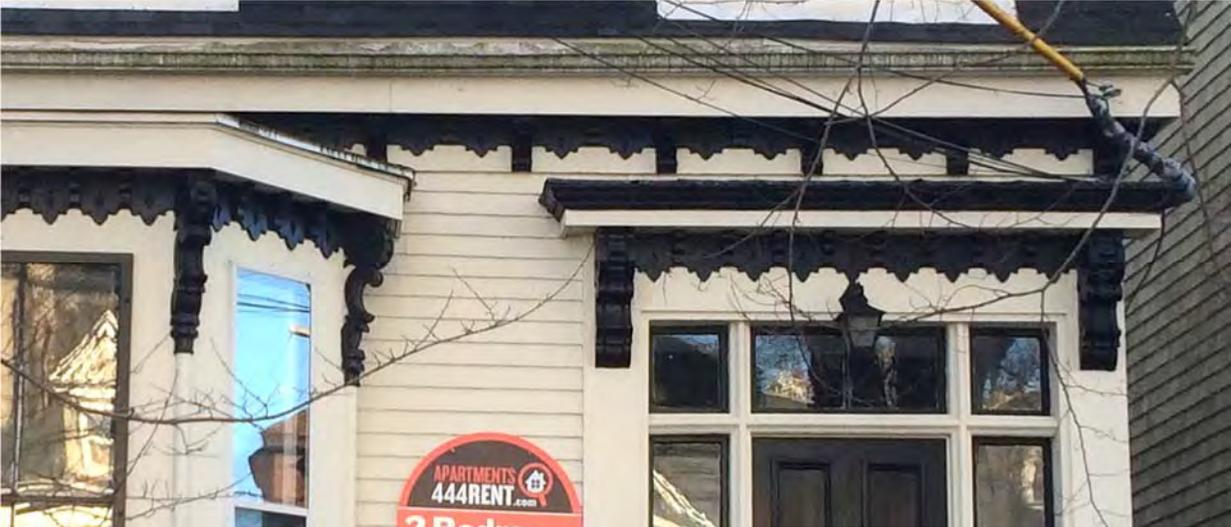
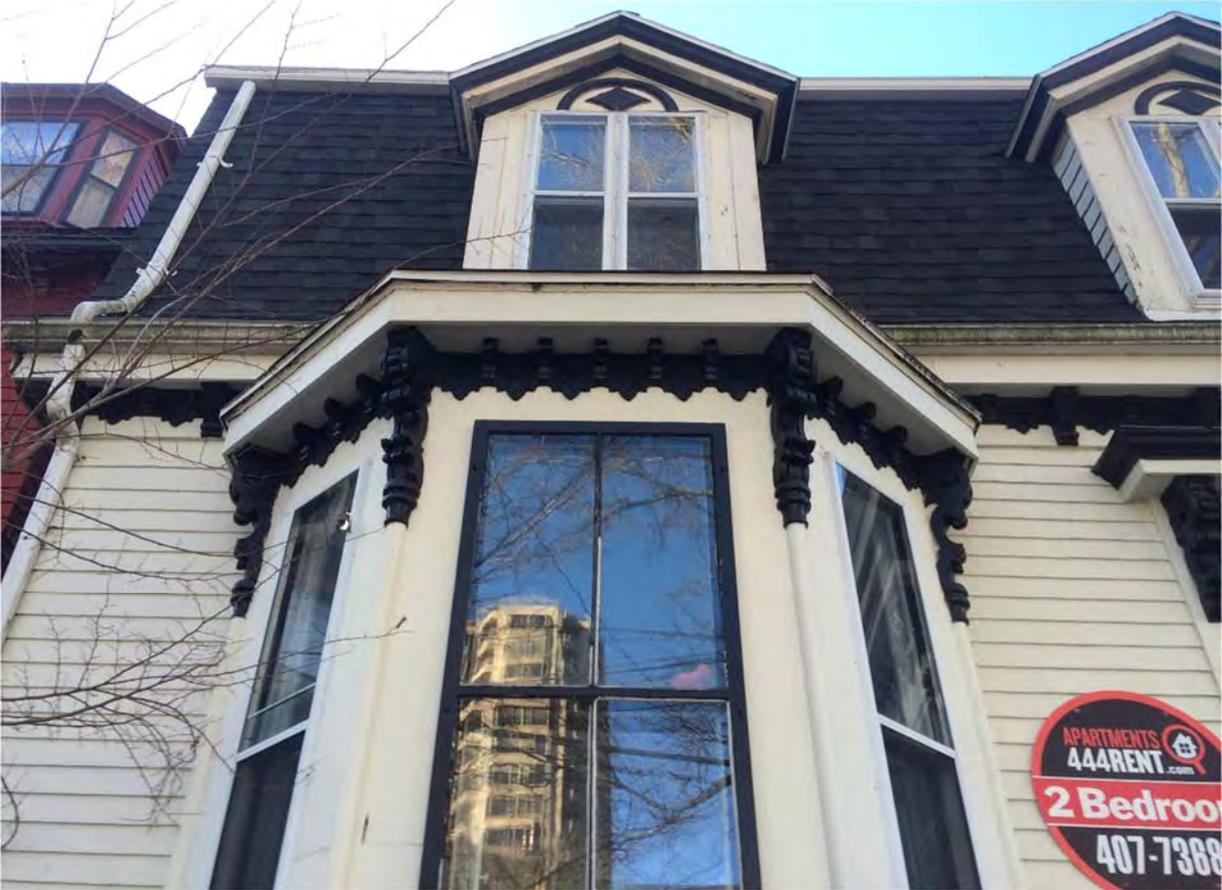
Bay and Entry Door Trim work

Aside from work to sub-divide the internal portions of the building, much of the original building remains. Exceptions include entry steps and railings, asphalt shingles on the mansard roof, replaced fascia boards, particularly at the bay window, window inserts with original framings, the front door, some newer windows on the rear addition, storm windows, and the balcony and fire escape. Much of the original trim work survives on the interior though altered for fire separations.

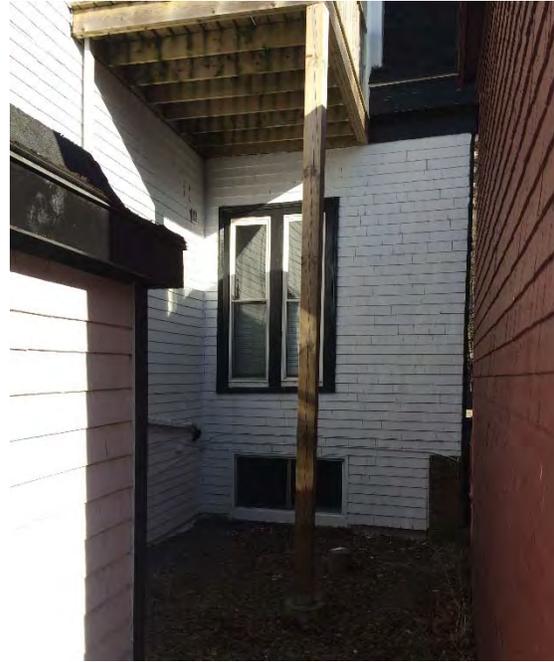
Rear Wall. Note original Window.

6. Repair of the existing rear ground floor window, including resetting of sill, complete with new wood insert windows.
7. Refurbishment of bay windows and provision of two new replacement storm windows.

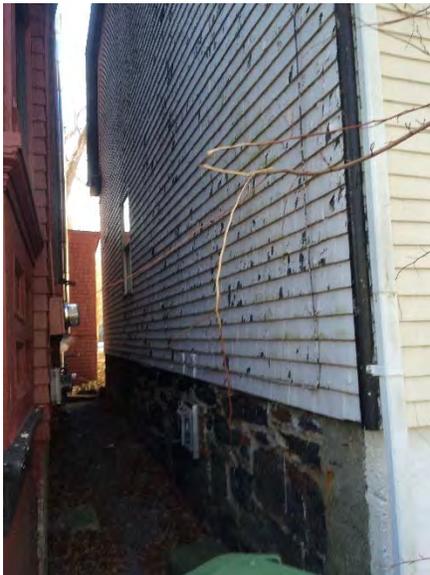
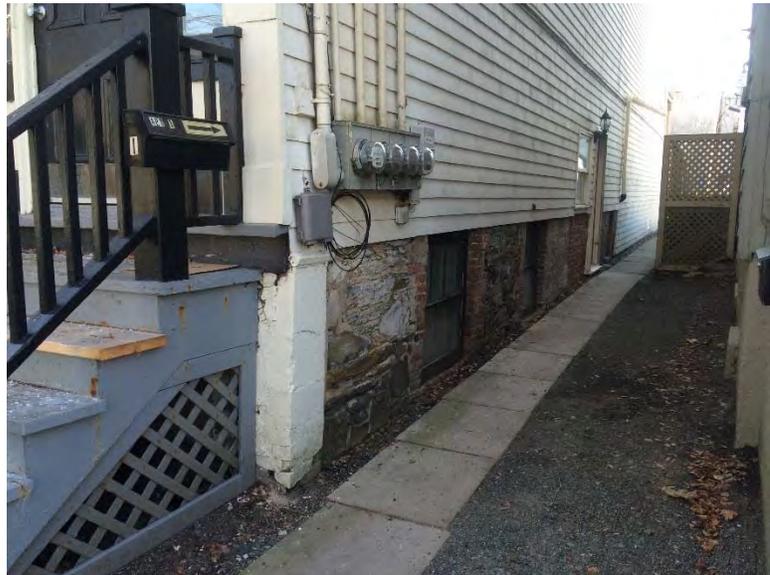
South and North Sidewalls. Note peeling paint shows darker Colour

8. Refurbishment of existing exterior door with provision of new latch set and gasketing.
9. General selective repair, cleaning and repainting of the wood trim and claddings. Colours to be based on analysis of existing material. 1950's photo and existing peeling paint suggests a darker colour scheme.

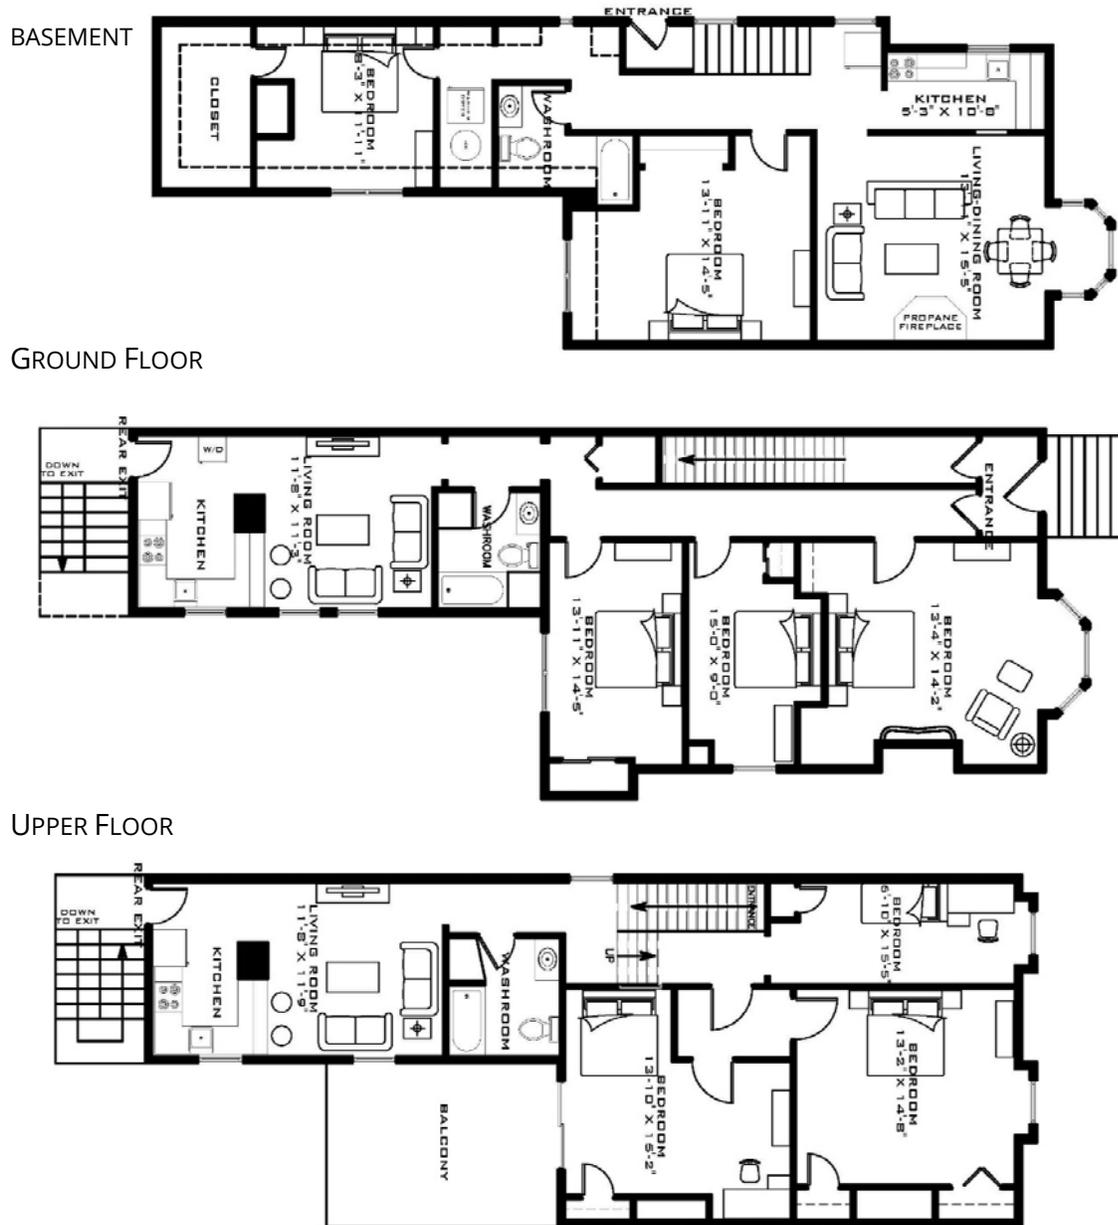
The floor plans generally show the interiors of the buildings as they are today and show that the general side hall with two principal rooms per floor with lesser rooms in the rear L. Based on the plans the building likely had three chimneys, two on the south sidewall for the principle rooms and one in the rear L, likely associated with a ground floor kitchen.

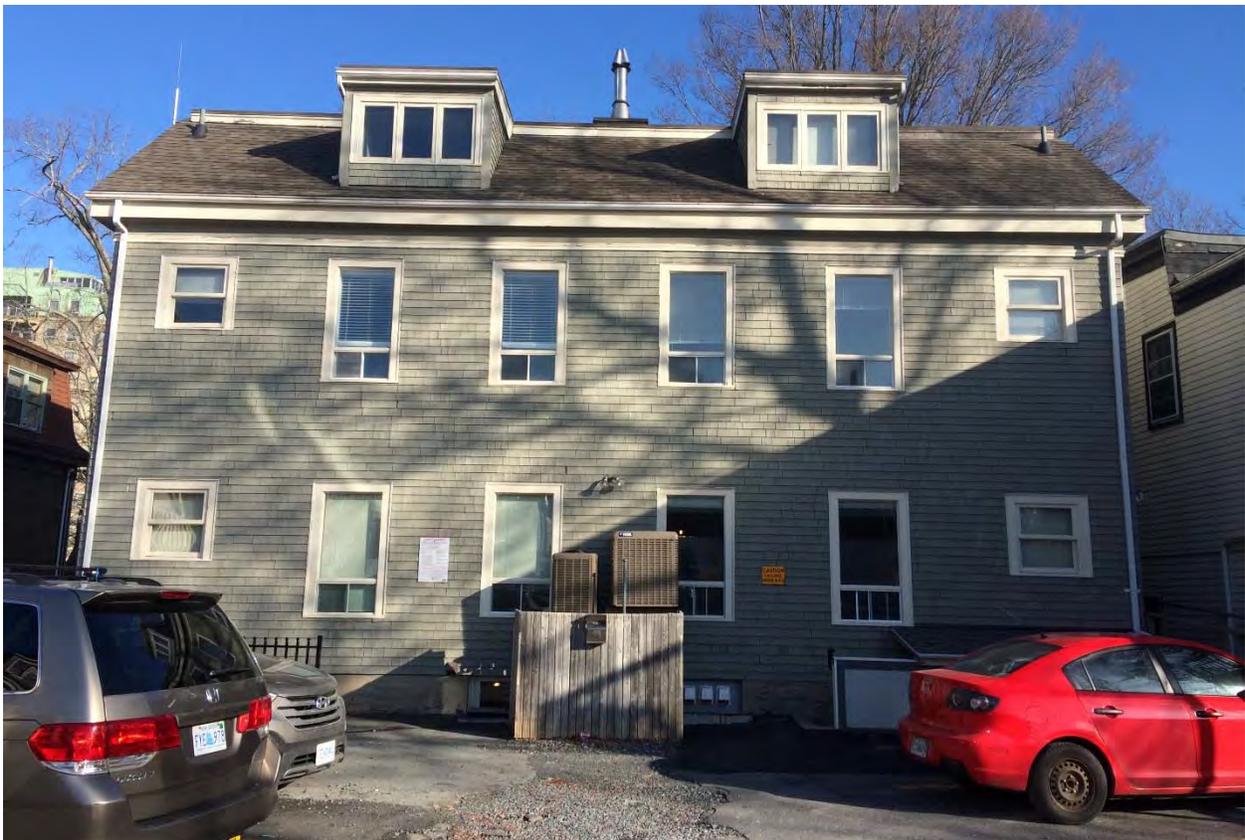
Rear Elevation

The building is in general good repair with minor deterioration noted at fascias, entry stairs, door sills and adjacent trims.

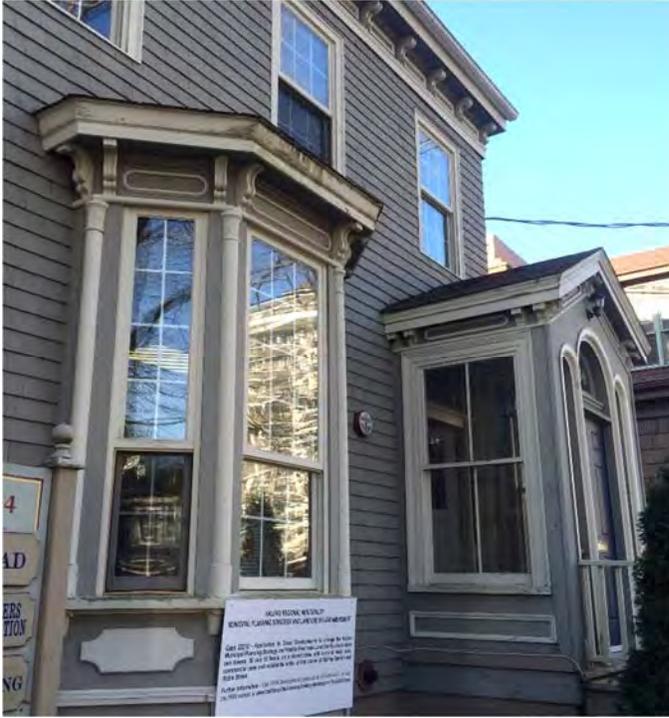
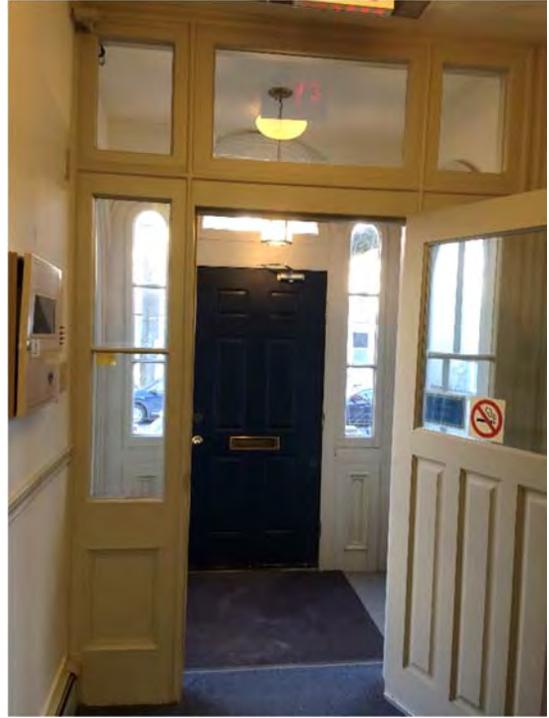
Bay Window and North Porch, and North Porch Interior

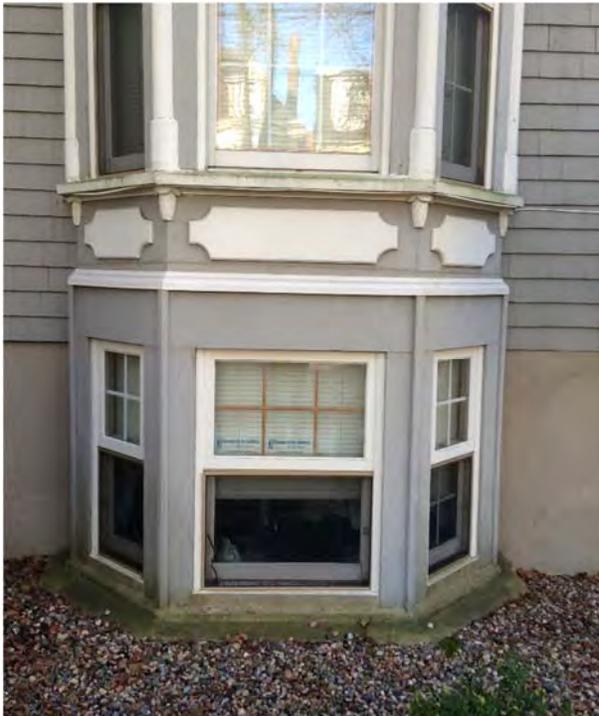
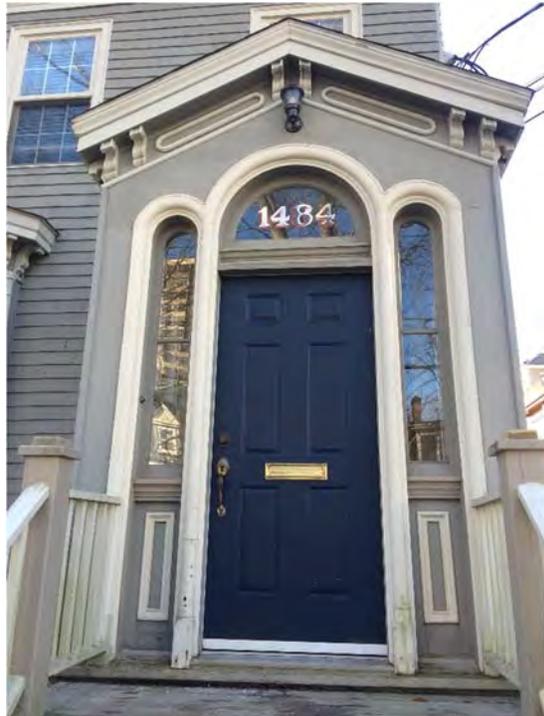
Bay Window at grade and porch entry door.

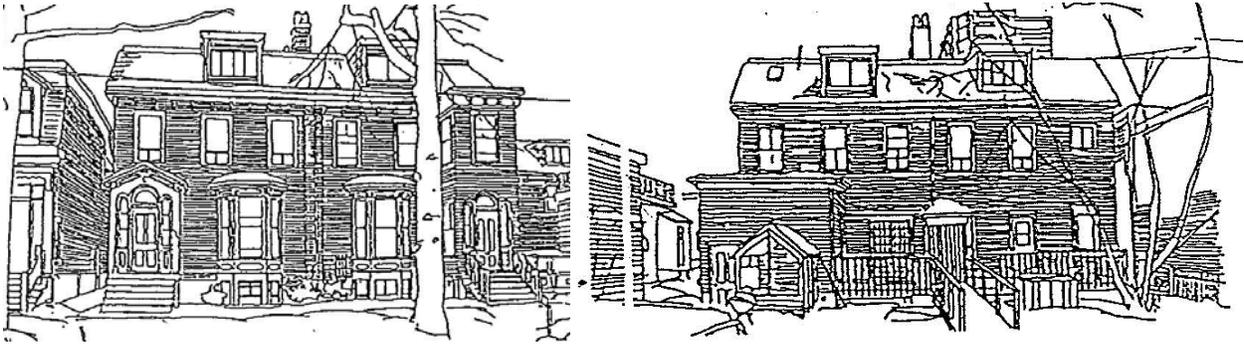
1990 Existing Elevation Sketches

The 1889 Atlas shows two rear single storey bumps, which do not appear on Hopkins. The more northerly of these bumps appears to be referenced for removal in a 1990 Halifax city Information report for the conversion of the property to commercial use, where it is shown in elevation and plan.

The 1990 renovations are related to the conversion of the homes from residential to office use. In addition to the rear removal they show a new parking layout for the rear yard, new exterior stairwell on either side for basement access, a new exterior south side ramp for ground floor access, interior wall removals and additions combining the buildings at each floor level, and the removal of an upper floor portion of the northern main entry porch and replacement with a roof replicating the southern porch.

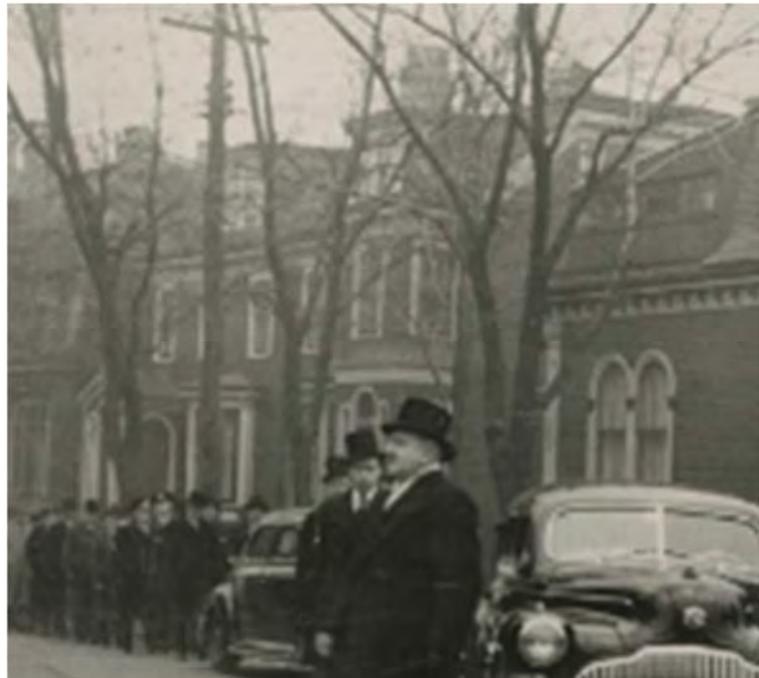
This porch is visible in the 1950's funeral parade photo. It is likely, but not certain, that the upper floor over the porch was a later addition. Also note that the south porch has arched side windows while the north has square windows. The north porch today retains the square windows. It is not the intent of the new work to re-instate this second floor of the north porch.

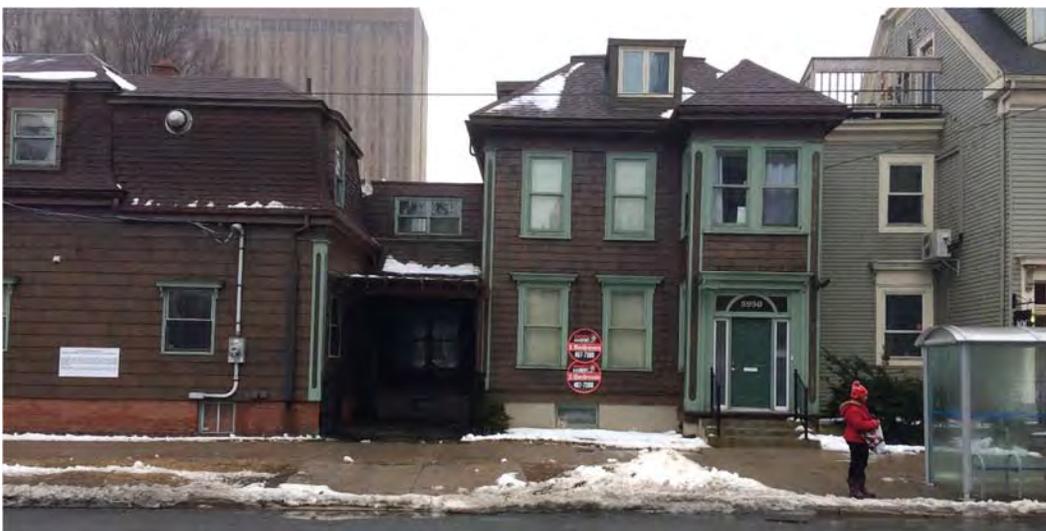
5950 Spring Garden North Elevation with adjoining addition to 1494 Carlton.

- Shortening of the rear yards.
- Demolition of 5950 Spring Garden Road.
- Demolition of 1990 additions joining 5950 Spring Garden and 1494 Carlton.
- Demolition of the rear L wing of 1478 Carlton Street.
- Shoring during construction of western foundations of 1478 to 1494 Carlton.
- Shoring during construction for north-west corner foundations of 1474 Carlton.

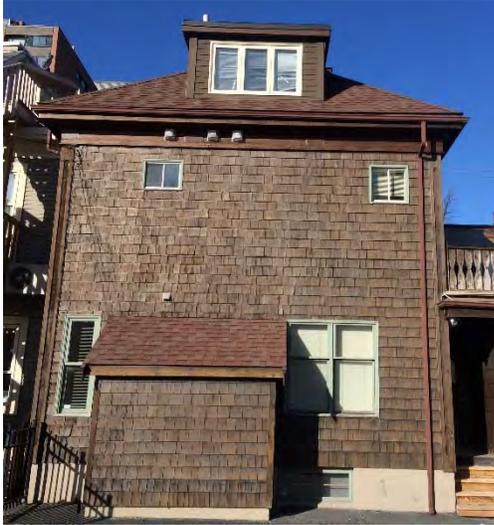
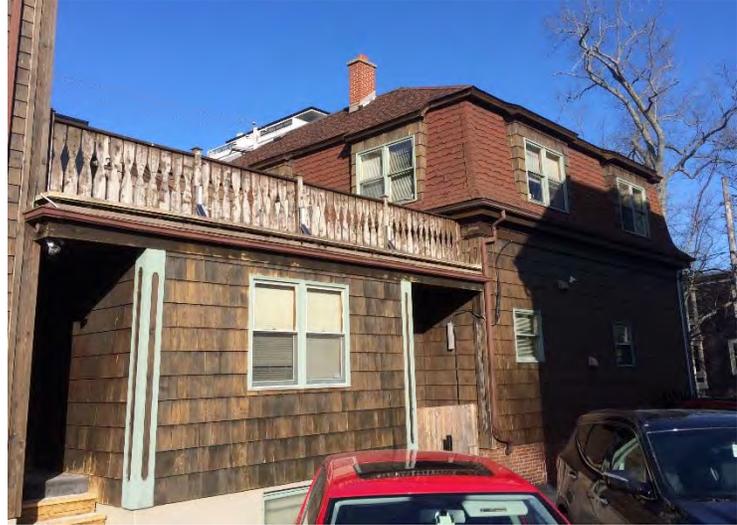
South Elevations.

1494 Carlton Street is a one and a half storey Second Empire home with Mansard roof, wood framed, shingle-clad walls sitting on a brick and un-coursed ironstone foundation. The building began as a north side-hall plan building with short rear L extending along Spring Garden Road. Later additions extended the building south and west to give the general form seen today integrated at basement and ground floors to its 5950 Spring Garden neighbour. The building has seen substantial renovation with the loss of original single roofing and siding, windows and doors, and decorative trim work. To describe it today one would note replacement modern windows and doors, not in keeping with the original in size, form or placement, inappropriate trim work where existing, and dark-

stained and wide weathering western red cedar shingle cladding and saw-toothed shaped asphalt shingles adorning the roof. Matching exterior finishes have been added to 5950 Spring Garden Road. Inside the buildings have been converted to office use.
