Item No. 14.6.2
Halifax Regional Council
January 15, 2019

SUBJECT: **Case H00461: Substantial Alteration to municipally registered heritage properties at 1478, 1480, 1484 and 1494 Carlton Street, Halifax**

04 ADJACENT REGISTERED HERITAGE PROPERTIES

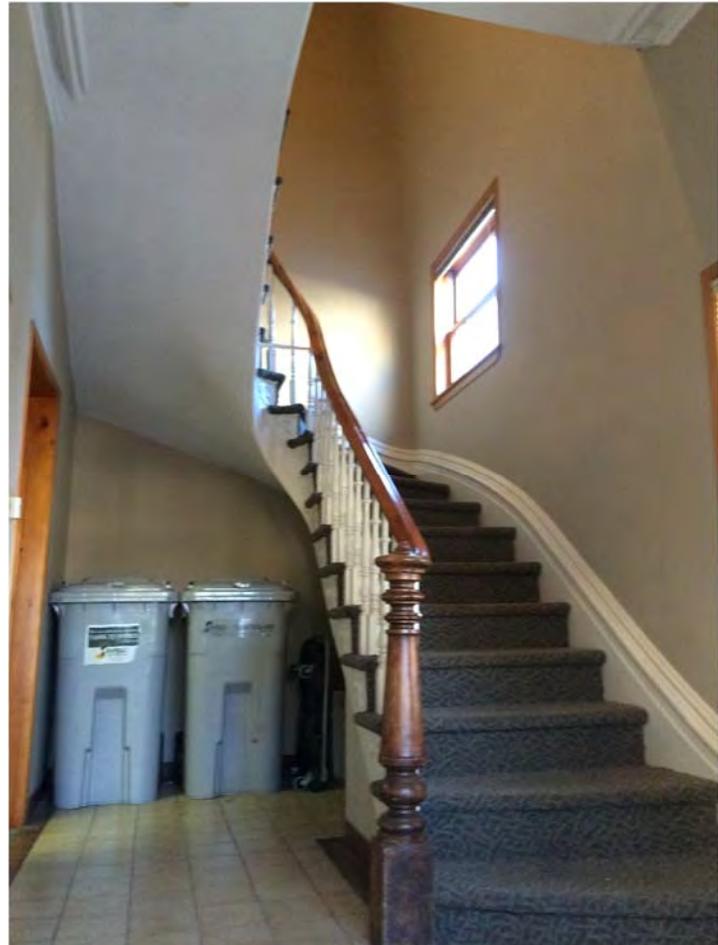
1990 Floor Plans by
G.E.C. Architect Ltd.

On the interior, portions of the original side-hall plan still remain, with the least changes made to the upper floor. Vestiges of original finishes remain, including the original curving entry hall stair, entry hall plaster moldings, and the occasional upper floor door trim.

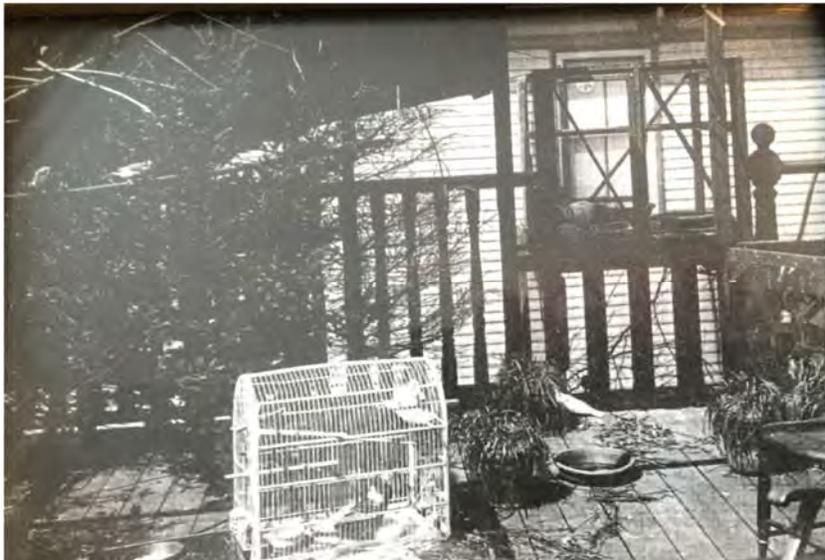
The aviary deck is shown in the following photos, earlier without enclosure, and later with enclosing walls and forms part of the cultural association with Ms. Saunders. The photos show the original railings on the south deck.

South deck aviary, looking west.²⁸

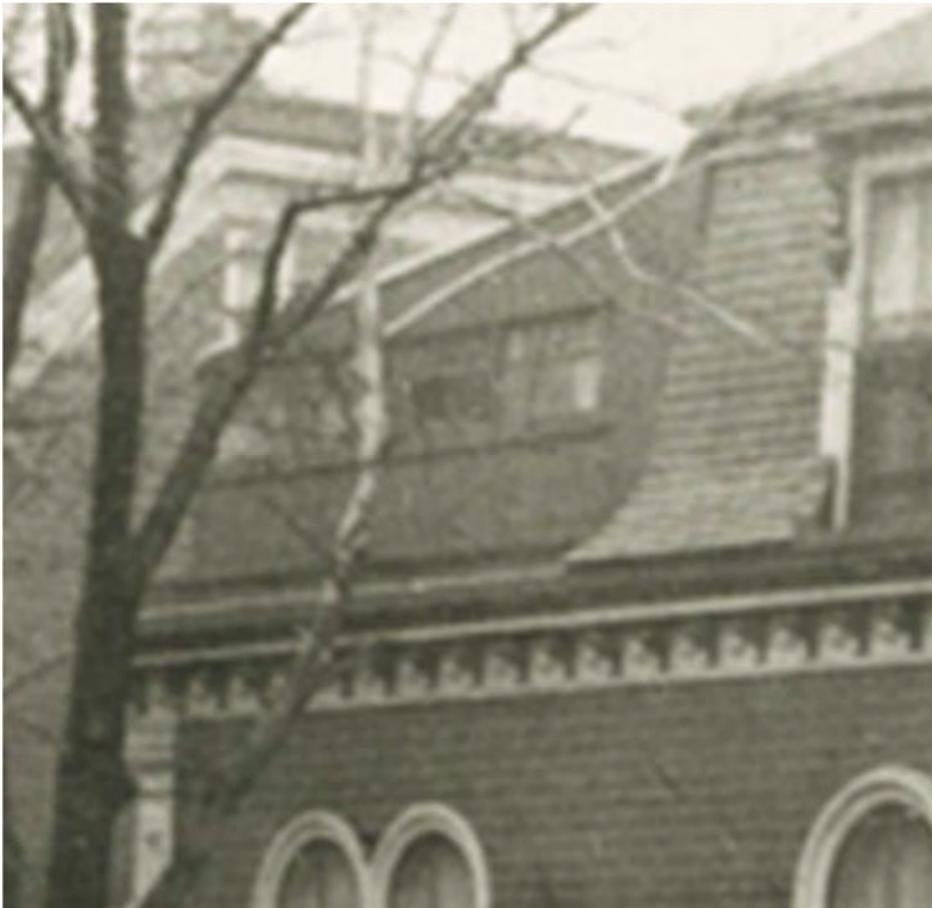
South Deck Circa 1950's with enclosure

The preceding fire atlas images show that in 1889 the footprint of the building did not extend as far south as the present building, a fact re-enforced by the basement floor plan. By 1895 the home at 5950 has been constructed on the rear yard of the property. The south addition is known to have been built prior to the the 1908 publication of My Pets, and the 1914 Atlas shows a second floor enclosure at the east side of the aviary deck. The 1950's aerial photo on page 16 shows the deck enclosure over the full width of the second floor deck.

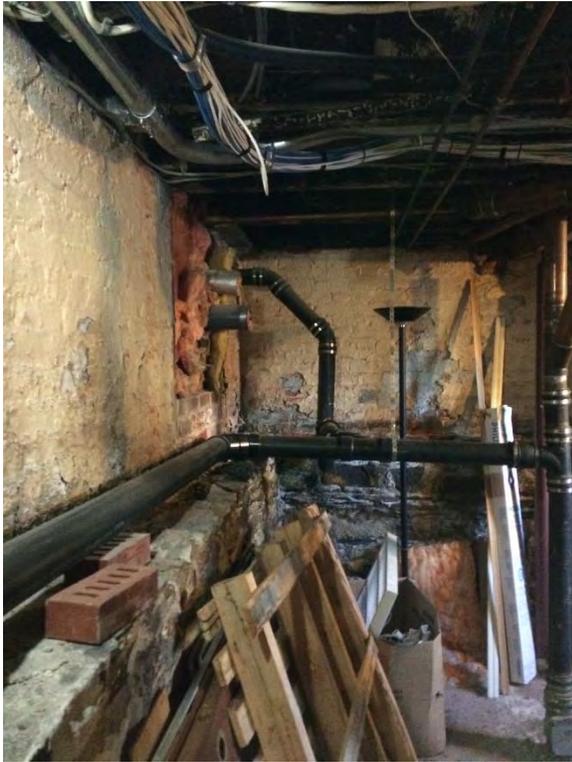
*Existing Step and Transition in Foundation Wall
Between Stone and Brick in rear L.*

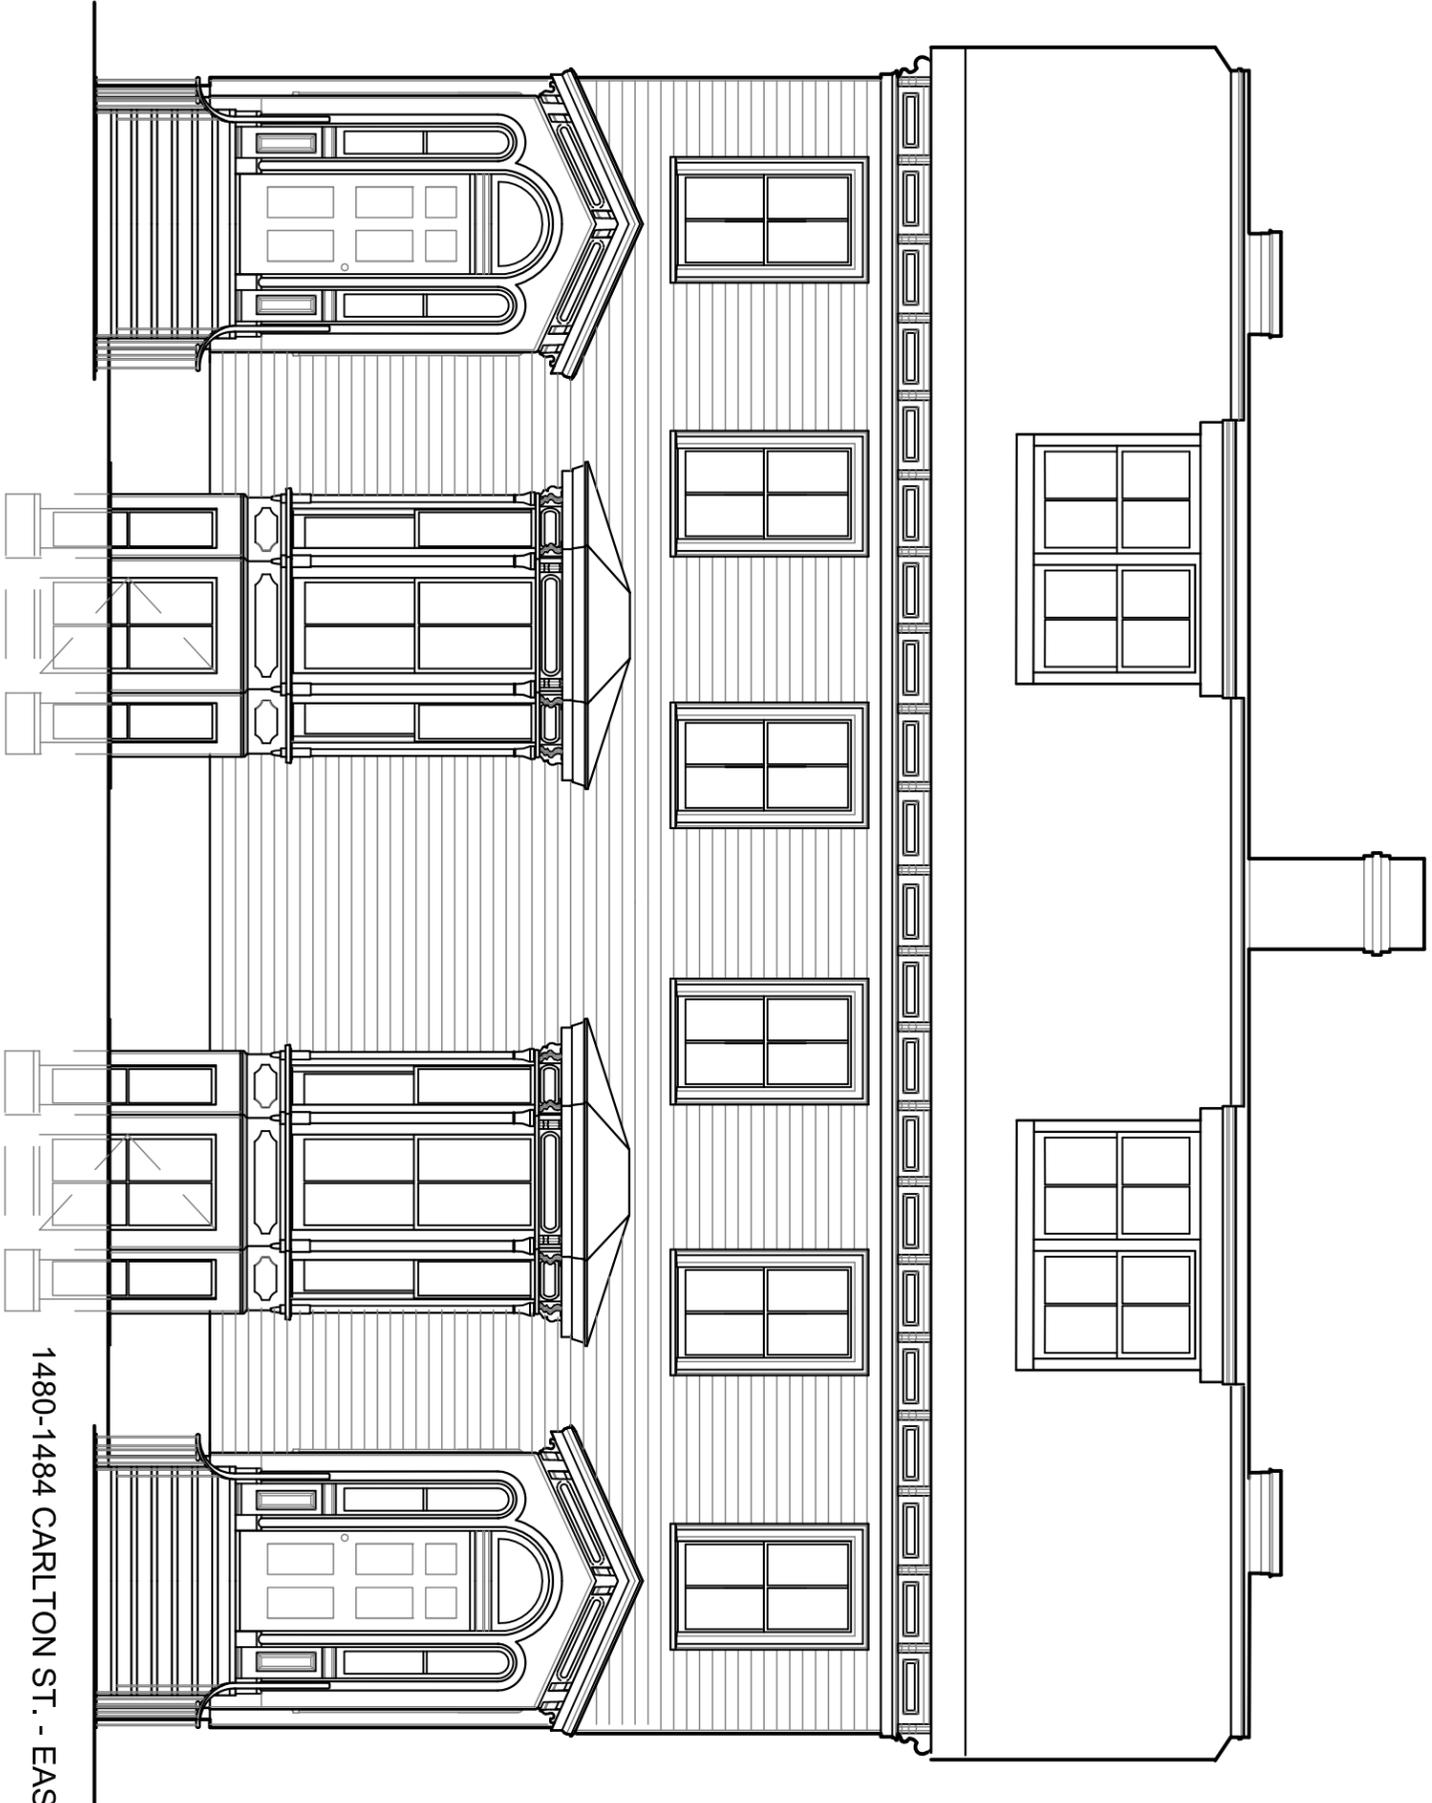
1480-1484 CARLTON ST. - EAST ELEVATION

1484-1480 CARLTON ST. - WEST ELEVATION

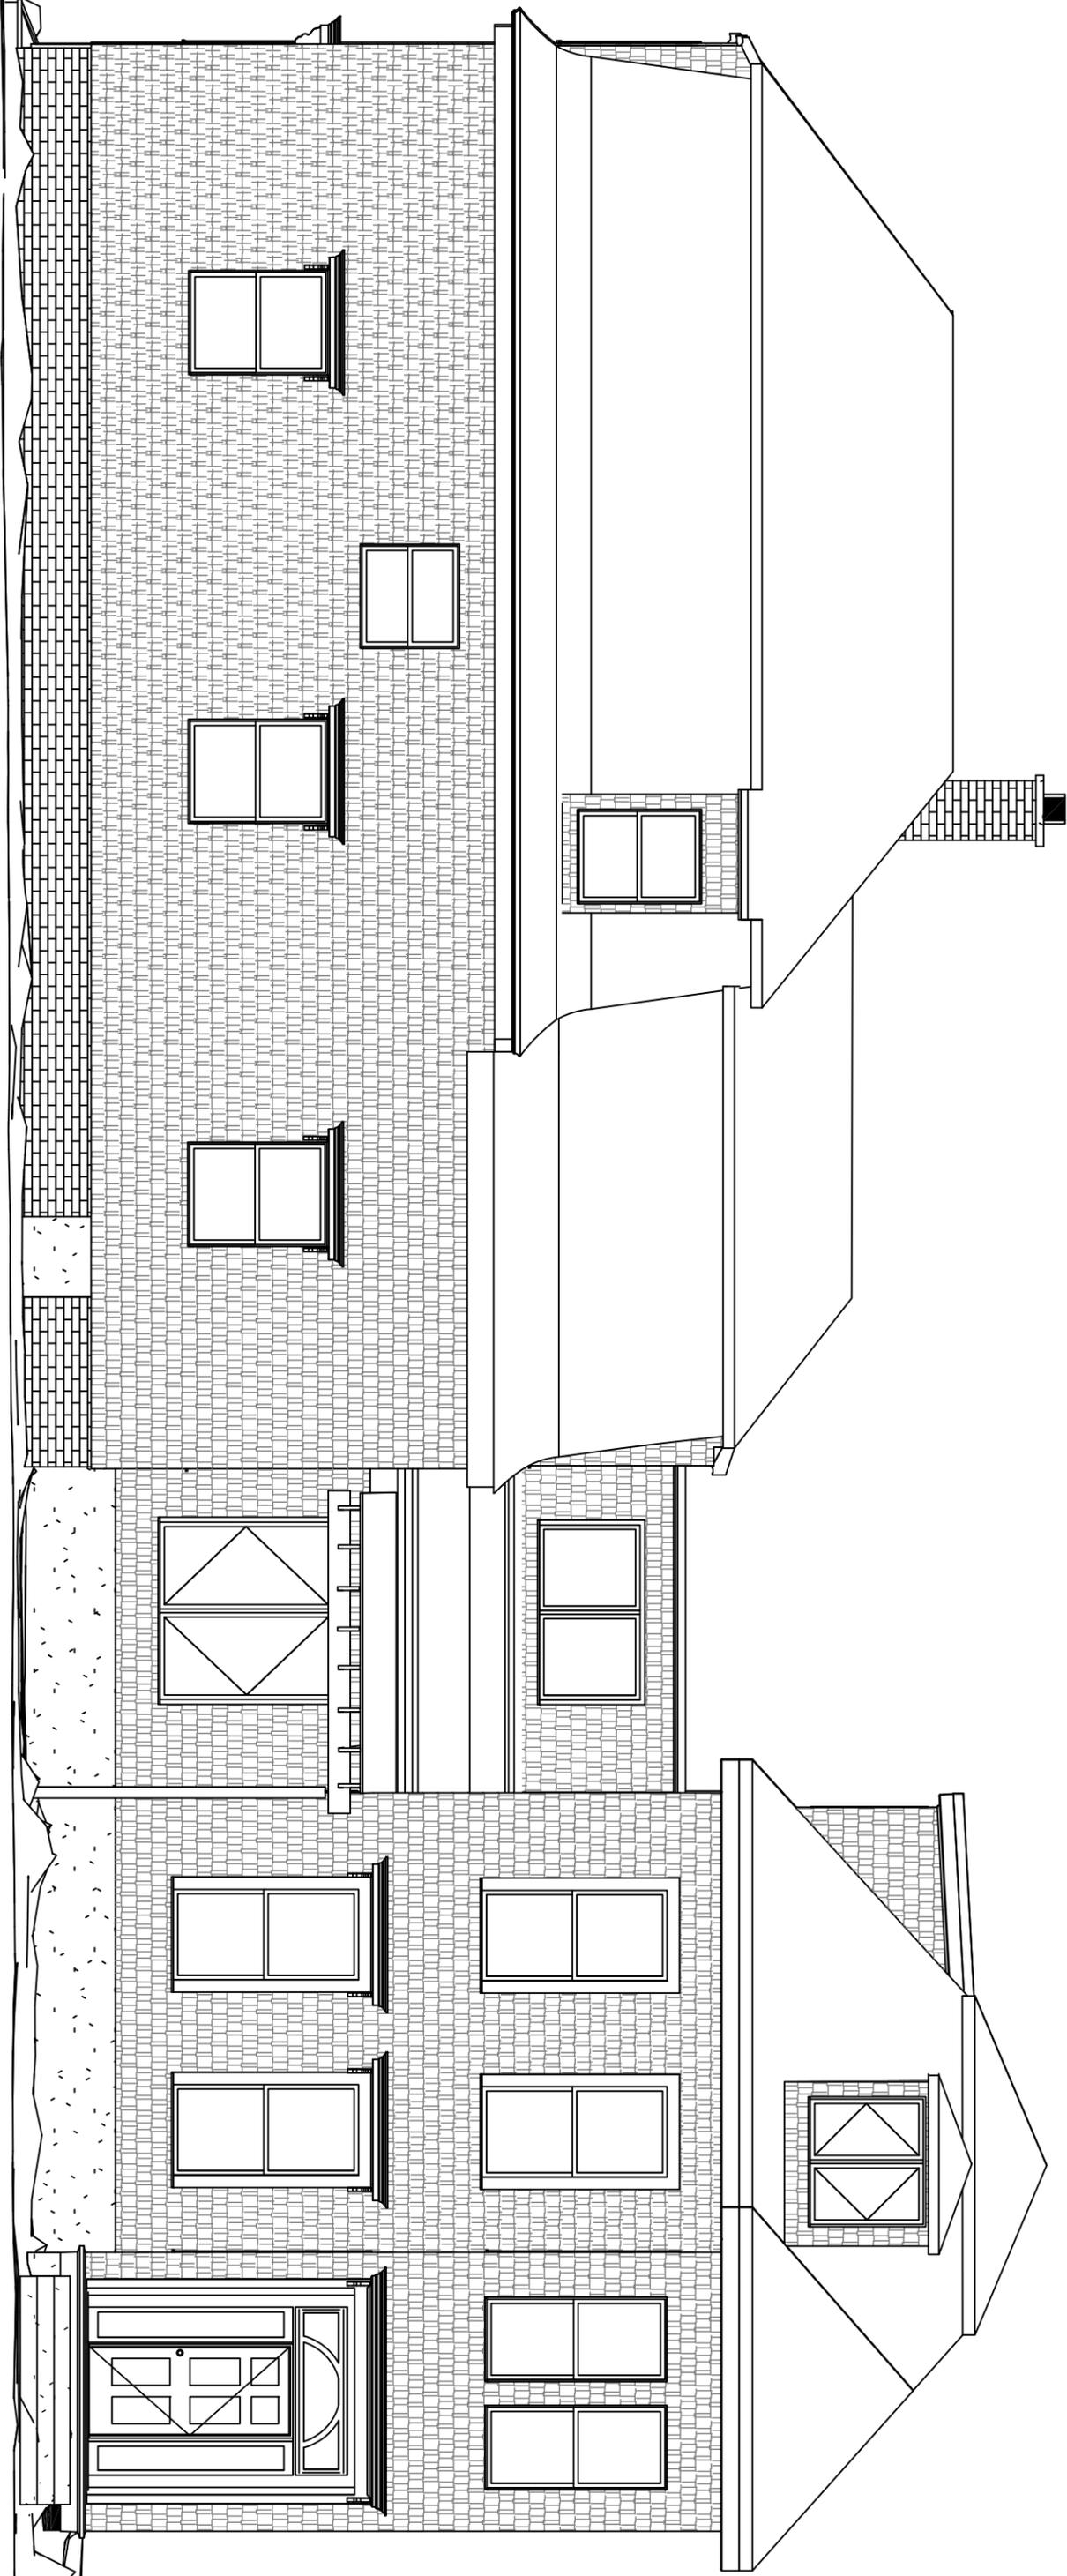
1494 CARLTON ST.
EXISTING
NORTH ELEVATION

EXISTING BRICK FOUNDATION

EXISTING SLATE-IRON-STONE FOUNDATION

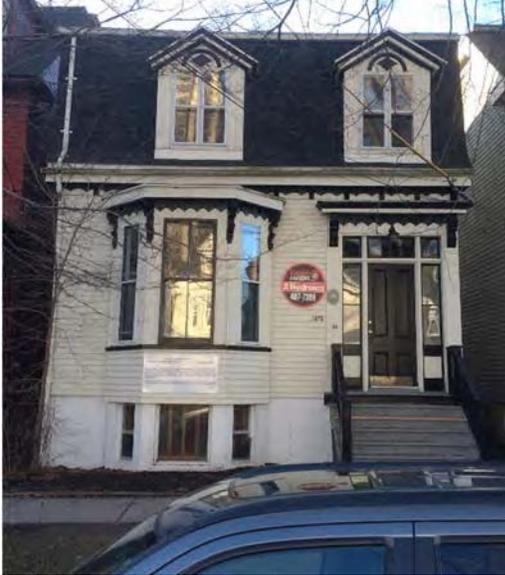
Victorian Streetscape: 1478 Carlton Street, Halifax (c. 1890)

- American Queen Anne / Second Empire design;
- Front lawn with sidewalk in close proximity to entry steps;
- One and a half and two storey wood framed structure;
- Side hall L-shaped plan;
- Asymmetrical two-bay street façade with bay window and entry door with
 - rectilinear transom and sidelights;
- Steep mansard roof with gabled dormers;
- Parged Ironstone foundation;
- Wood shingle siding;
- Two over two single hung windows;
- Decorative exterior trim at eaves, bay window, entry door and dormers;
- South-side chimney and fireplaces.

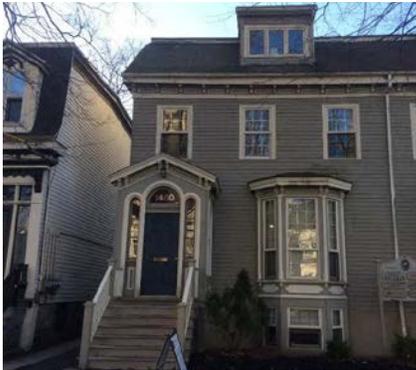
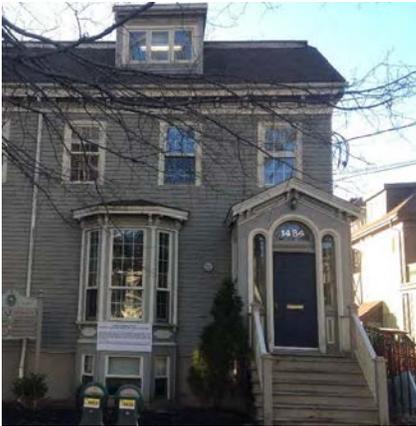
Victorian Streetscape: 1480 and 1484 Carlton Street, Halifax (c. 1860)

- Modified Halifax Style symmetrical duplex with late Victorian/Italianate detailing;
- Front lawn with sidewalk in close proximity to forward facing entry steps;
- Two and a half storey wood framed structure;
- Side hall plan;
- Three-bay street façades with lower bay window and gabled entry porch under
 - three second floor windows;
 - 39
- Truncated principal gable roof with simple shed dormers front and back level
 - with the low slope portion of the roof;
- Central back-to-back chimneys along the dividing line between duplex halves;
- Painted Ironstone foundation with brick at window openings;
- Wood shingle siding;
- Two over two single hung windows (where originals exist);
- Round-arched entry door transom and sidelights;
- Decorative exterior trim at eaves, bay window, entry door and windows.

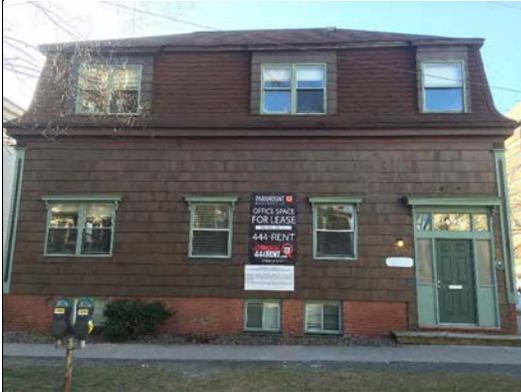
Victorian Streetscape: 1494 Carlton Street, Halifax (c. 1860)

- Second Empire design;
- Front lawn with sidewalk in close proximity to entry steps;
- One and a half storey wood framed structure;
- Side hall L-shaped plan;
- Asymmetrical three-bay principal street façade with double-arched windows
- (removed) and entry door with shallow-arched transom and sidelights (altered);
- Full Mansard roof with shallow shed dormers;
- Painted brick foundation to grade, on ironstone below grade;
- Wood shingle siding (altered);
- Two-over-two, single hung windows (altered);
- Decorative Second Empire / Italianate exterior trim at eaves, window, entry door and dormers (altered/removed);
- South chimney. (along original south wall)
