LAKE MAJOR DAM REPLACEMENT

New Dam Location & Layout

Lake Major Dam Replacement Project

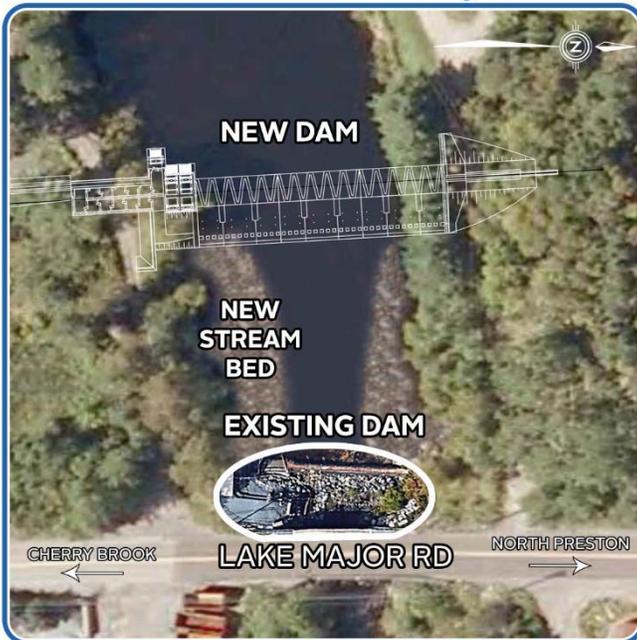
This image shows the new dam location in relation to Lake Major Road with fishway and a representation of how the new stream bed will look.

- A labyrinth spillway section to help mitigate flood risk;
- Monitoring and surveillance equipment for efficient operation;
- New "pool and weir" fish ladder (DFO approved) to support fish migration;
- Two sluice gates to provide environmental flows to support downstream aquatic life;
- Meets Nova Scotia Environment (NSE) requirements. Environmental Assessment approval was given on February 9, 2017;
- NSE project approval was given on May 28, 2018.

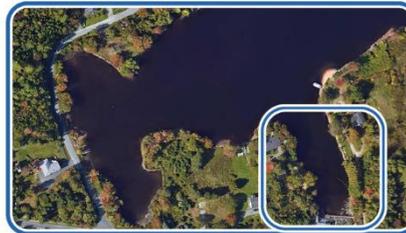
This image shows the area of Lake Major in the immediate vicinity of the project, and the existing dam in the bottom right corner, adjacent to the bridge.

The existing dam is a rock-filled timber crib structure and was built for a private milling operation in the late 1940's. Lake Major dam is reaching the end of its useful life and needs to be replaced.

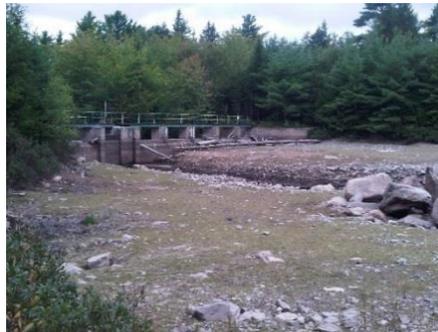
East Lake Dam 2018 Repair

In January 2018, Nova Scotia Environment approved repairs that were subsequently done to the East Lake Dam as part of the Lake Major Dam operating requirement. The mechanism to close the sluice gate of the East Lake Dam was bent, which prevented it from closing tightly. The water level of Lake Major was very high at the time and a significant rainfall was forecast.

The work plan was designed to fix the mechanism so the gate could be closed before the rain event occurred, in order to greatly reduce water flow into Lake Major, which would in turn put less stress on the Lake Major Dam.

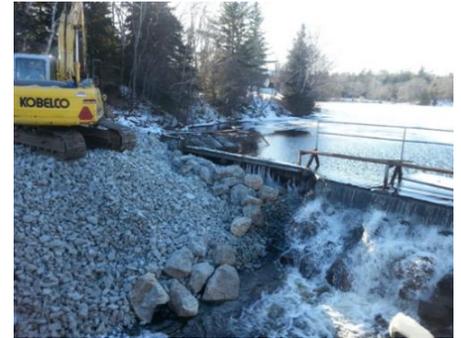
Lake Major Dam Fish Pump

A CanaVac fish pump purchased from a local manufacturer and installed in May 2016 was placed at the Lake Major Dam, to transfer fish from the Little Salmon River into Lake Major while the fish ladder is out of commission.

In the first seven months, the fish pump successfully transferred an estimated 40,000 fish including gaspereau, white suckers, trout and a few other species upstream over the dam. In 2016 and 2017, approximately 34,000 and 16,000 fish transfers were counted, respectively.

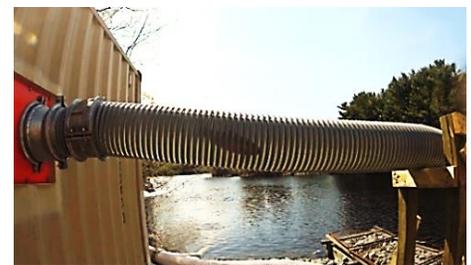
The project included design and installation of a stainless steel chute on the dam to aid in downstream migration of fish. Numbers of fish passing through the Little Salmon River into Lake Major had not been documented prior to this work. The fish pump will be utilized until a new dam with a permanent fish ladder is operational.
