Portland St and Eisener Blvd

MicroTraffic Video Diagnostic Findings and Recommendations

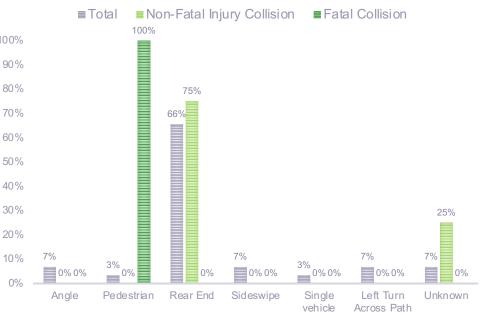
CONFIGURATION DISTRIBUTION OF COLLISIONS

- The provided collision data included 29 collision records from January 1, 2018 to April 100% 12, 2021. Of the 29 records, 14% (4) were 90% classified as non-fatal injury collisions, 3% (1) as a fatal collision, and 83% (24) as property 70% damage only collisions.
- The collisions were classified into the general descriptions shown in the adjacent figure based on the initial impact type and provided directional information.
