Draft Report

Halifax Forum Redevelopment 2901 Windsor Street Halifax, Nova Scotia

February 2018

Project Number 1701079

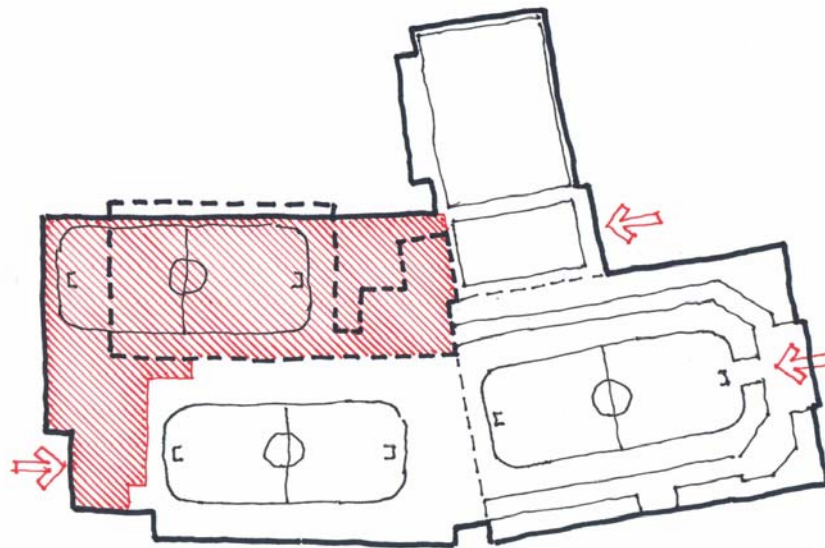
5.2.3 Renovated Complex Sketch

- The thick dashed line denotes the former building outline that is proposed to be demolished
- ////// The red hatch denotes the area of new construction
- ➡ The red arrows show the main entrances to the complex from the parking areas.

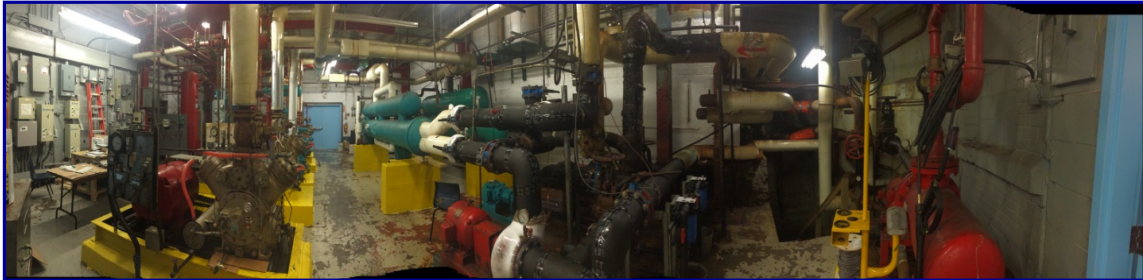
The system supporting the cooling capacity of the two existing ice pads is a plant located in the back of the ice resurfacer room of the Civic Centre. The below image is a panoramic view of this room.
