RE: A Traffic Impact Statement for a proposed Re-zoning of #1268 Cole Harbour Road

1.0 INTRODUCTION

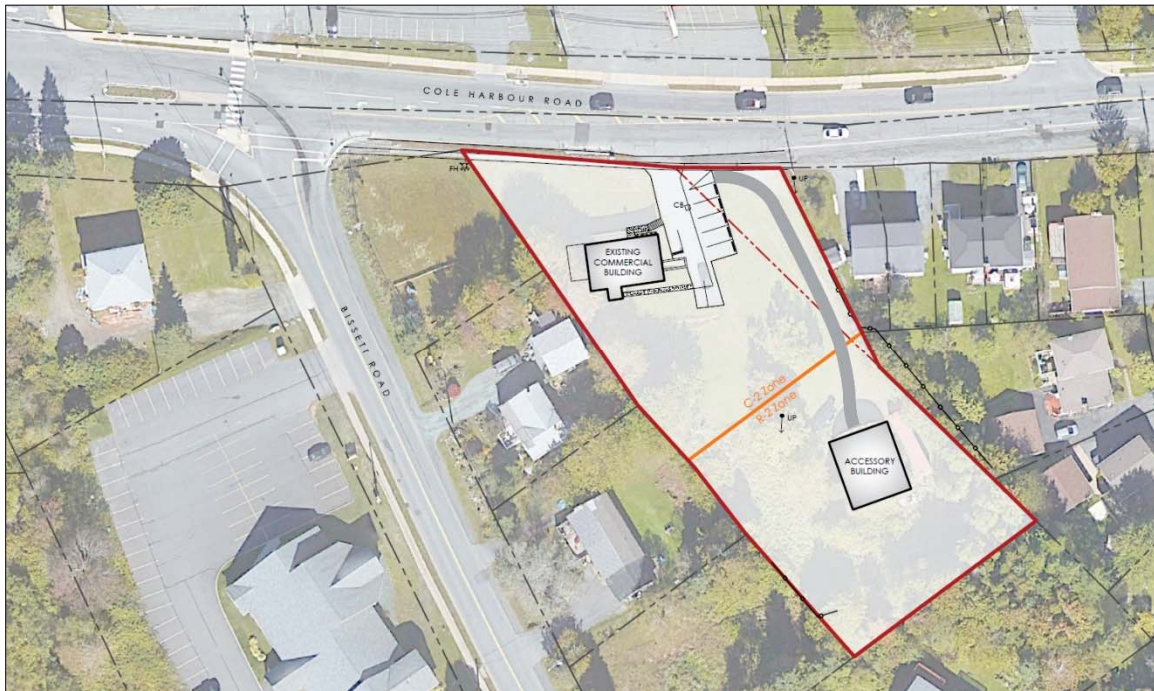
Figure 1: Study Area and Site Context

The site context is generally illustrated in *Figure 1*.
