**Item No. 15.1.1**  
**Halifax Regional Council**  
**December 3, 2019**

**SUBJECT:** Intersection of Beaver Bank Connector (Hwy 101 Access) & Old Sackville Road

Concept Sketches

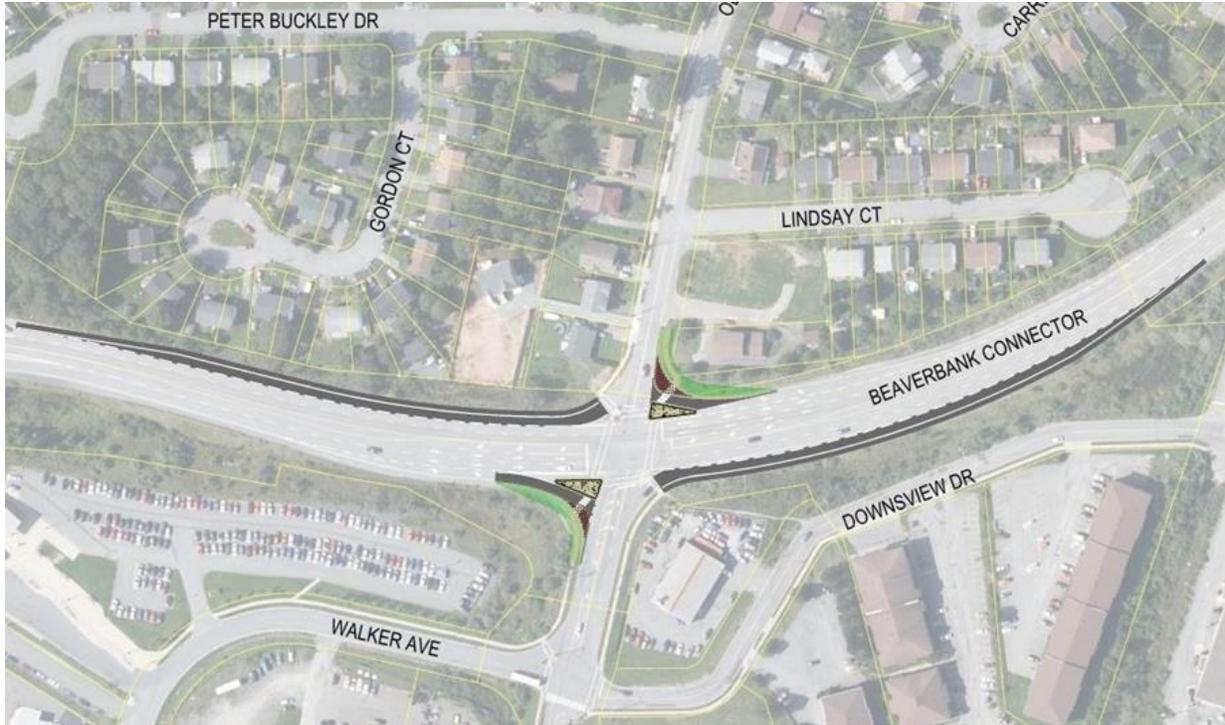
Concept Option 3 – Smart Right-Turn Channels & Acceleration Lanes

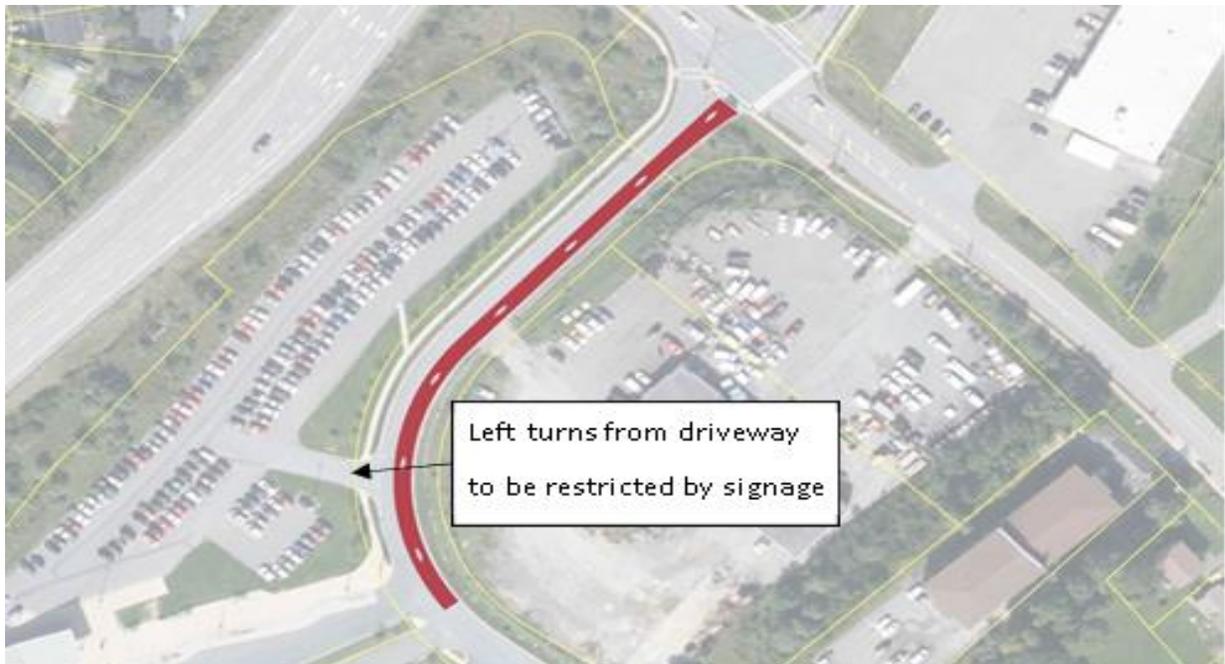
Concept Option 6 – Convert Walker Avenue to One-Way + Provide Dedicated Transit Lane

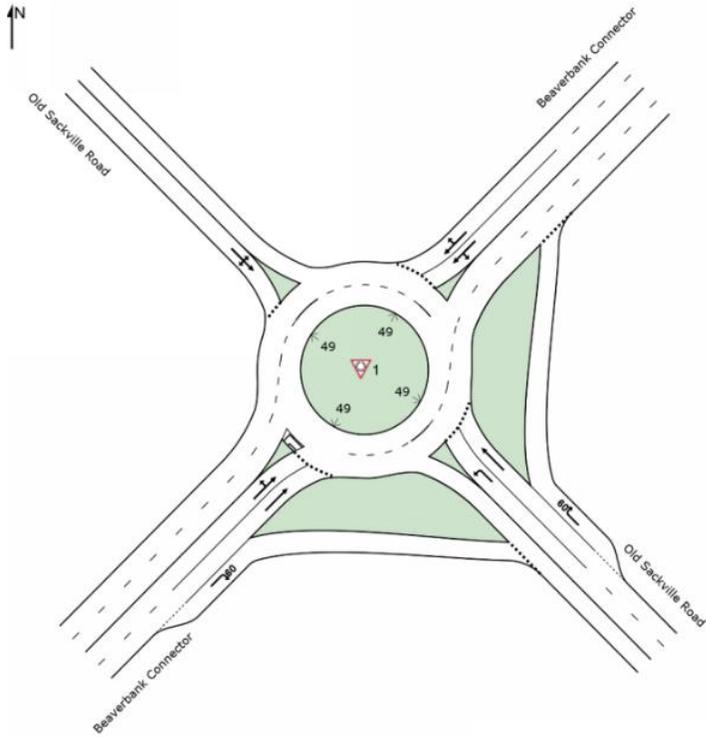
Concept Option 7 – Roundabout

Option A – Eastbound Shared Lane

The final improvement option put forward by the consultant involves converting the existing signalized intersection into a roundabout. Although roundabouts tend to result in less severe collisions as compared to signalized intersections because of lower vehicle operating speeds and reduction of head-on and right-angle type collisions, existing topography at this location does not lend itself to implementation of a roundabout. A roundabout at this location would have grades significantly outside recommended guidelines and would result in a higher than normal frequency of rear-end collisions to be expected. Also, a roundabout at this location would not address the operational issues at the Old Sackville Road / Walker Avenue / Downsview Drive intersection and could lead to increased queue spill-back due to the short distance between the two intersections (which would decrease with construction of a roundabout). **Significant right of way requirements, unacceptable approach grades, high capital costs and limited benefit associated with this option would make this a non-viable option and it should not be pursued.** A sketch of this concept, providing the lane configuration for two of the most probable layouts, is included in Attachment 2.

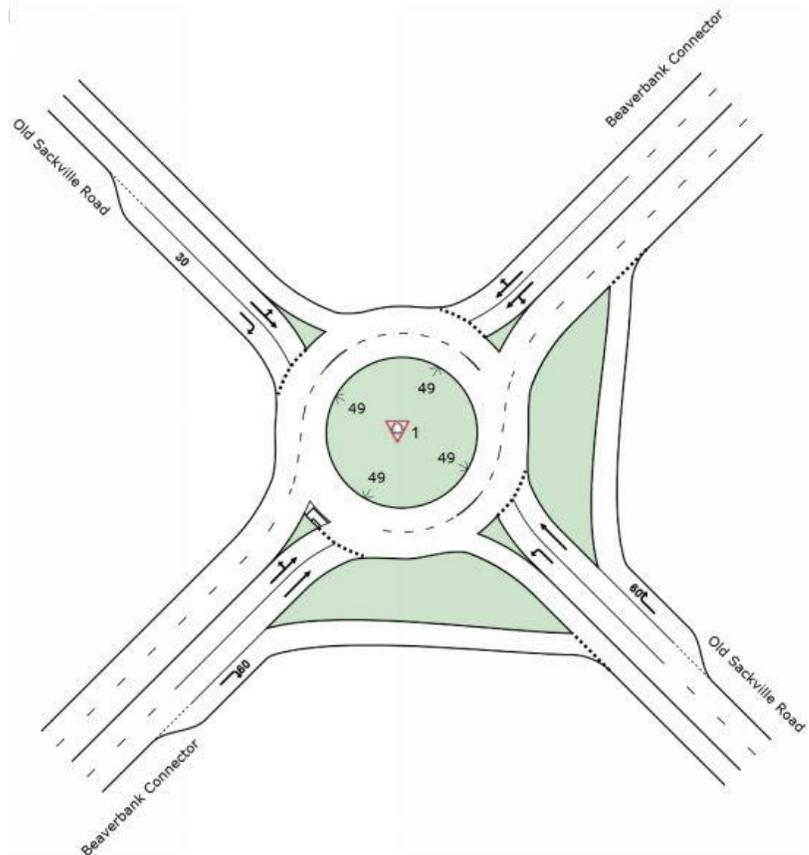
Option B – Eastbound Right-Turn Lane
