Heritage Impact Statement

2539 Agricola St

CLIENTS
Bruno Ruffinengo, Karen Schnare
and Grant Ruffinengo

Prepared by
EcoGreen Homes
2159 GOTTINGEN STREET
HALIFAX, NS B3K 3B5
902-412-2329
info@ecogreenhomes.ca

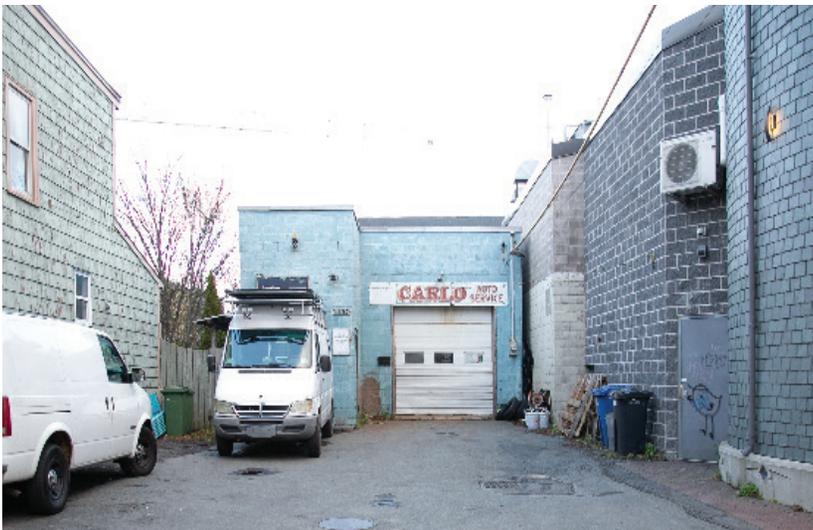
Fig. 2 Showing 2537 Agricola St, “Carlos Auto”

The site contains two PIDs with two buildings, 2539 Agricola St, a recently registered Heritage building “The Open Mic House” and 2537 Agricola St, “Carlo Auto” shown below in figure 2. Built in the 1980s, Carlo Auto is a one-story masonry unit building built as an automotive garage with little historical or architectural value. As such its conservation is not being considered for this project. It is an example of older small-scale North End Halifax industrial uses that are now making way for the increase of residential density in this area of the city. Both properties exist in a COR commercial zone designation. (Fig 3.)

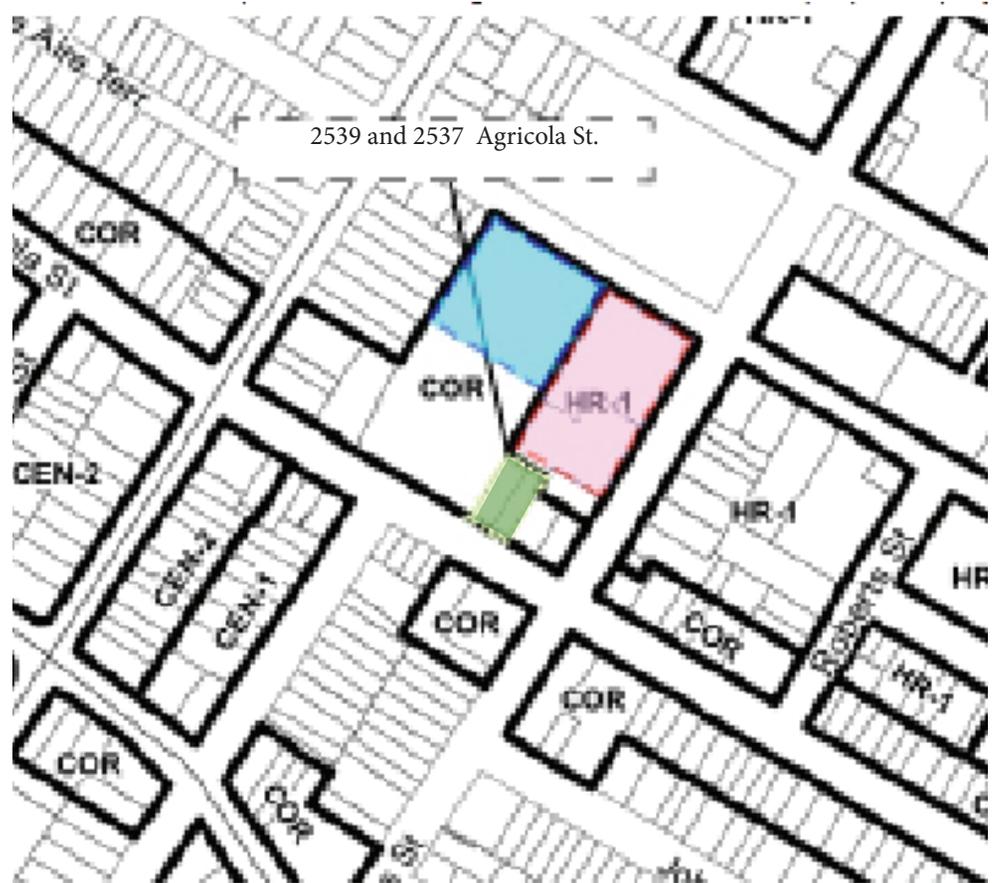
Fig. 3 Existing apartments behind shown in pink. New development of Maynard Lofts shown in blue, Site shown in green.

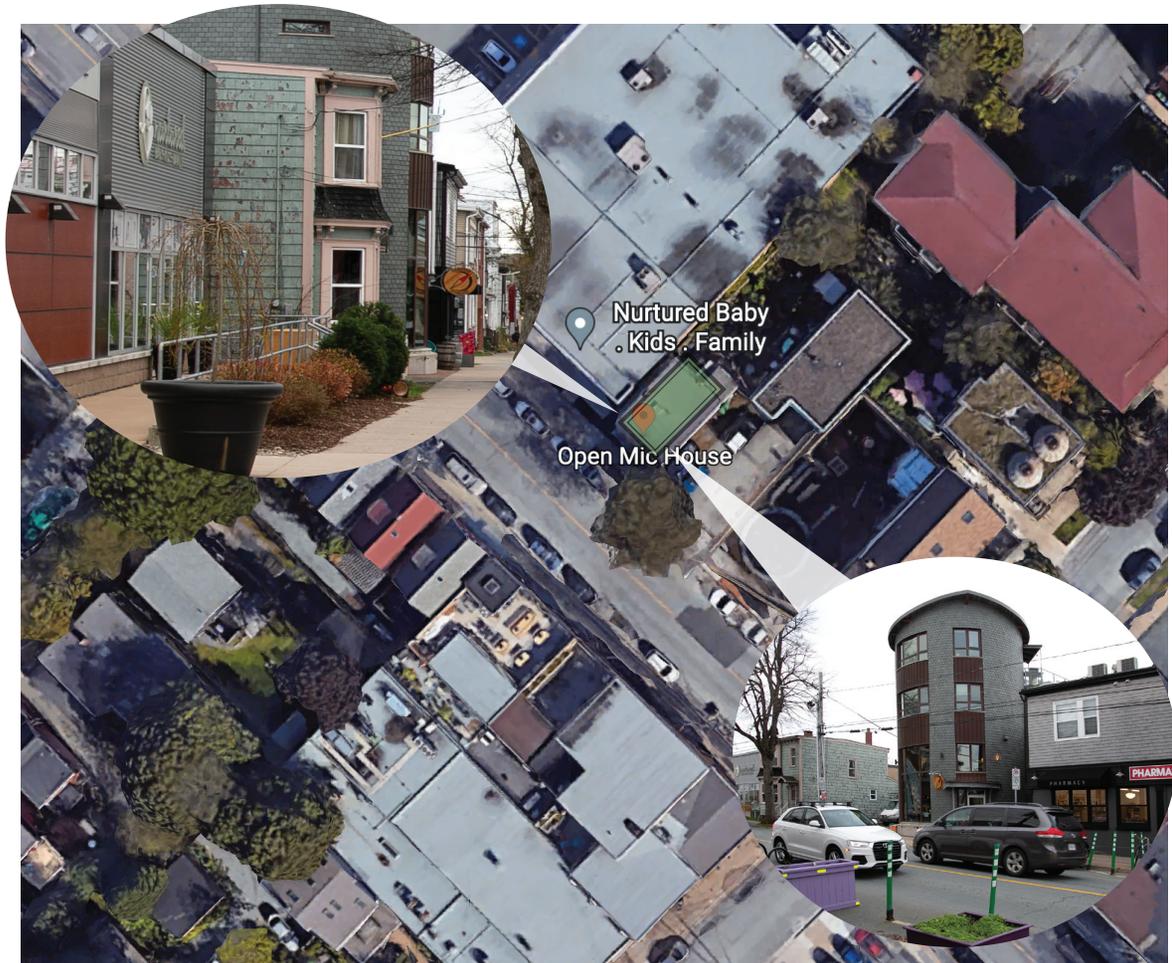
Fig. 5 Showing “Open Mic House”, in relation to adjacent buildings. notice that the NW side of the house is hidden by Nurture store.

2539 Agricola Street is an example of what is known locally as a “Halifax Box”. When comparing the 1914 map to another from 1878, it appears another Box to the north of 2539 was constructed around the same time and featured a similar outline. However it was previously demolished and is now the home of the NSLC, Cycle Smith and Nurtured. It is interesting to note the NSLC building is only one meter away, and hides most of the north side of 2539 as shown in the photo to the right (Fig. 5)

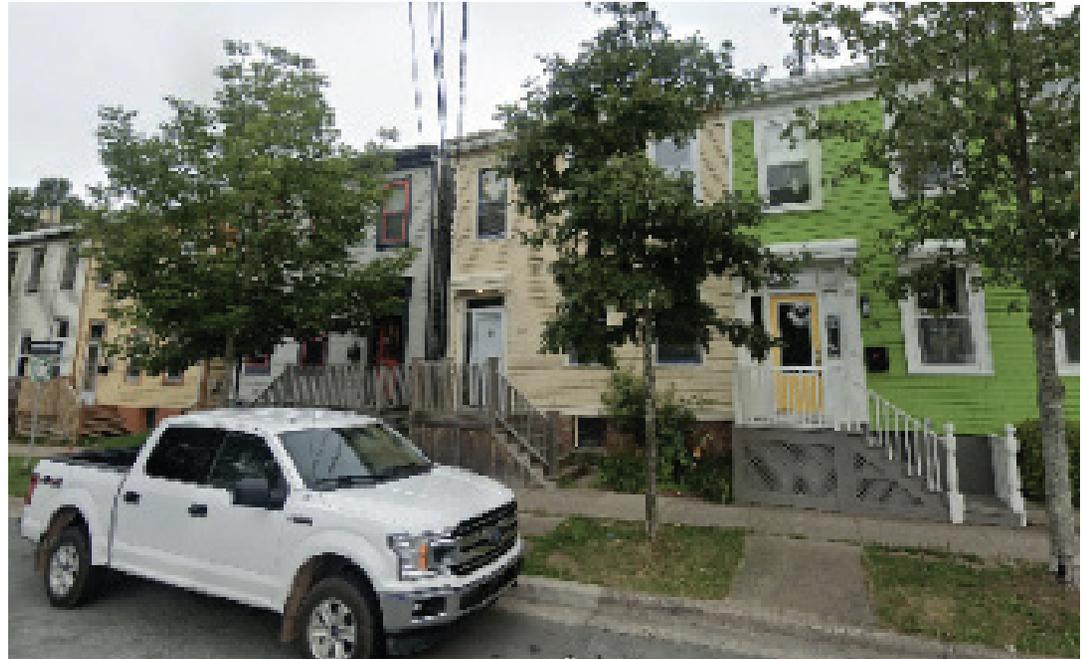
Fig. 7 Showing. 5795(gray), 5797 (yellow) and, 5799 (green) Charles St where only the front portion of this houses are visible

5799 is detached while 5797 and 5799 are duplexes where only the front façade is visible (See Fig. 7) .

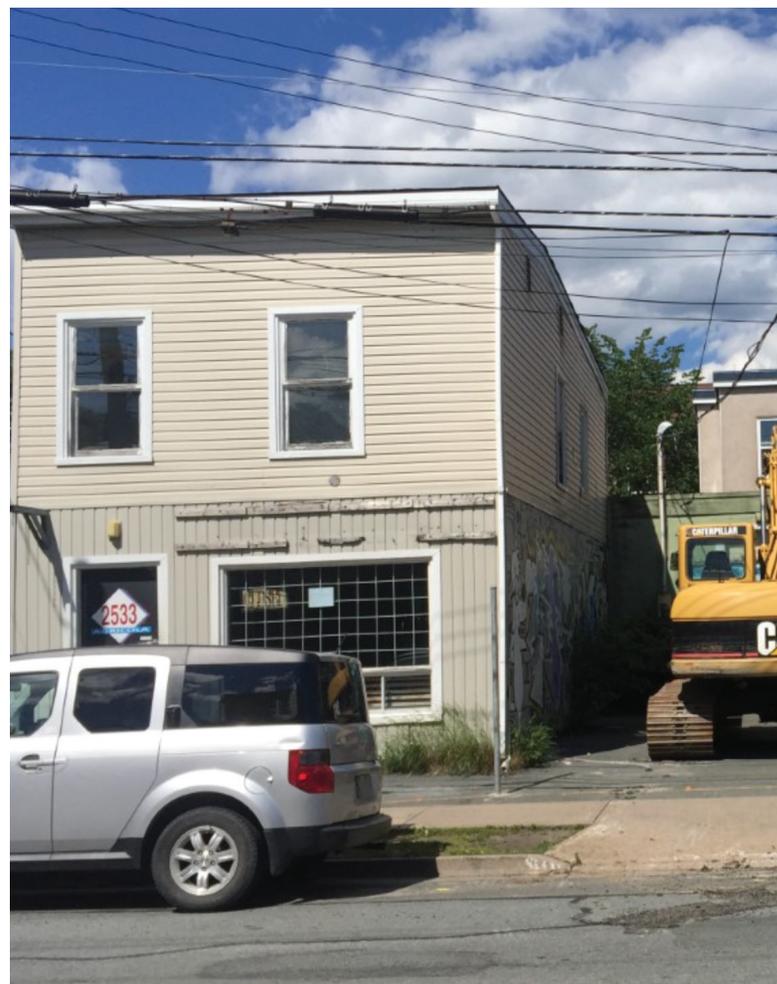
Fig. 8 Former Halifax box at 2533 Agricola St “Nauss Bicycle” demolished to build Compass Pag.9

Next door at 2533 Agricola, there existed another similar Halifax Box, home to Nauss bicycle until 2017(Fig. 8). This box was much plainer as one can see in the attached photos. It was in very bad repair after many alterations during the course of its industrial use. 2539 however is mostly original and retains its heritage details.

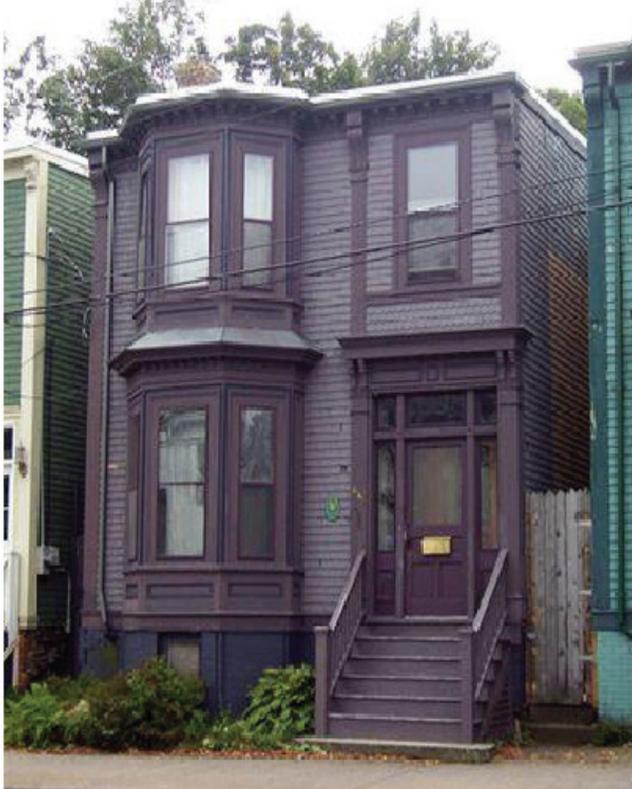
Fig. 11 Showing a remaining example of Halifax Box 2548 Gottingen St.

Examining local neighborhood examples of the Halifax Box can help illuminate the defining elements of 2539 Agricola. 5516 North St and 2548 Gottingen St. are both registered historic properties designed by Halifax architect Henry Frederick Busch. (Figures 11-12) Like 2539 Agricola St, these houses are styled in the Halifax Box derivative of Late Plain Victorian architecture, with similar front facades featuring an asymmetrical bay window and wood trim details. Both are clad with wood shingles, with no detailing except on the front façade. Please note again that only the front facade and a small portion of the sides are visible from the street. 2539 is a more modest example from this era and perhaps somewhat narrower.

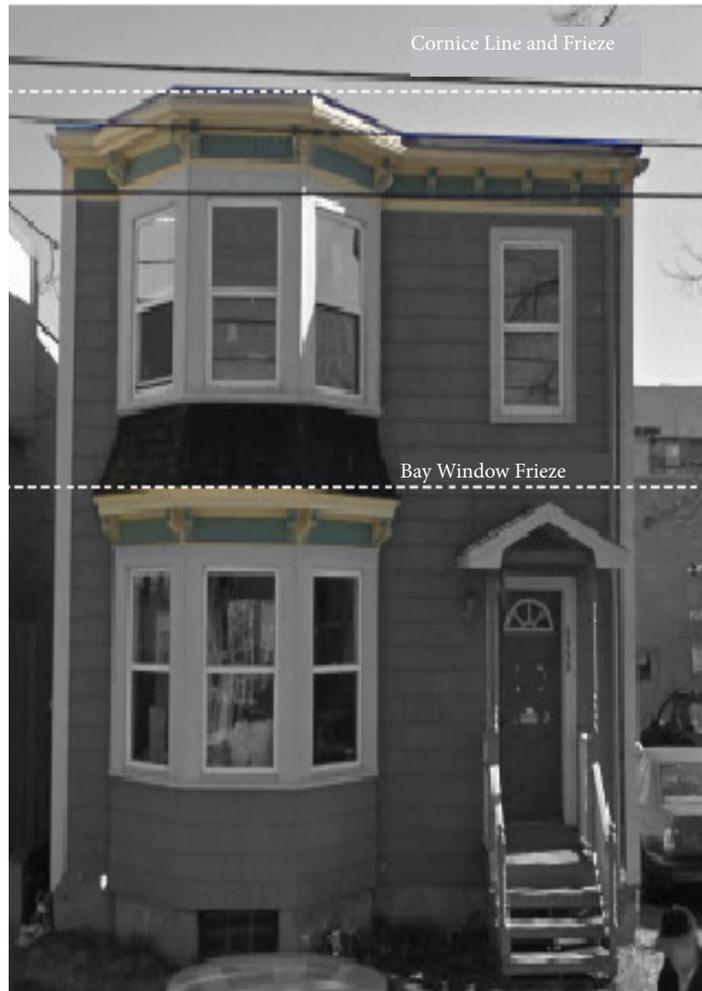
Fig. 13 Horizontal elements showing characteristics of the Halifax Box style. The frieze features ornamental cornice brackets to accentuate the roof lines.

The following figures 13 and 14 show the front facade of the 2539 Open Mic House vertical and horizontal elements outlined for clarity. These elements were used to help shape and proportion the design of the new building as Conservation Standard 11 dictates.

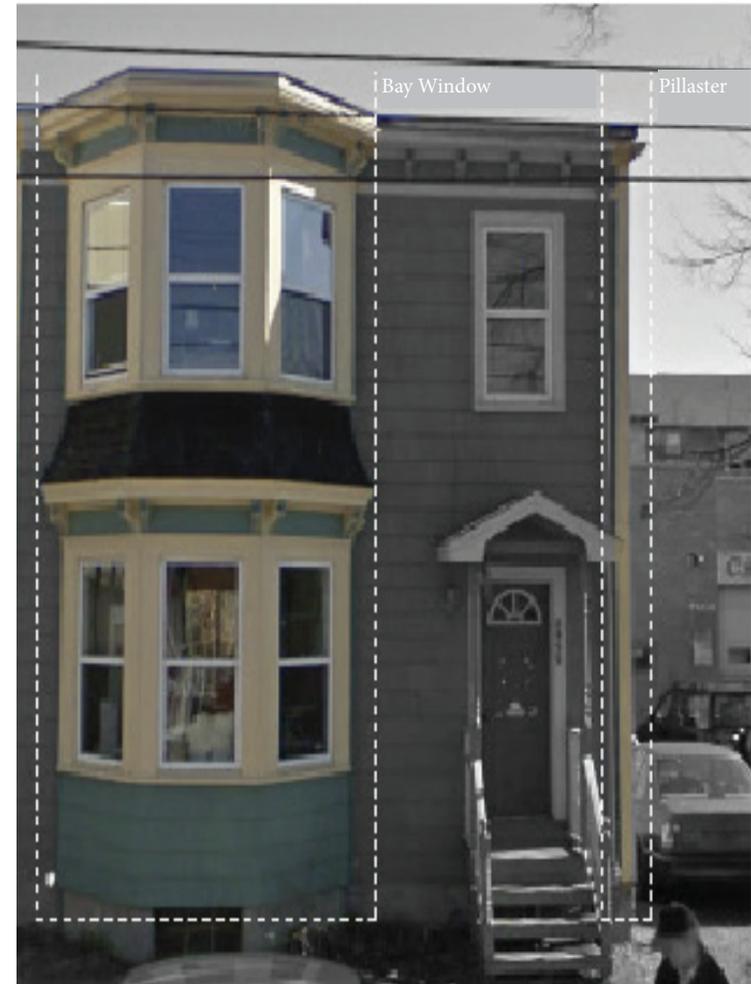
Fig. 14 Vertical Elements Showing characteristics of the Halifax Box style.

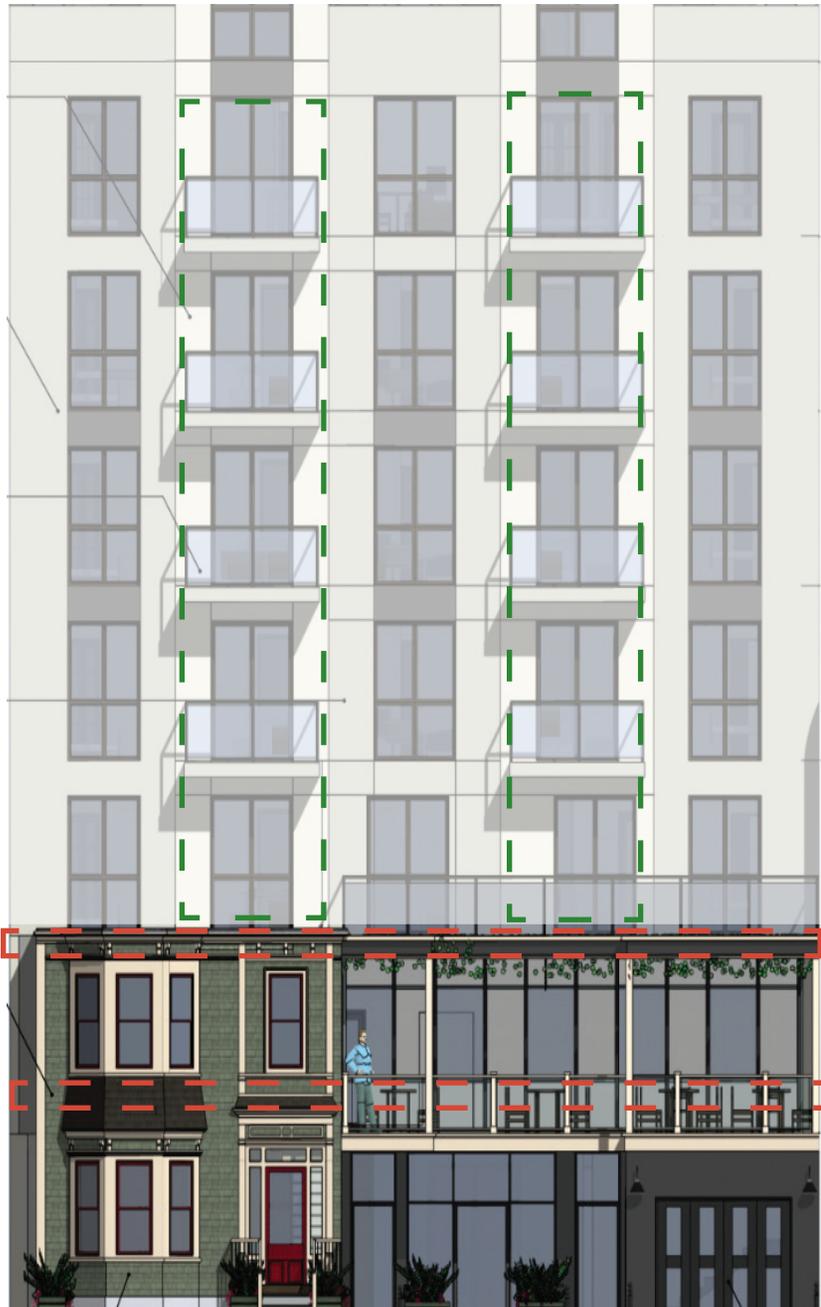
Proposed elevation with the heritage house in front of the new building. The dotted lines show the vertical and horizontal extensions of the proportion found in the Open Mic House. New parking garage entrance to right has period style doors.

Fig. 15 Vertical and Horizontal Elements characteristics of the Halifax Box style extended in new facade

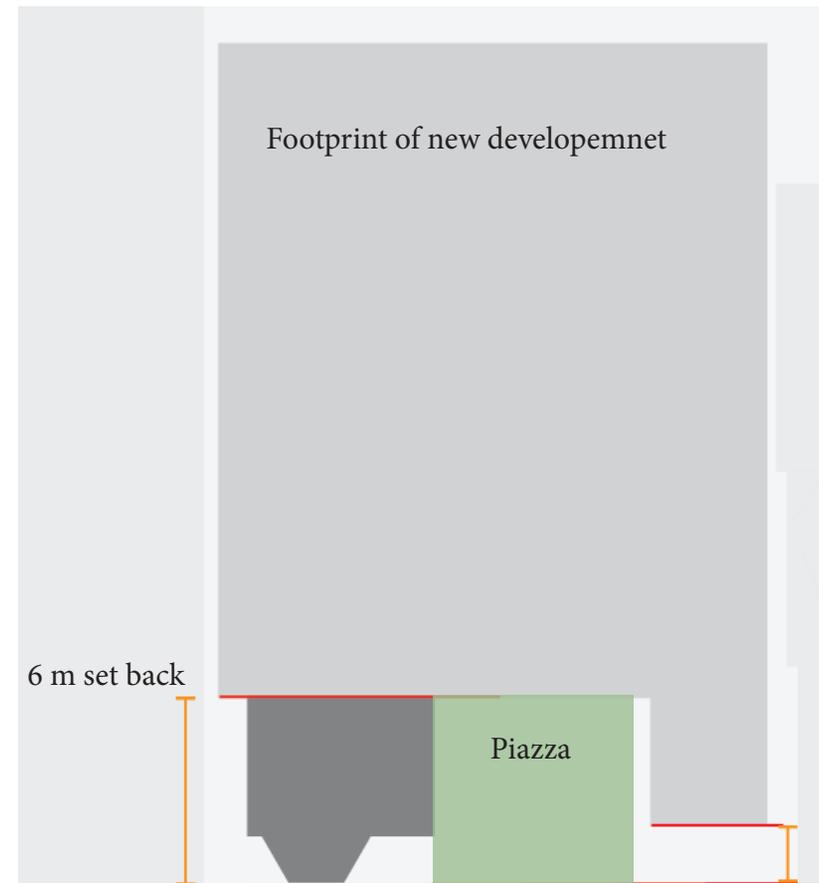
Fig. 16 Showing 6 meters setback, Open Mic House, and piazza in green.

Creating the piazza and also the ensuing setback of the development by retaining the majority portion of the Open Mic house contributes to the spaciousness of the public right of way; as such they are public benefits. Retaining the majority of the heritage house is in line with the intention of HRM heritage planning. The build-able footprint of the new mixed used building will be significantly reduced by both retaining the majority of the “Open Mic House” and the creation of the piazza. This is the rationale for the request for additional reasonable height for the new development. (Fig. 16)

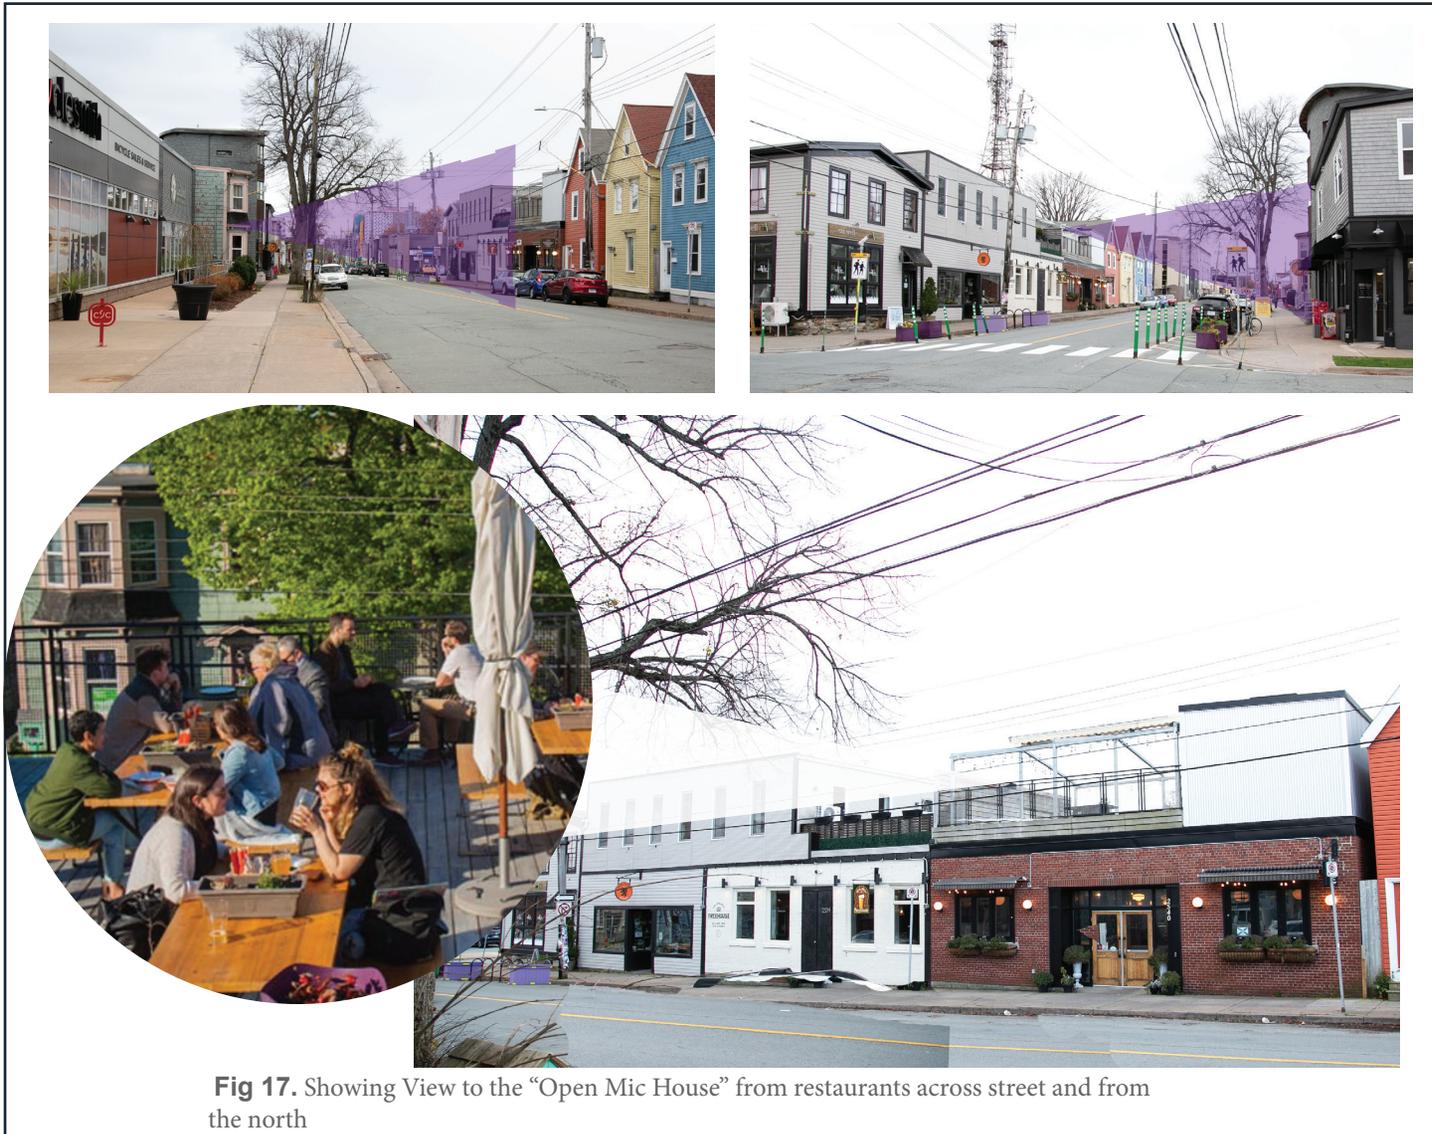
Fig 17. Showing View to the “Open Mic House” from restaurants across street and from the north

These diagrams attempt to show the indirect benefits for surrounding businesses. Patrons from the restaurants and bars across the street will be better able to both see and hear the musical events to be staged on the new balcony. Patrons enjoying the view and sounds of musical events in warmer weather will have the feeling that the street forms an “integrated whole” even though the musicians are across Agri-cola. Our street study showed us the new balcony adjacent to the new side doors is the best location for the stage area and will provide excellent sight lines for this whole block.(Fig. 17)

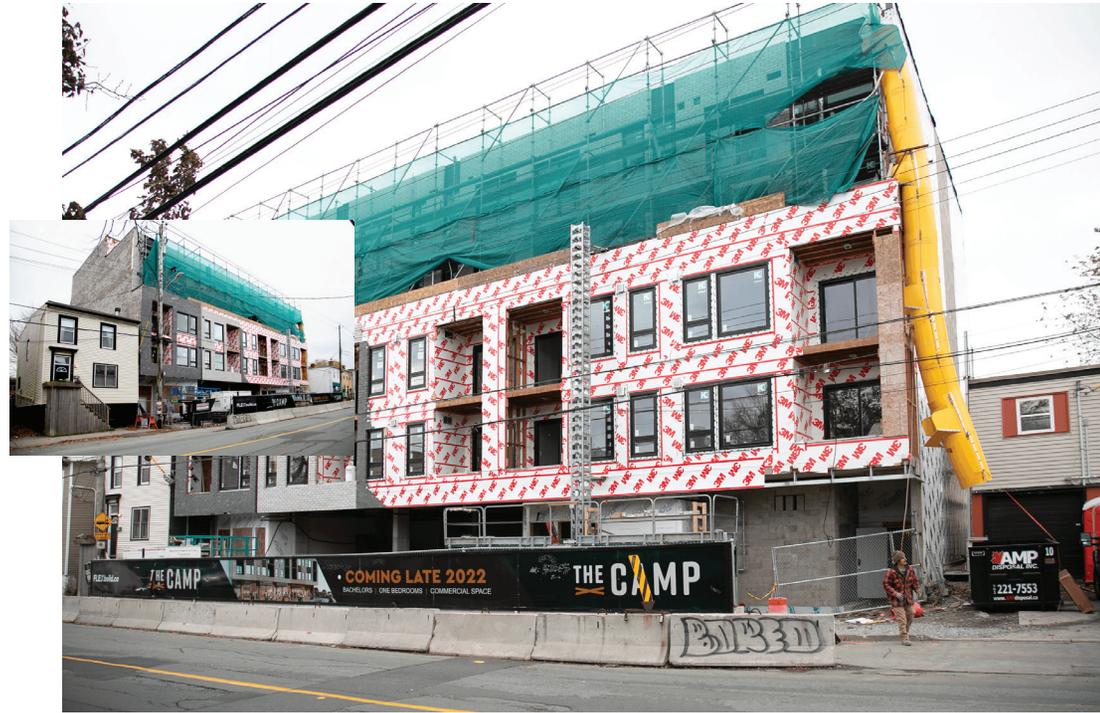
Fig 18. Photo of current development at 2440 Agricola St

The setback proposed of the new main building is more than six meters. Given the size of these two lots and the width of Agricola Street, this is very significant. The setback will create spaciousness for the Agricola street-scape. This is inviting for the public and thus aligned with HRM planning objectives. The typical setback under current bylaws defines the street-wall at the curb and is thus more imposing. One can experience this by standing in front of the new development at 2440 Agricola St, as one example. Simply put, current as of right developments do not create the same degree of spaciousness for the street scape. (See Fig. 18)

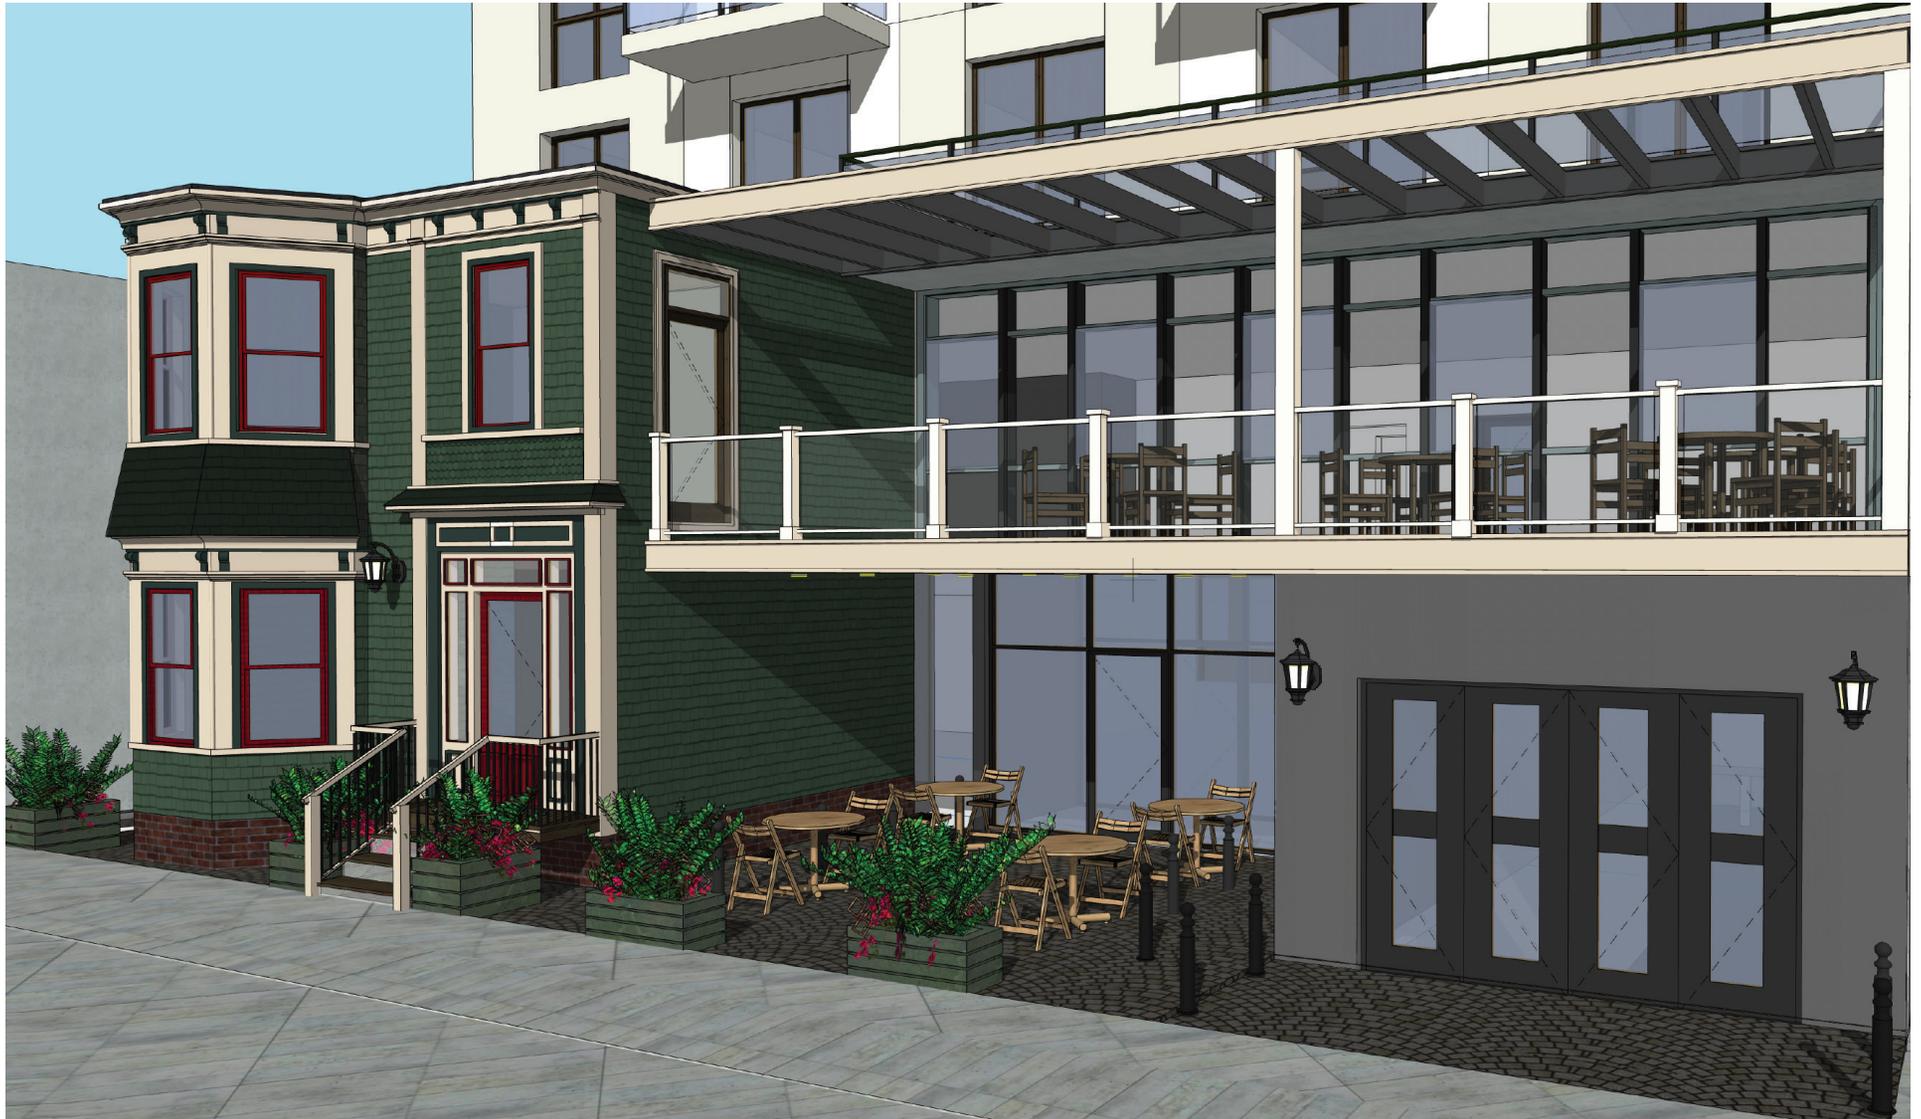
Fig 19. “The Open Mic House” with new side door opening to the balcony stage and seating area and the piazza below. Note the “Box Form” is easily visible.

Standard 5 states” find a use for an historic place that requires minimal intervention.” The addition of a door opening on the side of the heritage house will allow the second floor balcony to become the new “stage” for musical events. As no significant historical features are found on the side, it is a good example of minimal intervention while creating a new use. This preserves the current cultural use and also enhances visitors experience meeting HRM MPS objectives. Patrons across the street who already stay to drink and eat during the musical evenings will have much better sight lines and acoustic experience as the performances will occur on the “stage balcony”. The following page shows the side door opening to the adjacent new balcony (Fig 19).

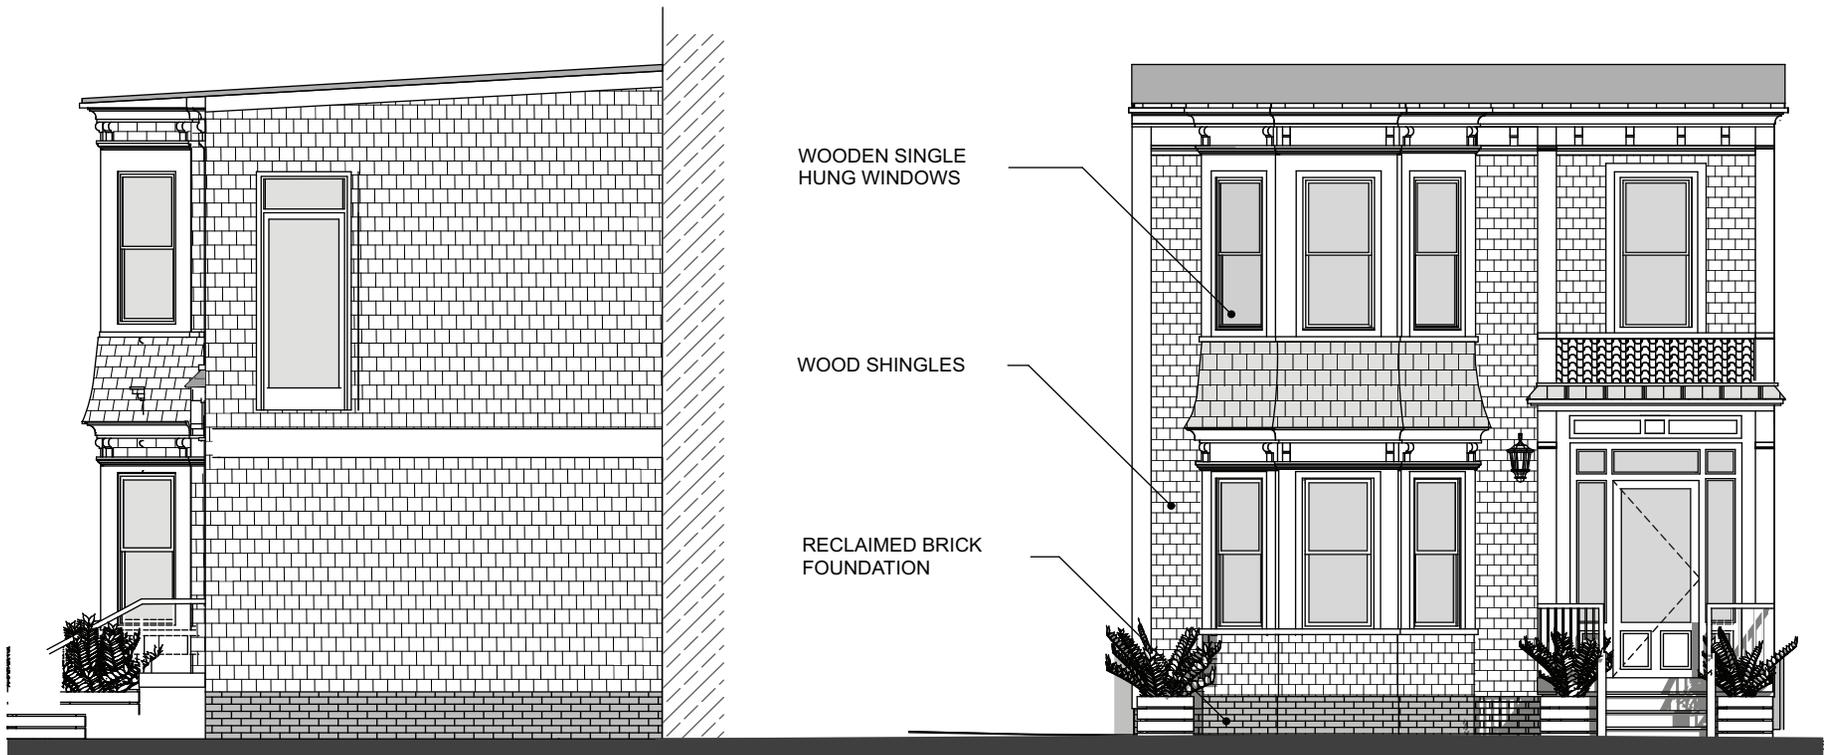
Fig. 20 Shows elevations of the proposed retained Heritage House

As the last remaining Halifax Box on this short block of Agricola Street, it is important from a heritage perspective to preserve and restore the house's key heritage features. The majority of the 2539 "box form" of the existing structure is proposed to be retained and restored including all of the heritage defining features found at the front of this building. We will be able to retain 54% of the front portion and still have room behind for the new building development. This adheres to many of the Standards of the Conservation Standards and Guidelines as it preserves all of the character defining elements of the heritage house. All of the wooden details on the house's front façade are largely intact but damaged or rotten. It will be possible to recreate and restore them as original. The conservation efforts will also comply with Standard 3. All the restoration will be documented.

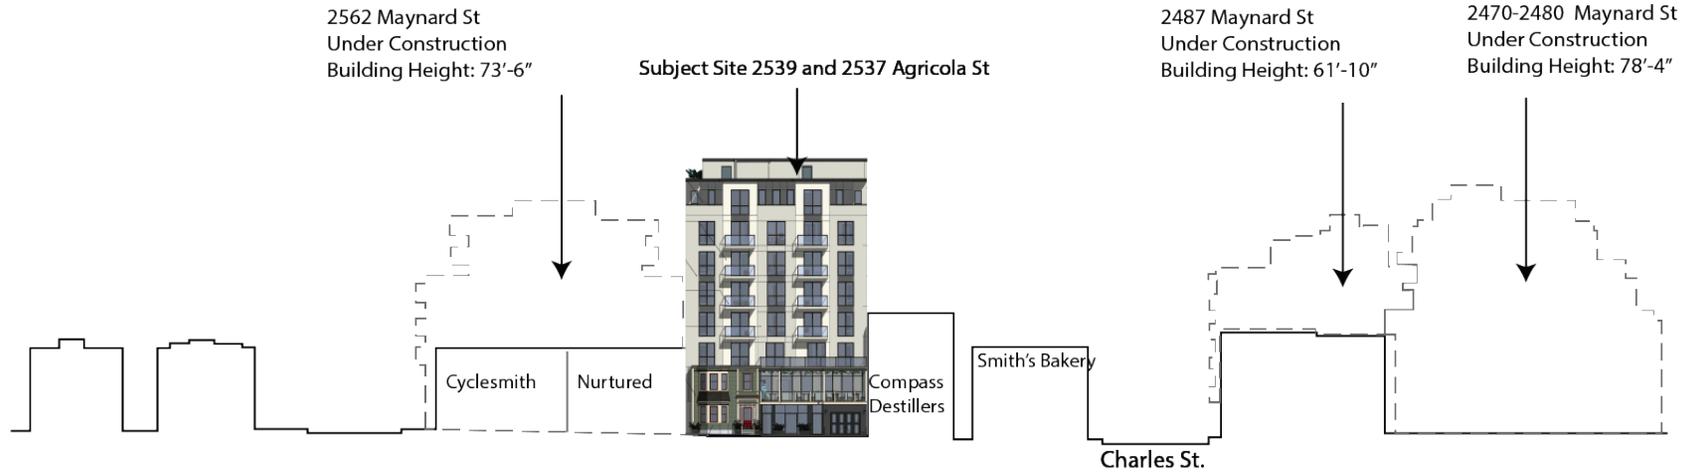
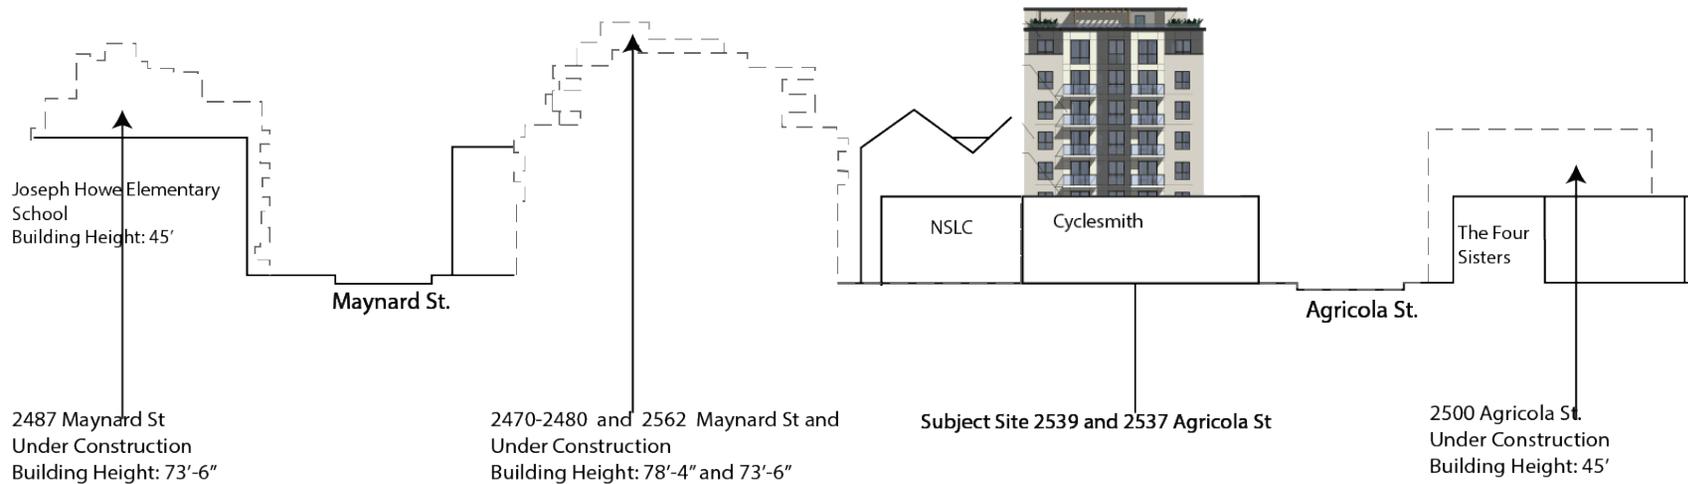
Fig 23. Showing Current Construction adjacent to 2539 Agricola Street

There are currently many new developments being constructed all around this site. The neighboring heights are similar as shown in the following two figures 23 and 24:

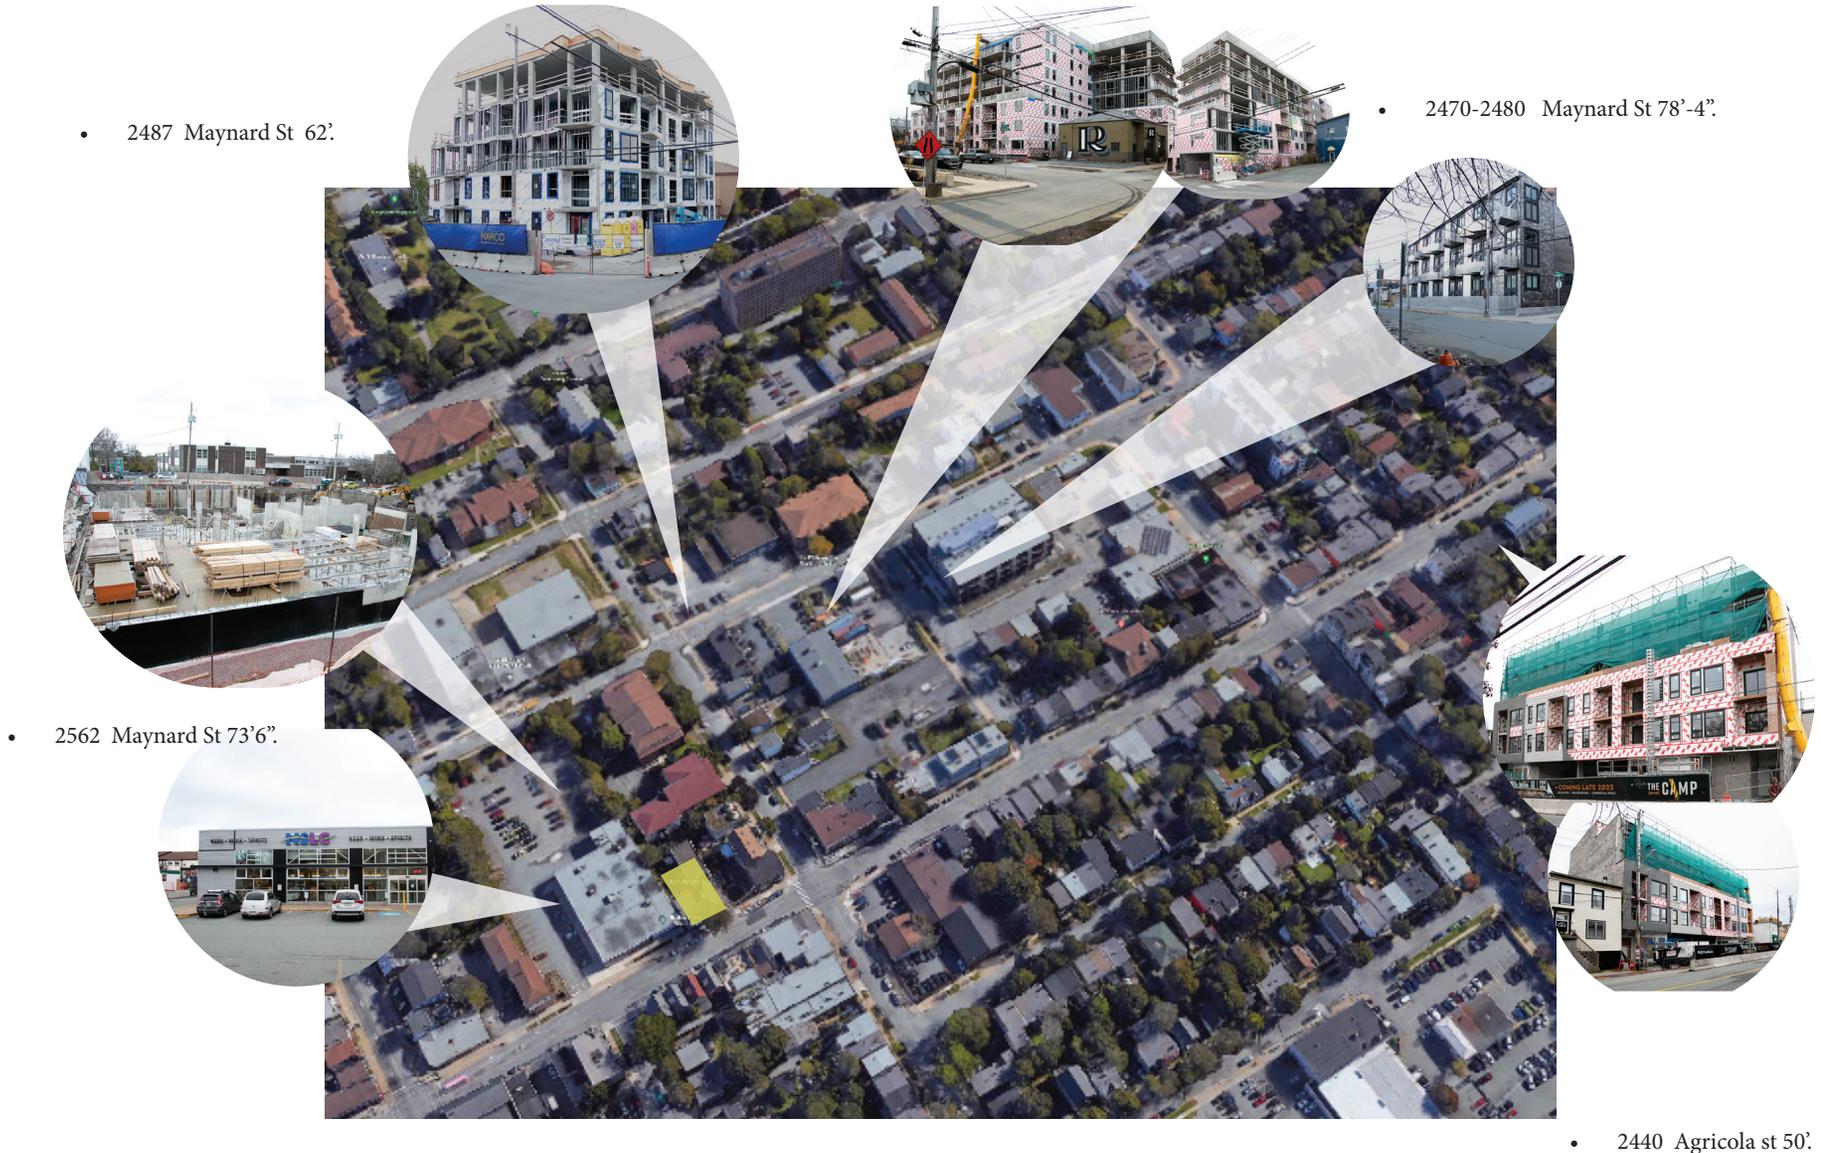
As one can see in the following image which shows the context of buildings under construction, the height proposed for the main building is of a reasonably similar scale. Further down on Robie and on Almon Streets, the new buildings are significantly higher.

Fig. 24 The image above shows current developments in progress in relation to site

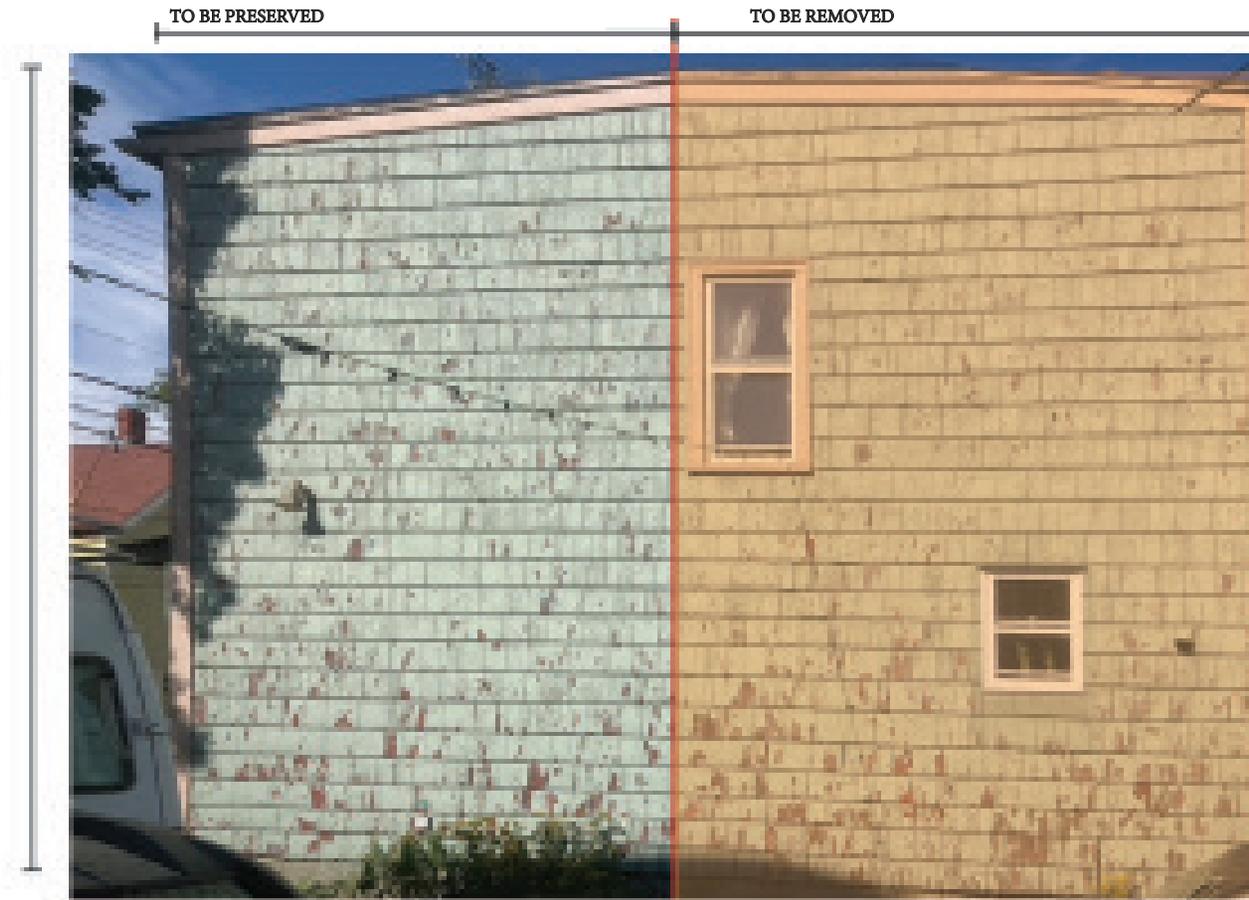
As the sides of the Halifax box form were normally never visible, keeping the majority of the house and restoring the front retains all key Heritage Defining Features. The joist structure of the house as drawn on page 27 makes the proposed removal fairly simple. As stated, the alternative to this would have been the complete demolition to make room for a conventional development.

Fig 25. Showing approximate retained and removed portions of the house

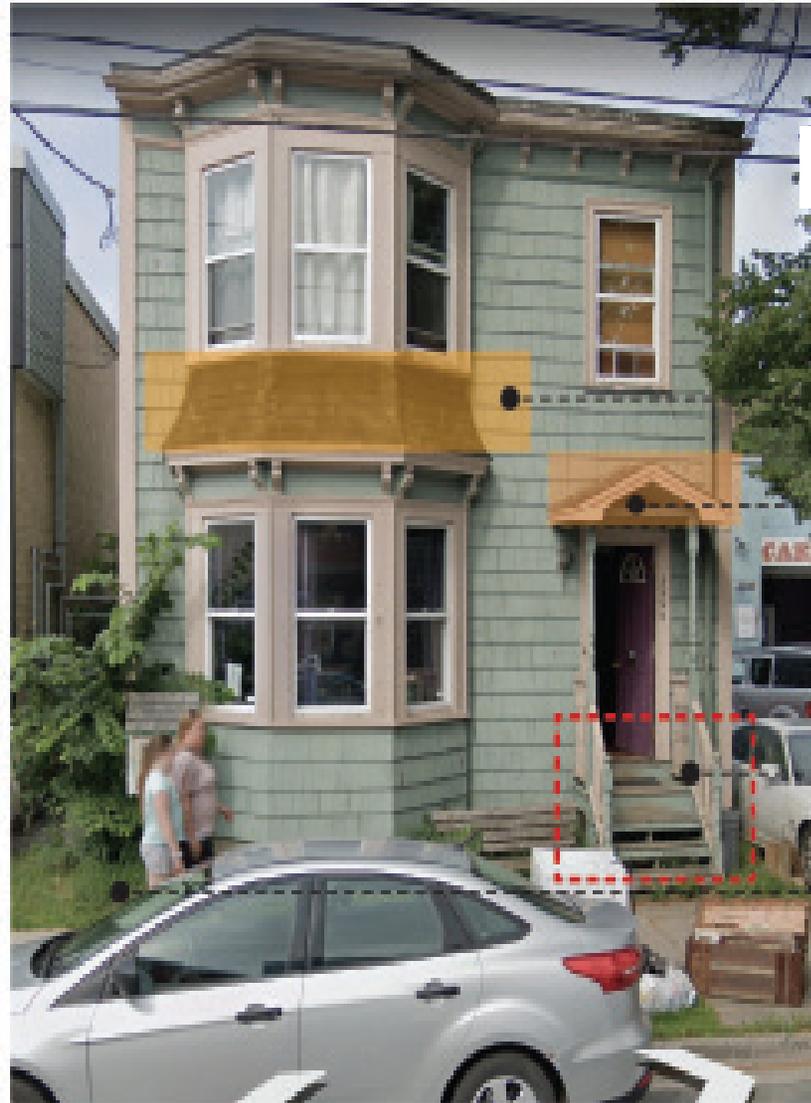
DETAIL MODIFICATIONS TO WEST FACADE.

ASPHALT SHINGLES TO BE REMOVED.

PORCH ROOF TO BE REMOVED
- NOT PART OF ORIGINAL BUILDING.

STEPS TO BE REBUILT.

UNSOOUND FOUNDATION TO BE REMOVED
THROUGHOUT BUILDING.

Fig 26. Showing Heritage Character Defining elements for restoration.

As noted earlier, the characteristic heritage details are found on the front facade. Fortunately, all the trim, corbels and fascia are intact, however many are rotten. All can therefore be restored to original condition either by scraping, sanding and repainting as needed, or by recreating new pieces as original. A new period piece front door, with transom lite and transom will be installed, with new surrounding period trim as shown on our renderings. Sidelights will also be installed providing the structure will allow that space. The asphalt shingles of the bump will be removed and replaced with new painted cedar shingles matching the siding which will also be redone as discussed below. Other details are shown adjacent. (fig 26)
