Heritage Impact Statement

2539 Agricola St

CLIENTS
Bruno Ruffinengo, Karen Schnare
and Grant Ruffinengo

Prepared by
EcoGreen Homes
2159 GOTTINGEN STREET
HALIFAX, NS B3K 3B5
902-412-2329
info@ecogreenhomes.ca

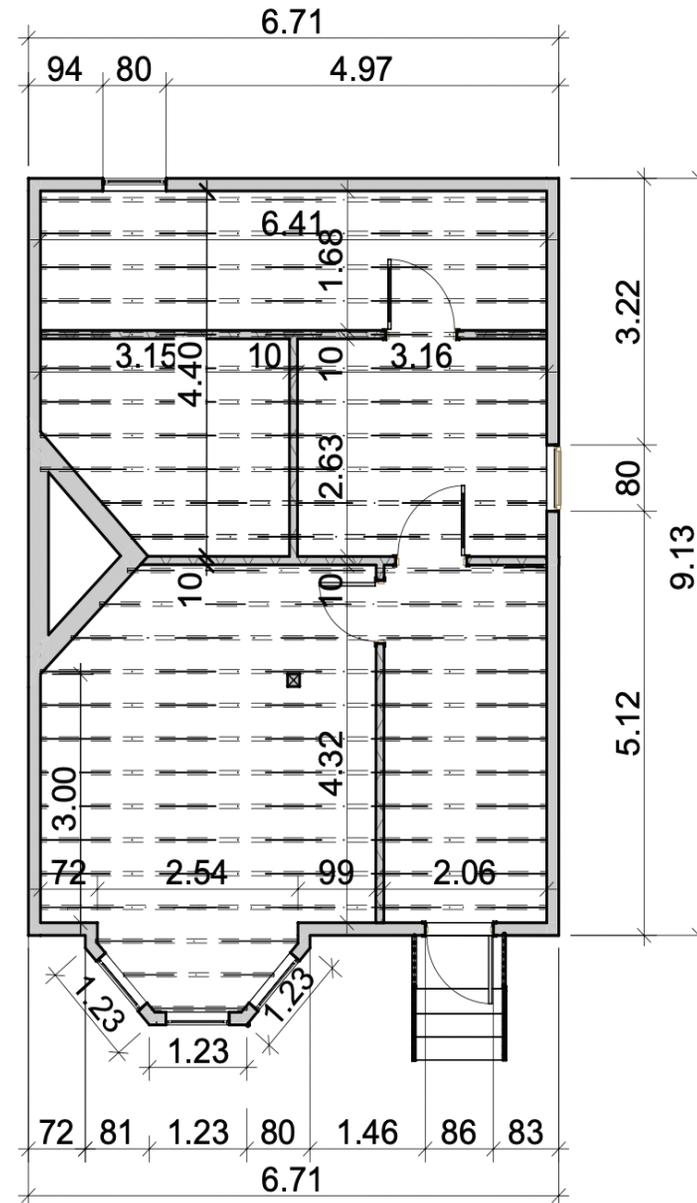
In our investigation of the of the existing structure of the house, we found that the floor joists run across the house on both the main and second floor. This makes it simple to retain the majority front portion of the house without compromising its structural integrity. The image shown here at right shows the existing main floor plans structure of the house. The second floor framing is identical except for the stair.

It is possible to cut the structure on any of the floor joists without compromising the remainder since all joists run across the width of the house. We tried to retain as much of the house as possible and still leave enough room behind for the new building. We found we could retain 54% but not more.

The existing site measured structure of the main floor is shown at the right. The second floor joists are the same orientation and have the same spacing on centre. The image on the page following shows the structural section of the house with portions to remain and to be removed. The roof ridge beam will be retained to maintain the existing structural integrity. The brick and rubble stone foundation will be removed as portions are structurally unsound. Besides being unsound, it has been parged over and not being original offers little heritage value. Only about 50 cm of the foundation is visible. The house will be re-seated on a reclaimed brick veneer energy efficient foundation. The renovation will be documented once work begins.

The house will be reinforced at the rear with a temporary new stud and plywood wall to prevent any possible damage or wracking during construction after consultation with our engineer. The temporary wall will be removed once the house is on new foundation and attached to the new structure behind.

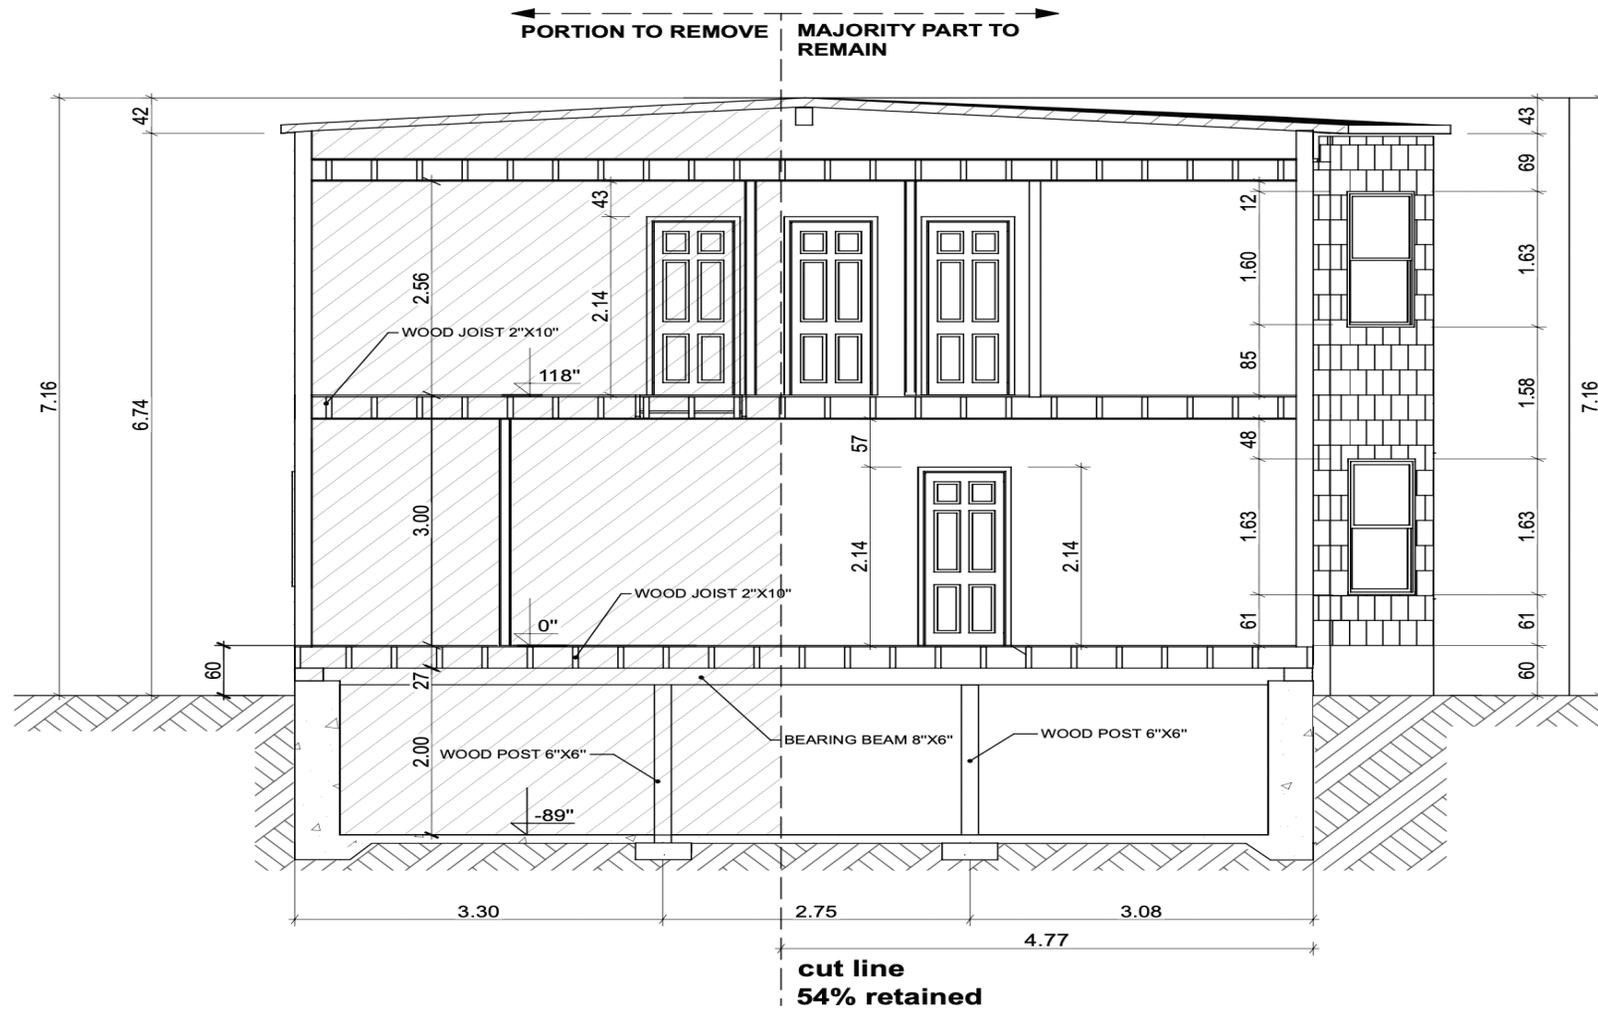
Fig 28. Showing removed and retained portions of Agrícola 2539

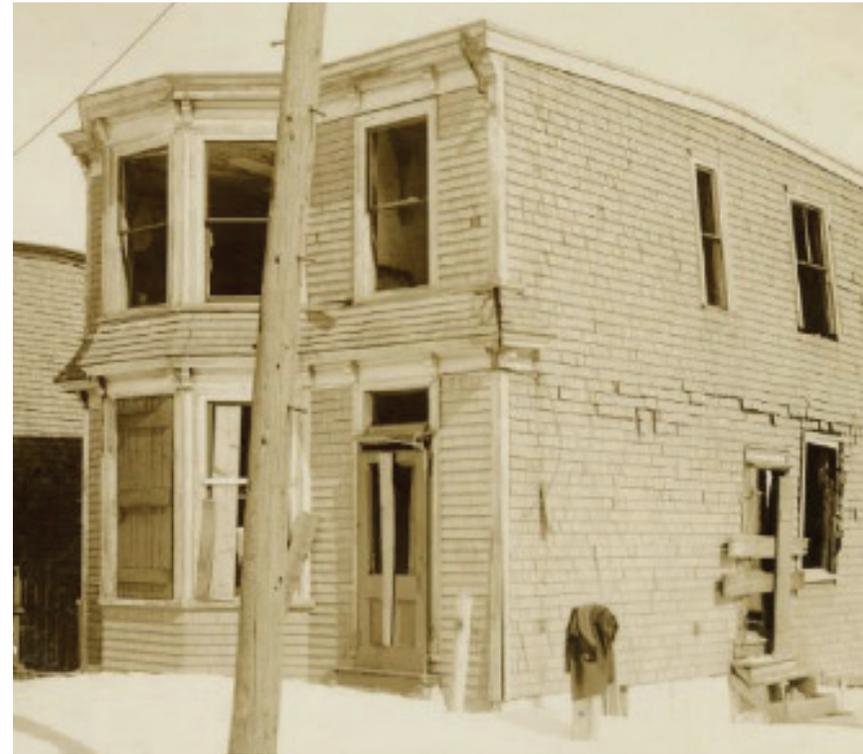
Fig. 31 Halifax Box House from explosion shows accurate scale of shingles. (Kitz, Janet, 1989).

The existing wood shingle siding is not original and the shingles are of too large a scale to be authentic for this age of home. Fig. 31 shows a similar house on Agricola Street, just after the Halifax explosion. We rely on this image for the scale of shingles as shown in our elevations following. The image is from the research report initiated by heritage staff to register the house. All the shingles on the Open Mic House will be re-placed with new pre-painted cedar shingles of this scale, including those shingles on the bump out.

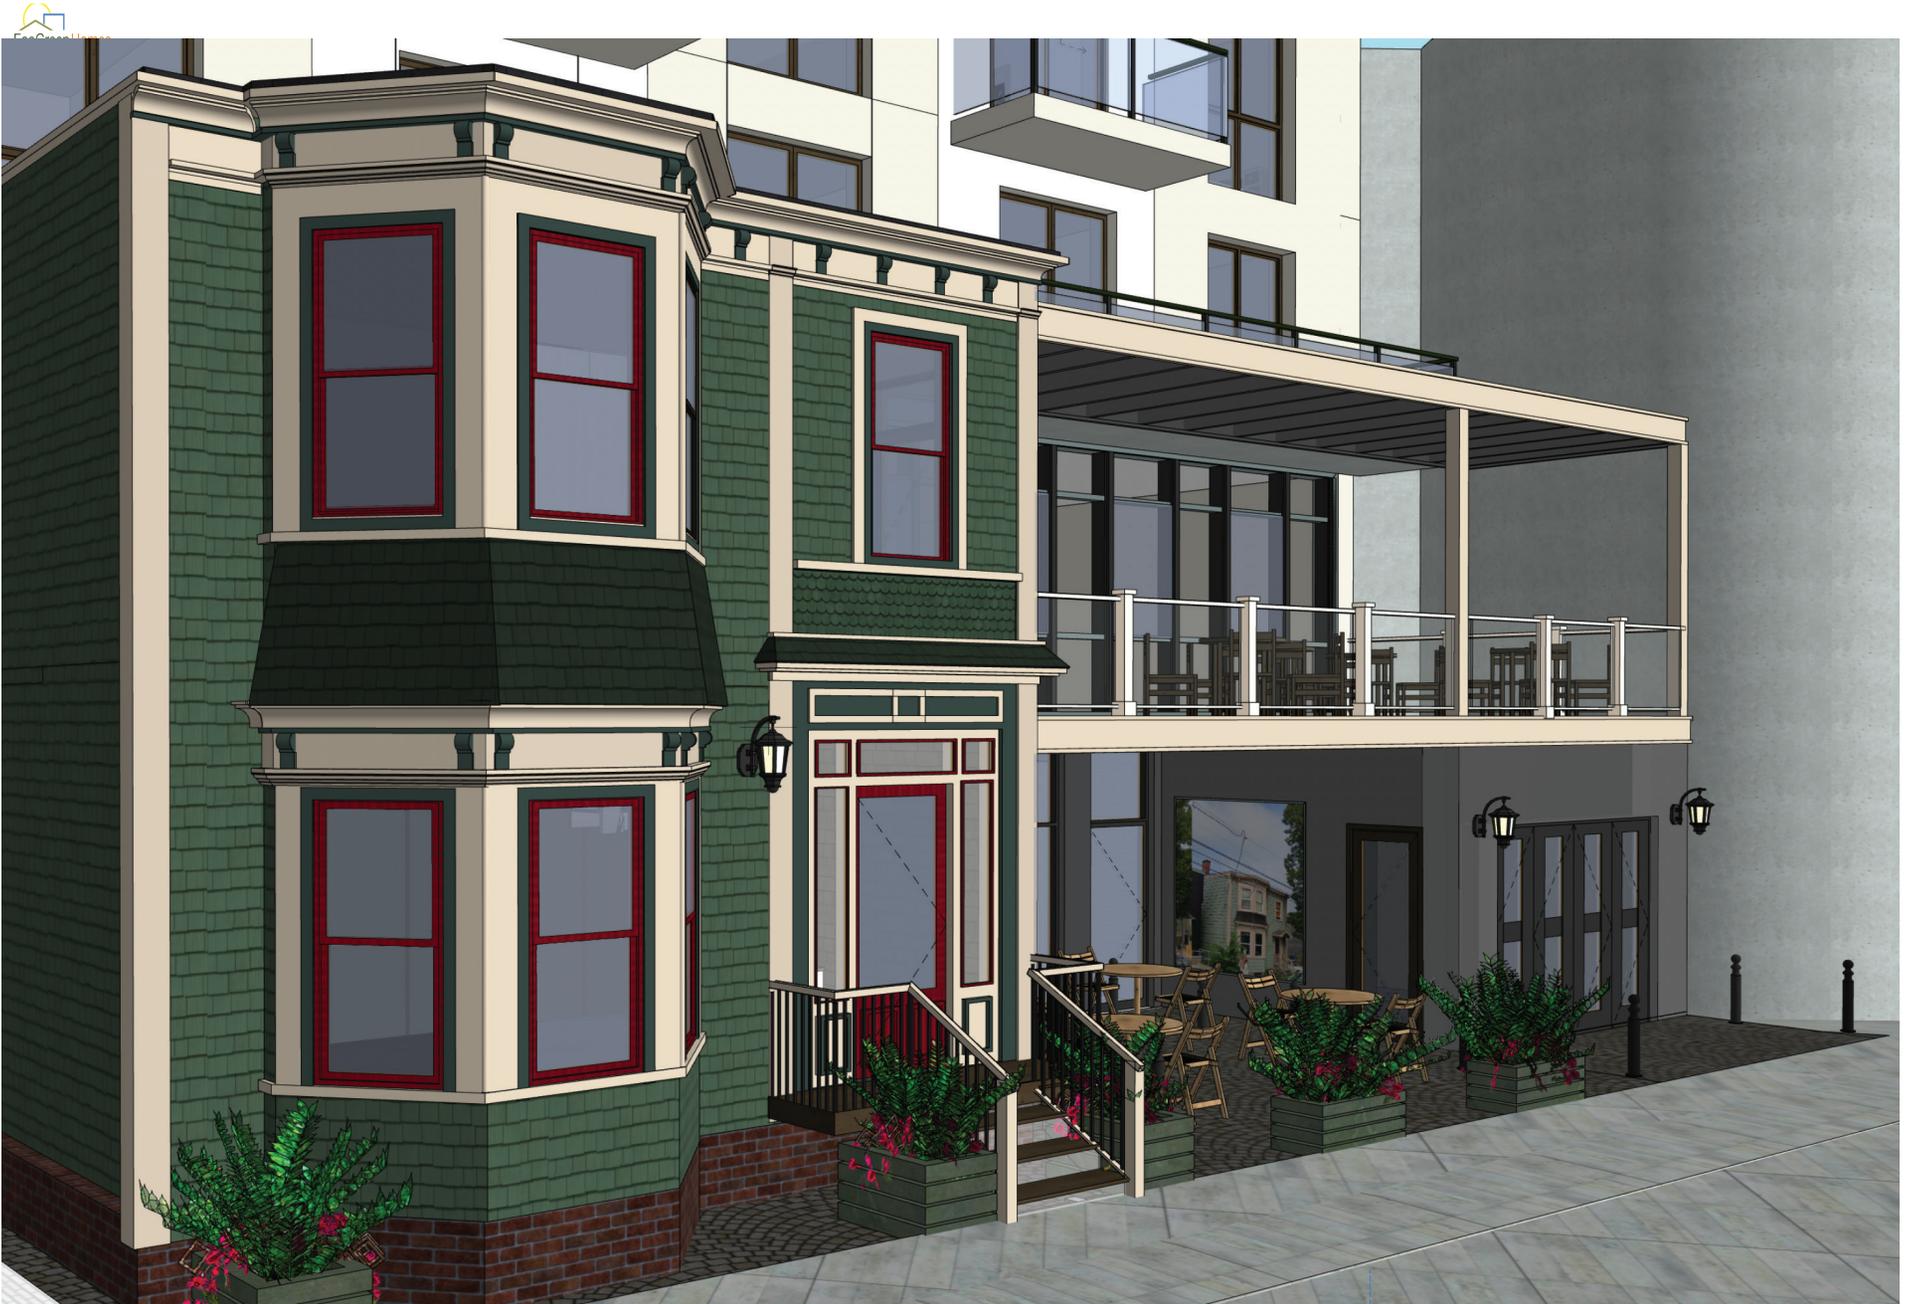
Fig 32. Showing “The Open Mic House” facade with complimentary extensions of horizontal elements into the new balcony using steel beams.

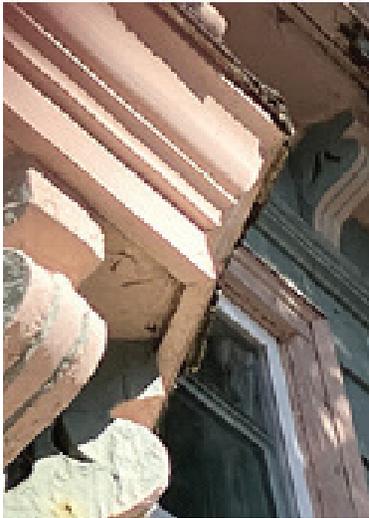
Fig. 33 Wood work will be scraped and repainted if not rotten or replaced using the original patterns.

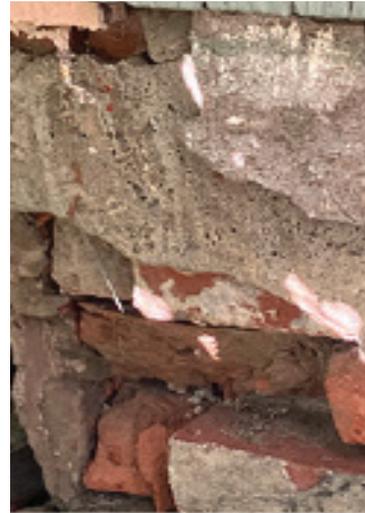
Fig. 35 Foundation is structurally unsound, and will be replaced with a new foundation featuring reclaimed brick veneer.

The existing brick and rubble foundation is structurally unsound and will be replaced with a new foundation featuring reclaimed brick veneer. During this phase the house will be supported in consultation with our structural engineer. The heritage woodwork will be repainted as possible or repaired, or if needed replaced with new wood to appear as original.

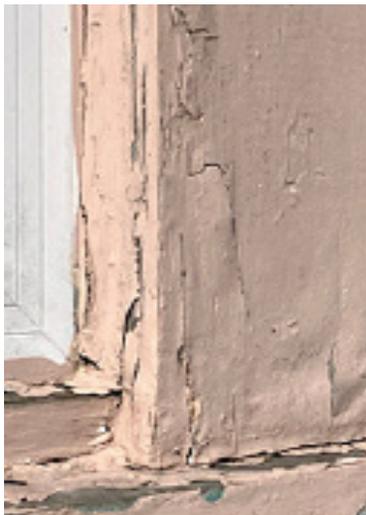
Fig. 34 The window trim is mostly rotten and will be replaced. The vinyl windows are outworn and will be replaced with triple glazed vinyl windows to look original

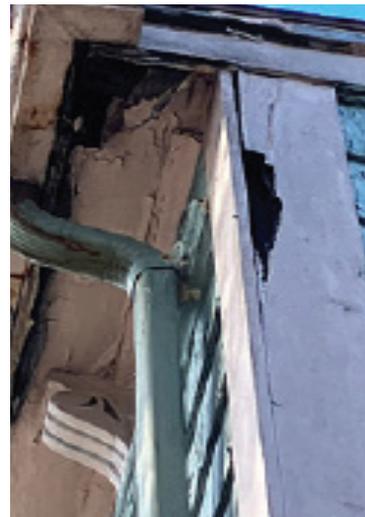
Fig. 36 Soffits and corner boards will be repaired or replaced and repainted.

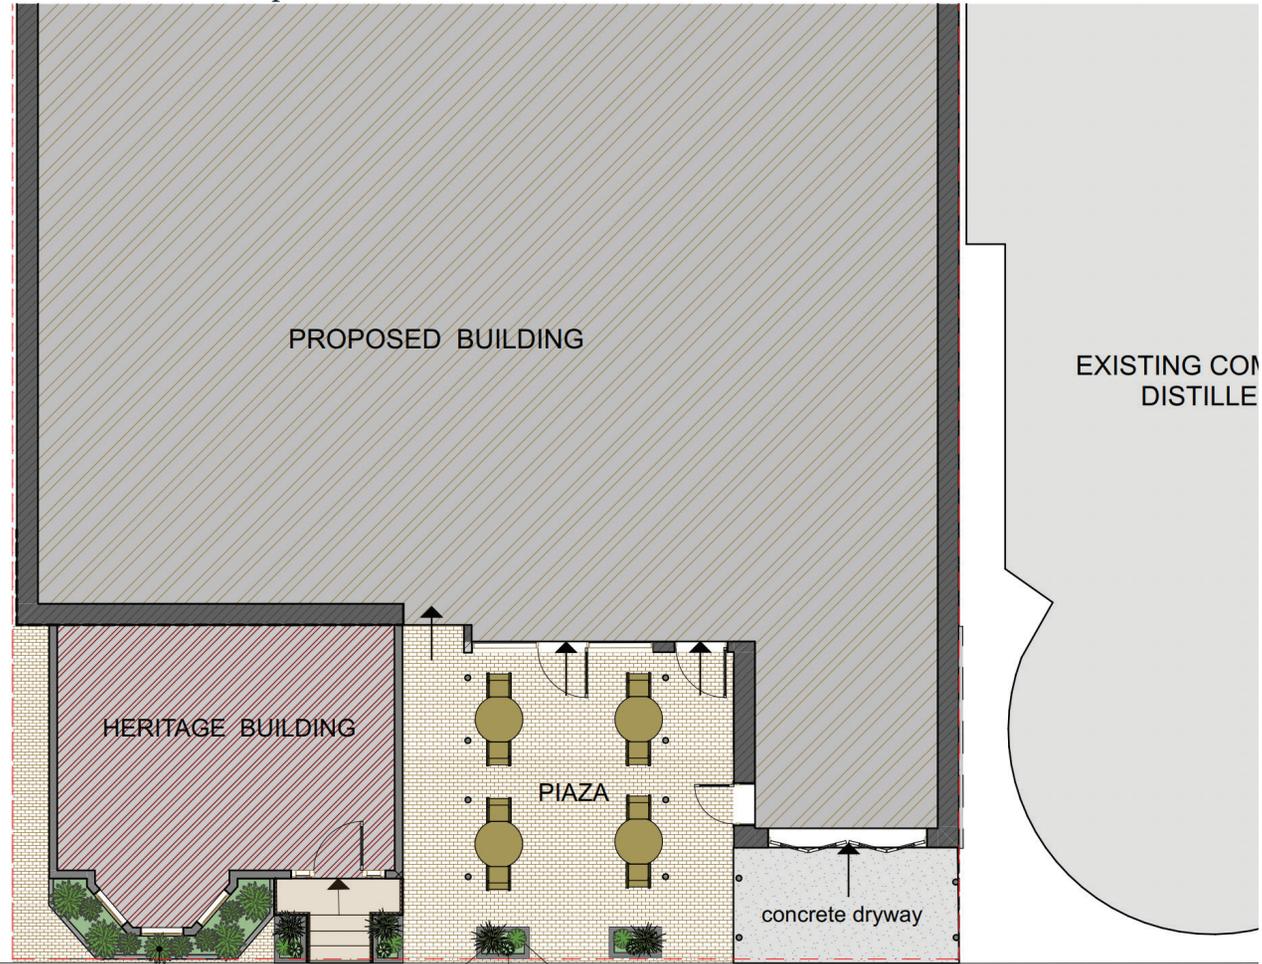
Landscaping Plan

EXISTING 2 STOREY COMMERCIAL BUILDING

- PROPERTY LINE

- OUTDOOR FURNITURE

- CONCRETE PAVING

- CONCRETE DRYWAY

- ARCTOSTAPHYLOS INDIGENOUS

- NEW YORK ASTER

- COTTONEASTER DAMMERI

- JUNIPERUS HORIZONTALIS
